LESSON 5:

Caustic Gouging

R. Barry Dooley and Albert Bursik

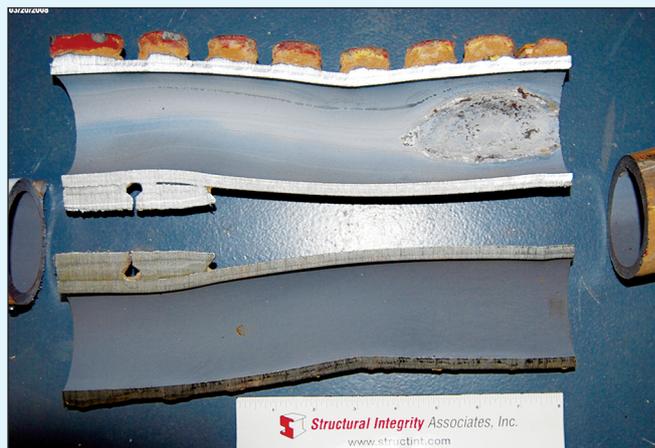
Figure 2:
Internal appearance of gouge.

Figure 1 is a photograph of a caustic gouging failure showing bulge on the outside of the tube. The internal appearance of the gouge is shown in Figures 2 and 3. This is a typical gouge on the tube inside caused by the flow disruption of the bend.

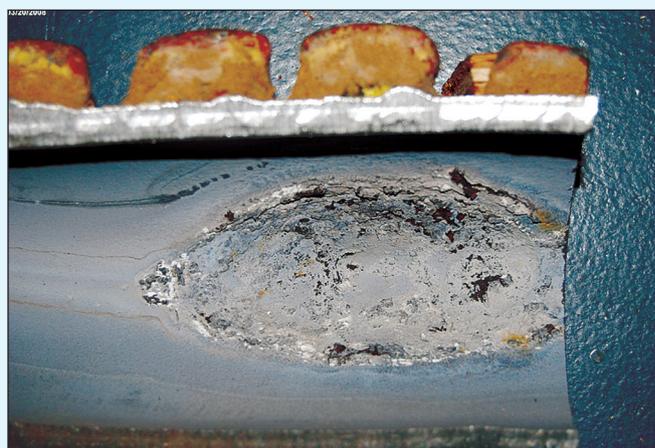
Figure 3 is a closeup view of the gouge. This is the classic shape of caustic gouging.

Figure 3:
Closeup view of gouge from Figure 2.

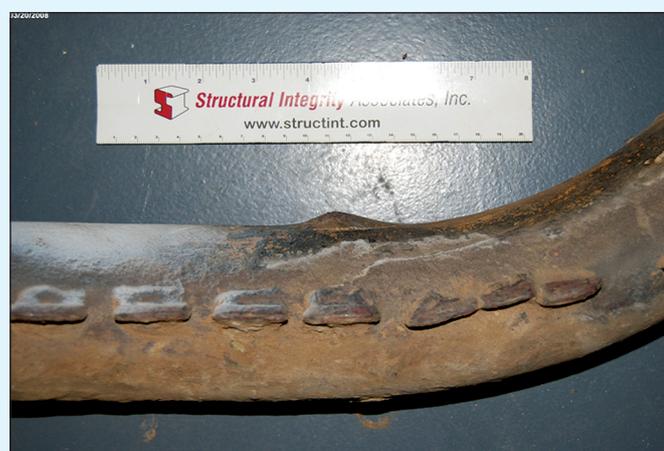
Figure 1:
Caustic gouging failure.

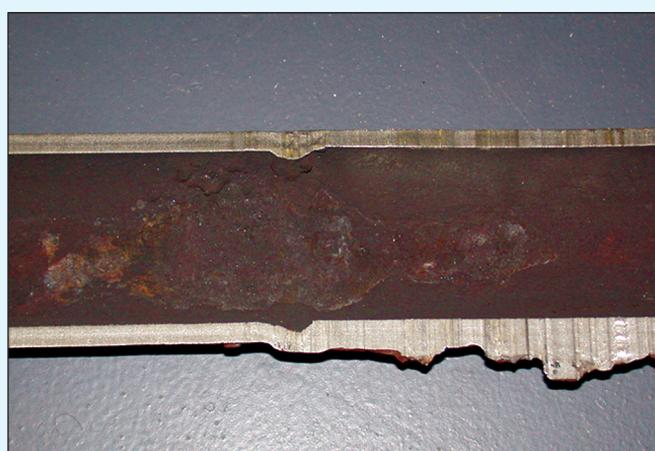
Figure 4 shows caustic gouging initiated at a tube to tube weld. The gouging has the typical appearance. Note the dirtiness of the tube internal surface. A view along the inside of a tube with heavy deposits and caustic gouging is presented in Figure 5.

Figure 4:
Caustic gouging at a weld.

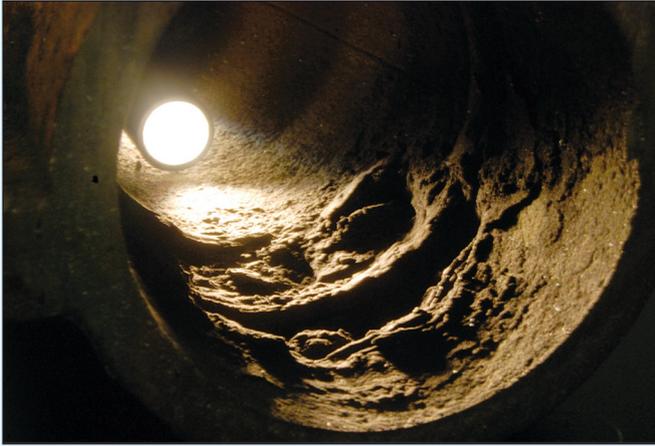
Figure 5:
Heavy deposits and caustic gouging.

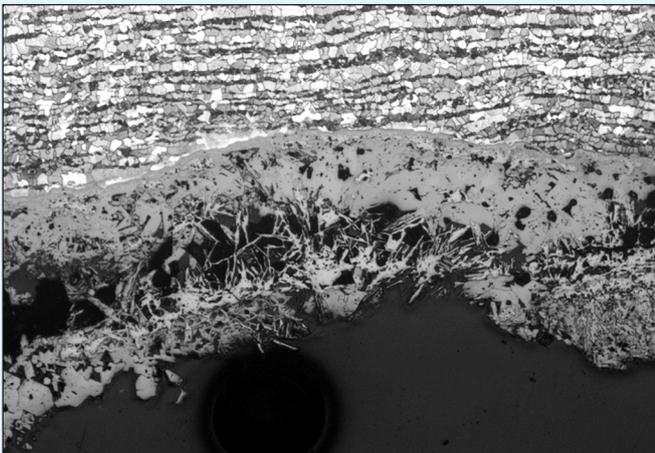
As discussed in the section *Mechanism of Caustic Gouging Failure*, sodium ferroate and ferroite crystals are formed by fluxing of the magnetite or the base metal. The appearance of these crystals is one of the most important distinguishing features of caustic gouging. You may see these crystals in [Figure 6](#).

Figure 6:
Typical appearance of caustic gouging. Note the thick deposits and the typical crystals within the corrosion products.

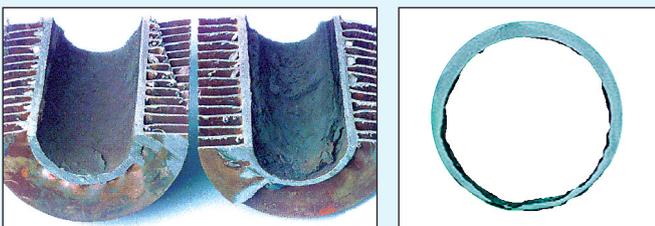
Figure 7:
Caustic gouging resulting from disturbed heat distribution, deposits and a subsequent concentration of caustic [3].

Caustic gouging may also occur in HP evaporators of HRSGs. [Figure 7](#) shows heavy deposits and gouging in a HRSG tube.
