ROOT CAUSES OF TRANSIENT TUBE TEMPERATURE ANOMALIES MEASURED IN HORIZONTAL GAS PATH HRSGS

J. M. Pearson,
J. Michael Pearson & Associates Co.Ltd.
1 Bela Court, Caledon East, Ontario, L0N1E0, Canada
R. W. Anderson
Florida Power Corporation, St Petersburg, Florida

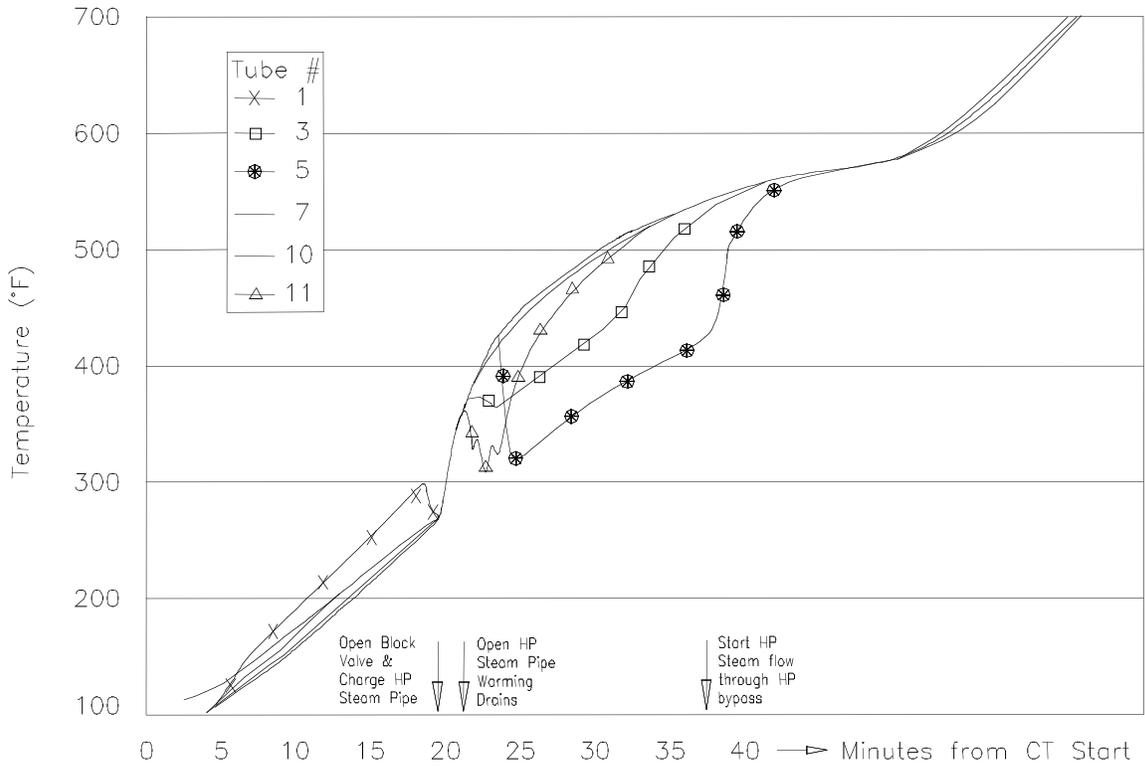
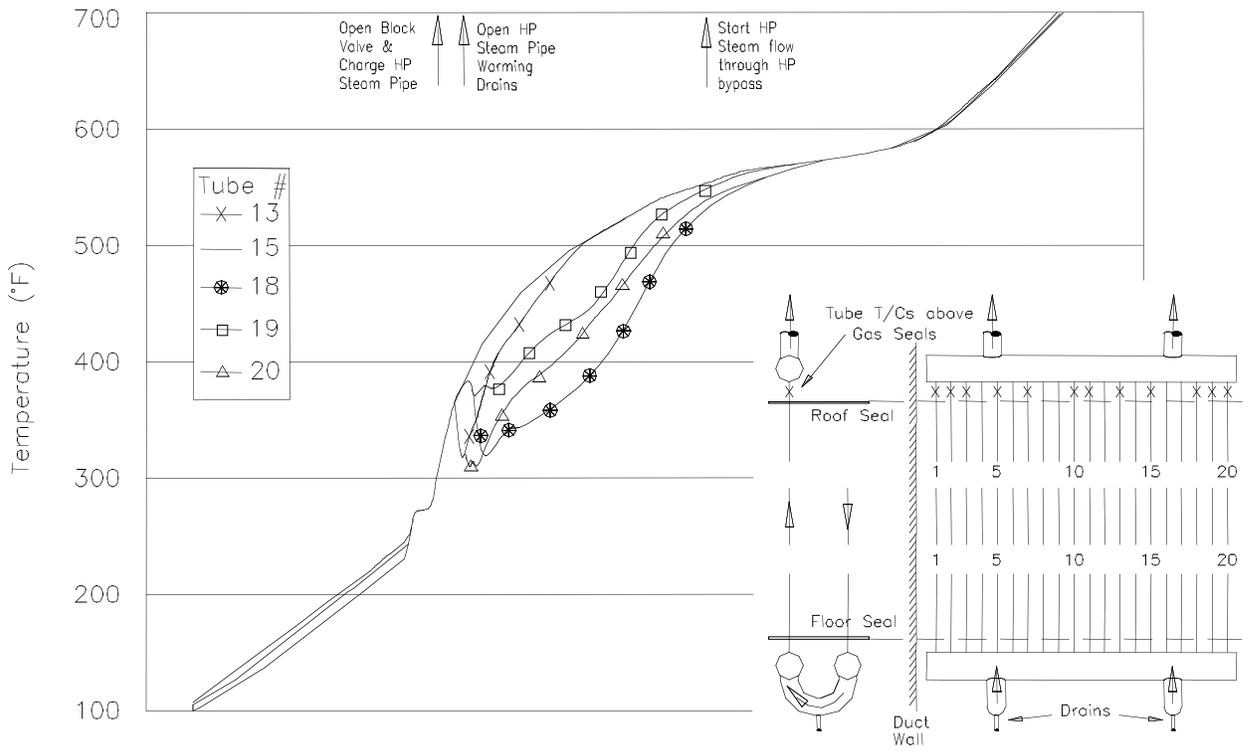
Fig. 1 – HP Superheater Outlet Tube Row Arrangement and Tube Outlet Temperature at Cold Start

The most widespread cause of tube temperature anomalies in HP superheaters and reheaters is failure to completely remove all condensate from lower sections of tubes, headers, steam pipes, manifolds, attenuators, etc, during CT/HRSG startups prior to establishing any steam flow from superheater or reheater. Figure 1 highlights during a typical cold start that even though superheater and reheater drains had been opened long before the startup and remained open, when a small flow of HP steam was established to warm the HP steam pipes, the consequential small pressure drop through the superheater caused condensate and saturated steam mixture to be displaced forward and upwards selectively through some tubes of the final steam outlet row of tubes, chilling those tubes at their outlet by up to 135°F relative to other tubes which continued to follow the rise in gas temperature. Even though the condensate or saturated steam has been heated during passage upwards to the thermocouple position at the top of the 65 foot long tubes, tube #5 remained at saturation temperature at tube outlet for about 15 minutes. Notwithstanding that this HRSG is nominally provided with drains at all low points of superheaters, and the blowdown vessel is installed in a pit to facilitate continuous drain pipe fall to the vessel, a substantial quantity of condensate could not be removed and was finally cleared into the hotter outlet pipe and header when the HP bypass valve opened and established a larger steam flow. A similar phenomenon was measured on tubes of all earlier sections of the superheater.

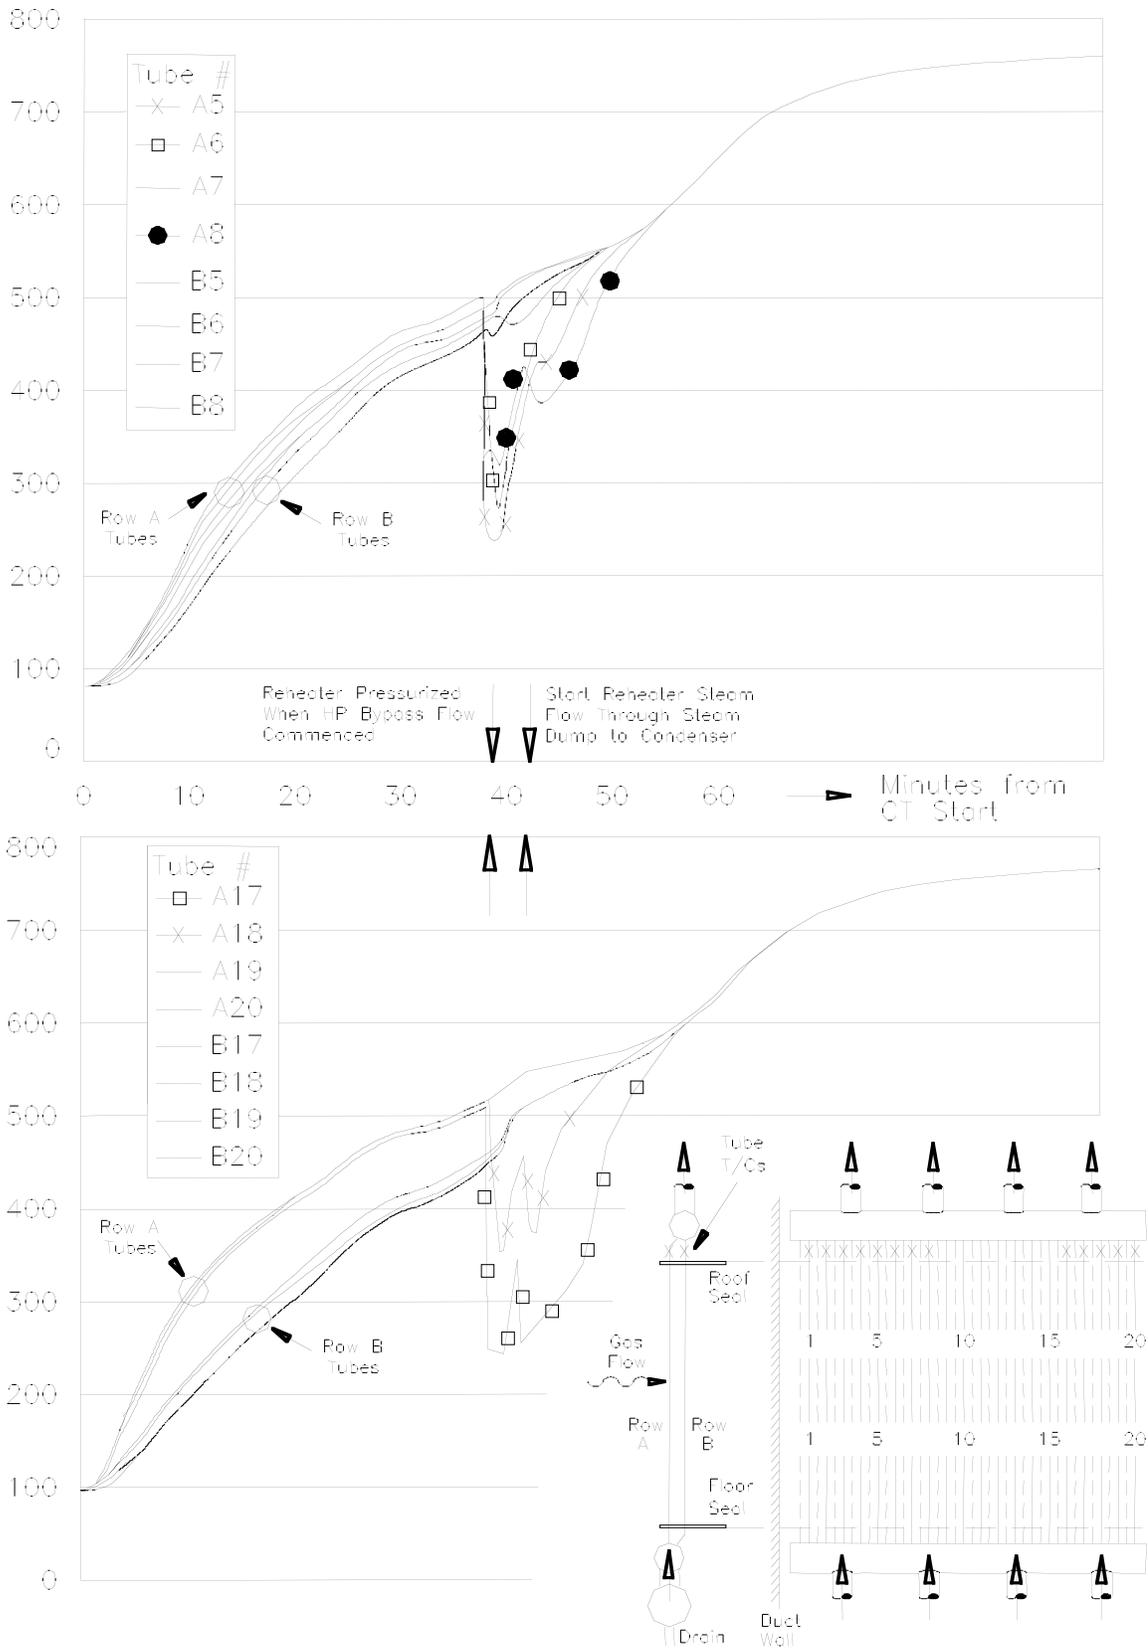
Fig. 2 – Reheater Outlet Tube Rows Arrangement and Tube Outlet Temperature at Cold Start

During the same typical cold start, a similar phenomenon occurred in all sections of the reheater which were also expected to have completely drained prior to startup. The steam outlet section of the reheater comprises two staggered rows of upflow tubes with both rows attached to the same upper and lower headers with each tube offset from one of the headers, which significantly intensifies the maximum thermal stresses caused by tube-to-tube temperature differences. Figure 2 highlights that during the initial part of the startup when conditions inside the reheater were stagnant the uncooled row A tubes which are exposed to inlet gas flow heated up quicker than the row B tubes. Some reheater row A tubes were up to 100°F hotter than adjacent row B tubes, which may be large enough to cause localized inelastic stresses, thus creep-fatigue damage, at

the weld of offset tube to the header. Even more disturbing, when forward flow was established through the reheater during pressurization from HP bypass steam flow to the cold reheat pipe, undrained condensate remaining in lower sections of the reheater was displaced forward and blown up selectively through some of the row A tubes. Tube #A18 was chilled at outlet 320°F below most of the nearby tubes, and severe inelastic stresses occurred at the weld of this offset tube to the upper outlet header which are likely to initiate creep-fatigue cracks in the weld after a small number of similar cycles. Some other row A tubes were also chilled at outlet by condensate or saturated steam. More condensate was displaced forward for several minutes through a few tubes after hot reheat steam flow was initiated. The phenomenon was never observed in any row B tubes, which at inlet are offset towards the side of the header, and tended to be more prevalent on row A tubes with inlets positioned in proximity and opposite one of the header inlet pipe branches and in tubes near to one or other blind end of the header, suggesting that the headers tilt from horizontal during the shutdown and startup. Similar behavior was observed at tubes in earlier stages of the reheater.

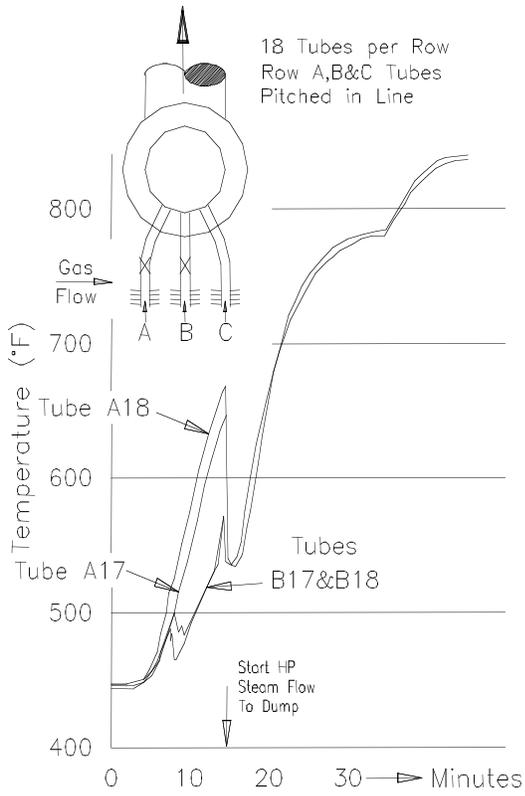
Fig. 3 – Tube Temperature at Outlet from Final HP SH Panel – Hot Start

The phenomenon of selective chilling of some tubes by condensate immediately after establishing forward flow and pressure gradient through the HP superheater has been observed in tube temperature measurements on several different designs of HGP HRSGs during cold, warm and hot starts. Tube temperatures recorded during a typical hot start on a different design of large, non-reheat HRSG are illustrated in Figures 3 and 4. The final outlet section of this superheater has three rows of tubes with 18 tubes in each row, arranged in-line parallel to the direction of gas flow, Fig 3. Row B tubes are perfectly straight and connected at bottom- and top-dead centers of upper and lower headers, respectively. Row A and row C tubes are each offset and connected by small radius bends to upper and lower headers, which intensifies the maximum thermal stress developed by any thermally-induced forces in these tubes. Prior to establishing any flow in the superheater, row A tubes which are most directly exposed to the inlet gas flow, were heated up to 120°F above the row B tubes. At the steam inlet to the second stage HP superheater, positioned in the steam path after the desuperheater, the row A tubes of this panel were heated more than 200F above the row B tubes, Fig, 4, and developed high thermally induced stresses at the attachment of the offset row A tubes to the headers. When steam flow was initiated, a substantial quantity of condensate was blown forward through many tubes in all sections of the superheater, Figs. 3 & 4, chilling tubes and quench cooling the tube holes through the outlet header wall. This HRSG was installed without any means for removing condensate when the unit is warm or hot.

Figures 2, 3 and 4 all highlight that significant temperature differences of between 100°F and 200°F developed in different designs of HRSG between the first and second rows of tubes attached to the same pair of headers during the initial stages of CT startup before a cooling flow of steam could be established through the tubes. Inevitably, when more than one row of tubes is attached to the same upper and lower header, at least one of the tubes will be offset which significantly increases the maximum thermally-induced stress at the attachment weld of the offset tube to the header.

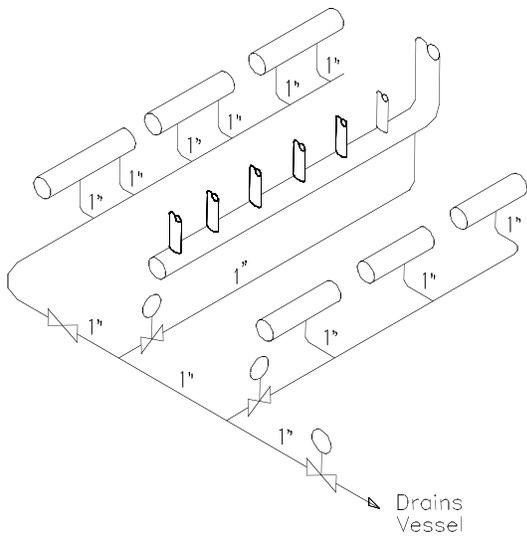
Fig. 5 – INCORRECT Interconnection of Superheater Drains to Disposal

- Drains from different sections of the superheater are often incorrectly interconnected into a single common drain pipe to the blowdown vessel, Fig. 5, because that is the cheapest installation and the importance of reliable condensate drainage to cyclic life of superheater and reheater components is not generally appreciated. Drains from different sections of superheater, (likewise for reheater), which operate at any time at different pressures should never be interconnected. The correct arrangement and sizing for the superheater drains is illustrated in Fig. 6. The drains from each different section must be connected directly to a manifold on the blowdown vessel and have separate, duplicate, motor-operated isolation valves to ensure tight shutoff is maintained. Much of the damaging condensate blown out of the final superheater tubes in Figure 1 came from earlier, separately-drained sections of the superheater through the superheater drain pipes which had been interconnected into a single small bore pipe which was supposed to drain all condensate to the blowdown vessel, as illustrated in Fig. 5. As a result of interconnecting, in this example, ten nominally 1" diameter drain pipes taken from 3 different superheater sections into a single 1" diameter longer pipe of identical flow area, then when steam flow and thus pressure drop was established through the superheater the path of least resistance route for condensate from the higher pressure sections of the superheater was through the six 1" drain connections intended to remove condensate from the final section of the superheater, rather than through the single 1" pipe to the blowdown vessel.

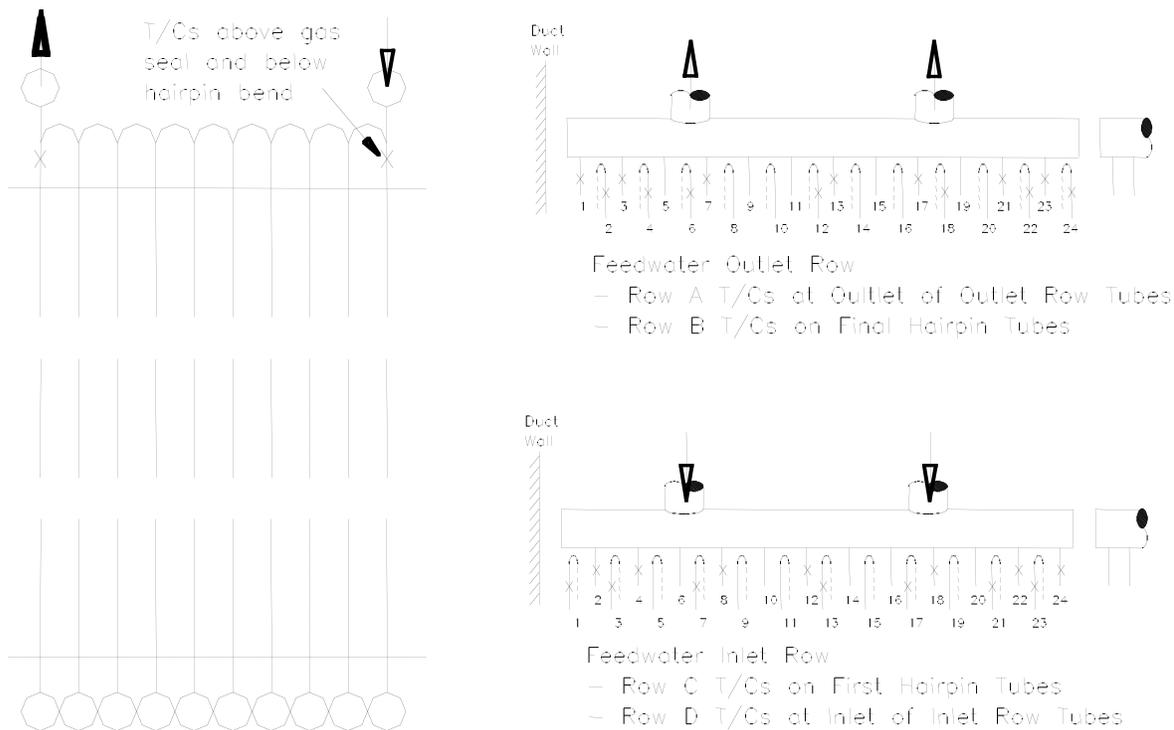
Fig. 7 – Hairpin Tube Economizer Module

Figure 7 illustrates the conceptual features of a typical hairpin tube type of module for an HP, IP or LP economizer. This type of economizer has highpoints at the top of numerous hairpin tube bends that are practically impossible to vent. The design intent is for economizer inlet feedwater to pass from upper inlet header down a row of 12 straight tubes to a lower return header. 12 inverted hairpin tubes, each pitched between a pair of inlet row tubes on the lower return header, pass the feedwater to the next lower return header. The feedwater passes through a series of hairpin tubes to the final lower return header. Finally, 12 straight outlet row tubes convey the feedwater up to an upper economizer outlet header. The rise in feedwater temperature through each hairpin loop is typically between 10 to 20°F. Velocities and pressure drop through each hairpin loop are usually small, so that if one or more hairpin tubes in a row remains air-locked or vapor-locked, then flow increases in the unblocked tubes and pressure drop rises by a very small amount. Provided that the flowing tubes can transfer sufficient heat for the HRSG to produce its rated evaporation, there is no means of detecting that some hairpin tubes are obstructed by an air-lock or vapor-lock and only partially filled with stagnant feedwater, except by installing thermocouples on hundreds of individual tubes.

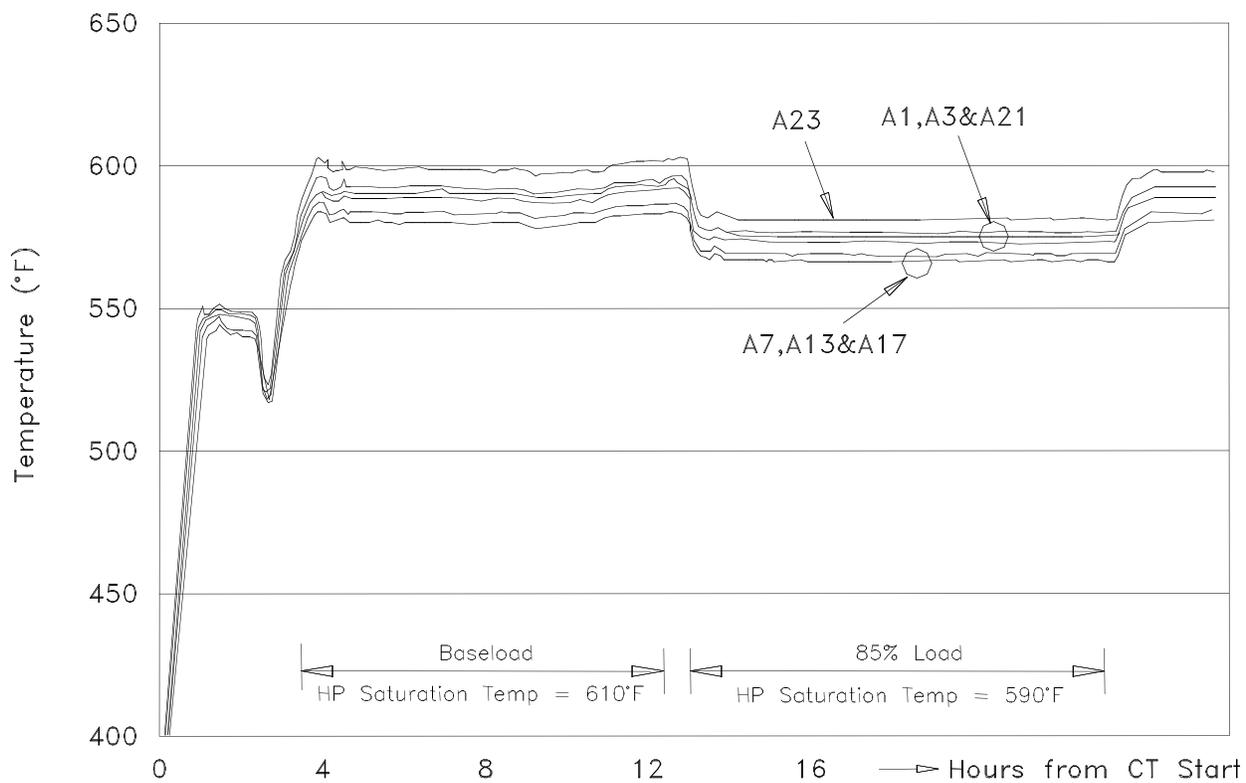
Fig. 8 – HP Final Economizer Module – Tubes Before Outlet Header

Figure 8 provides temperatures measured at the outlet of seven of the twelve outlet- row tubes of one of three identical modules, which comprise the final HP economizer section of a large HRSG. The temperatures of those tubes, as measured by thermocouple, remain within a spread of 20°F and range from about 10 to 30°F below saturation temperature. There is nothing in Figure 8 to indicate whether or not there is steaming in the earlier tube rows of this economizer. However, temperatures measured below the hairpin bend but above the roof seal on seven of twelve final row hairpin tubes, Fig. 9, indicate that during a typical startup and throughout several hours of operation at baseload and 85% load, four of the seven tubes fitted with a

thermocouple remain 15 to 45°F above the saturation temperature of feedwater in the tubes and close to the gas inlet temperature to the section, indicating that the upper parts of these tubes are dry, and whatever water is in the lower parts of these tubes is stagnant. The other three tubes with thermocouples, and probably the majority of the hairpin tubes in the same row without thermocouples, operate with feedwater temperature about 25 to 45°F below saturation temperature. In the first hairpin tube row following the economizer inlet tubes one tube is vapor-locked or air-locked continuously and the adjacent hairpin tube is also obstructed by vapor for several hours, Fig. 10. The hairpin tubes with stagnated flow are those closest to the end of headers, which have a smaller pressure drop than those closer to the inlet and outlet branches, and are also most affected by leakage of any hot gas along duct sidewall and in the gap between adjacent modules. The stagnation of feed flow through the hairpin tubes at each end of the header also caused flow to stagnate or recirculate upwards in the end tubes of the inlet row of the economizer, Fig 11. Four of seven inlet row tubes installed with a thermocouple at tube inlet record temperatures of the order of 100°F above the temperature of the incoming feedwater.

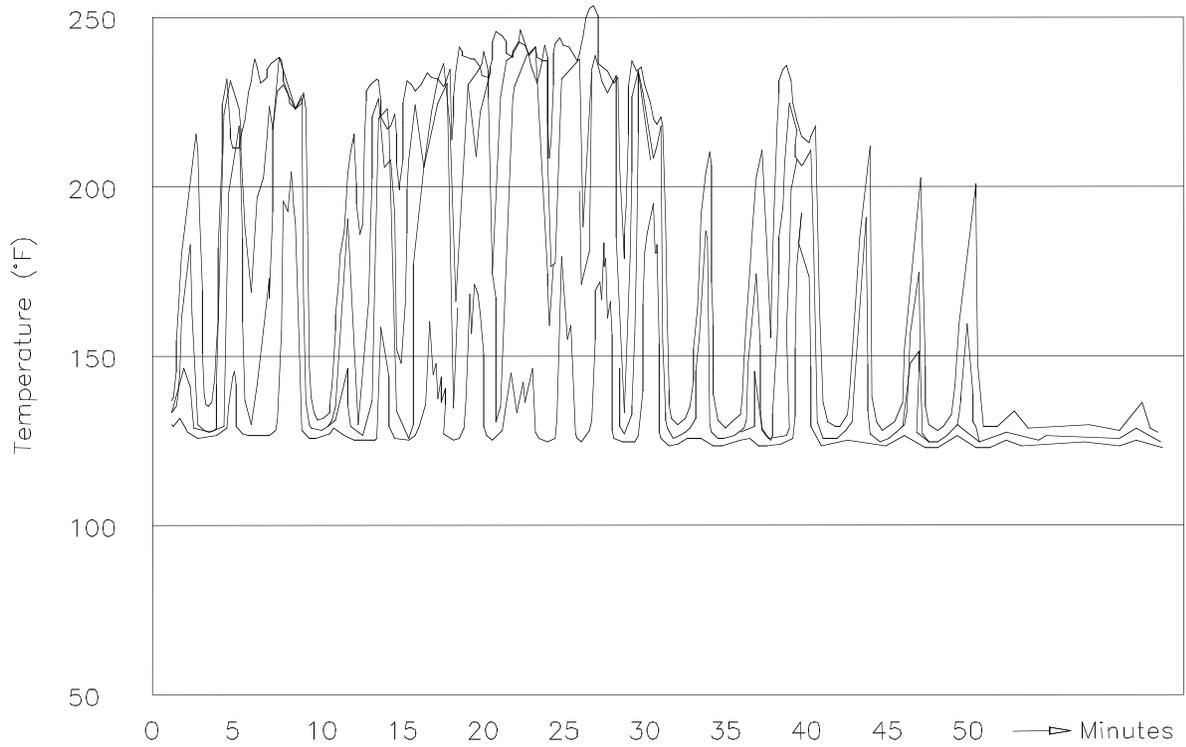
Fig. 13 – LP Economizer Module – Inlet to Inlet Row Tubes

The phenomenon, of large differences in temperatures of tubes in the same row attributed to air- or vapor-locks obstructing flow in some hairpin tubes, occurred consistently during many startups over several months. The phenomenon was equally evident and more pronounced in IP and LP economizers. For example, during the same event recorded for the final HP economizer in Figures 8 to 11, four of seven LP economizer outlet row tubes fitted with a thermocouple at their outlet end operated consistently between 35 and 70°F above saturation temperature and close to the gas temperature at the inlet to the LP economizer, Fig 12. Furthermore, after feedwater flow commenced the temperature of some tubes fluctuated numerous times during a single startup of the CT as they cleared and re-stagnated in synchronism with sharp changes in feedwater flowrate probably caused by the continually fluctuating system resistance as vapor obstructions were cleared from tubes and then returned, Fig 13.

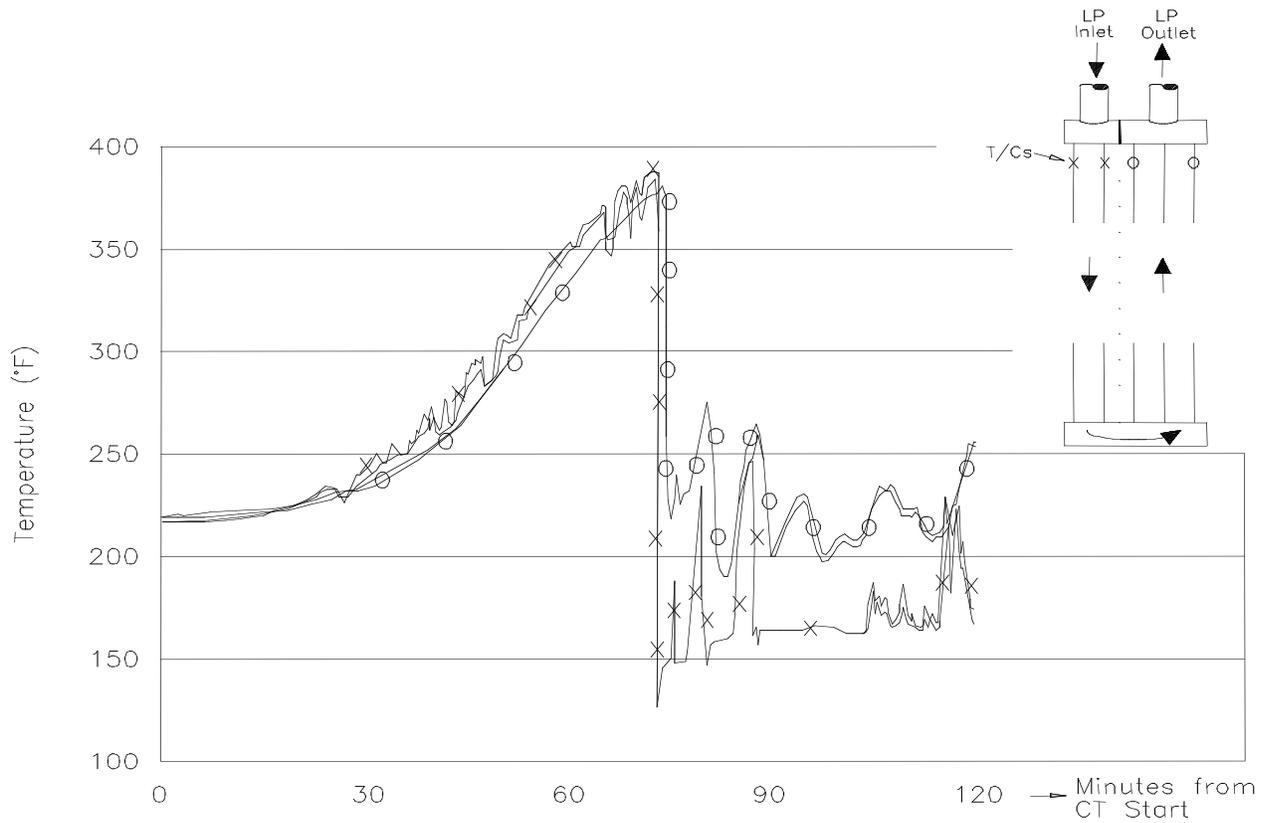
Fig. 15 – Two Pass LP Economizer Panel with Division Plate in Upper Header

lower return header and to a common upper header with an internal division plate to separate the inlet from outlet feedwater. During the typical startup recorded in Figure 15, LP feedwater was not required until about 73 minutes after CT startup, by when the stagnant inlet and outlet pass tubes had all heated up to about 375°F. The initial flow of cold feedwater took of the order of one minute to flow down to the bottom of the inlet pass tubes displacing the hot water into the outlet pass tubes. When cold water reached the return header, transiently the inlet pass tubes were chilled to about 125°F while the outlet pass tubes were still at 375°F. Thus for a brief period, (which is all that is needed to develop the tube forces and inelastic thermal strains that cause localized plasticity and fatigue damage), the temperature difference between the two passes was about 250°F. This temperature difference is higher than those that have caused tube failures in economizer panels with shared upper and lower headers. On other units supplied with colder feedwater from the condenser, and when the commencement of LP feedwater flow is delayed and stagnant tubes heated above 400°F, the brief transient difference in average temperature of inlet and second pass tubes may exceed 300°F, which will develop very high thermal stresses at tube attachments to headers, especially in tubes that are offset from the vertical center-line of the header.

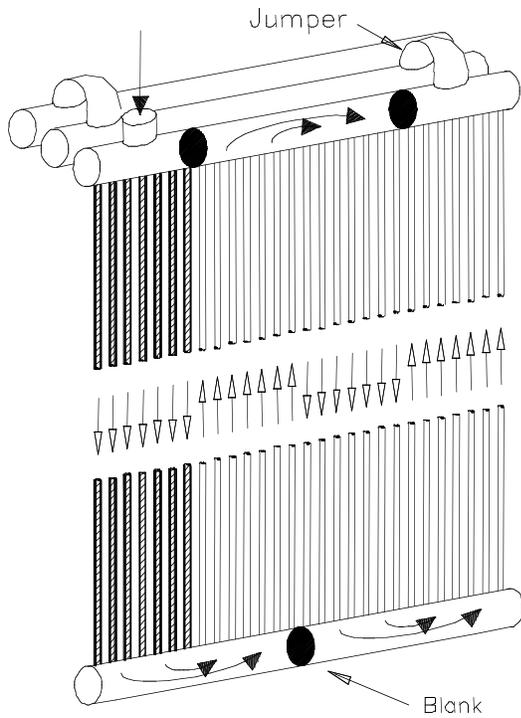
Fig. 16 – Typical Multipass Low Temp Economizer/Preheater Inlet Panel

Although physical separation of lower headers overcomes one design weakness, it does not address a related thermally-induced fatigue failure mechanism which affects many, but not all, HRSGs installed with economizers assembled from a series of panels arranged with two or more serpentine feedflow passes, Fig.16. The feedwater inlet panel of serpentine-type preheaters or of LP, IP and HP economizers that are supplied with cold feedwater water direct from the condenser without significant preheat are subjected to transiently large thermally-induced stresses in the tubes of the first two passes each time during startups that feedwater flow is introduced into stagnant economizer tubes heated to gas temperature. For example, the inlet panel of a small LP economizer section illustrated in Figure 15 comprises a downflowing inlet pass of two tubes and an upflowing return pass of three tubes. All five tubes are attached to a

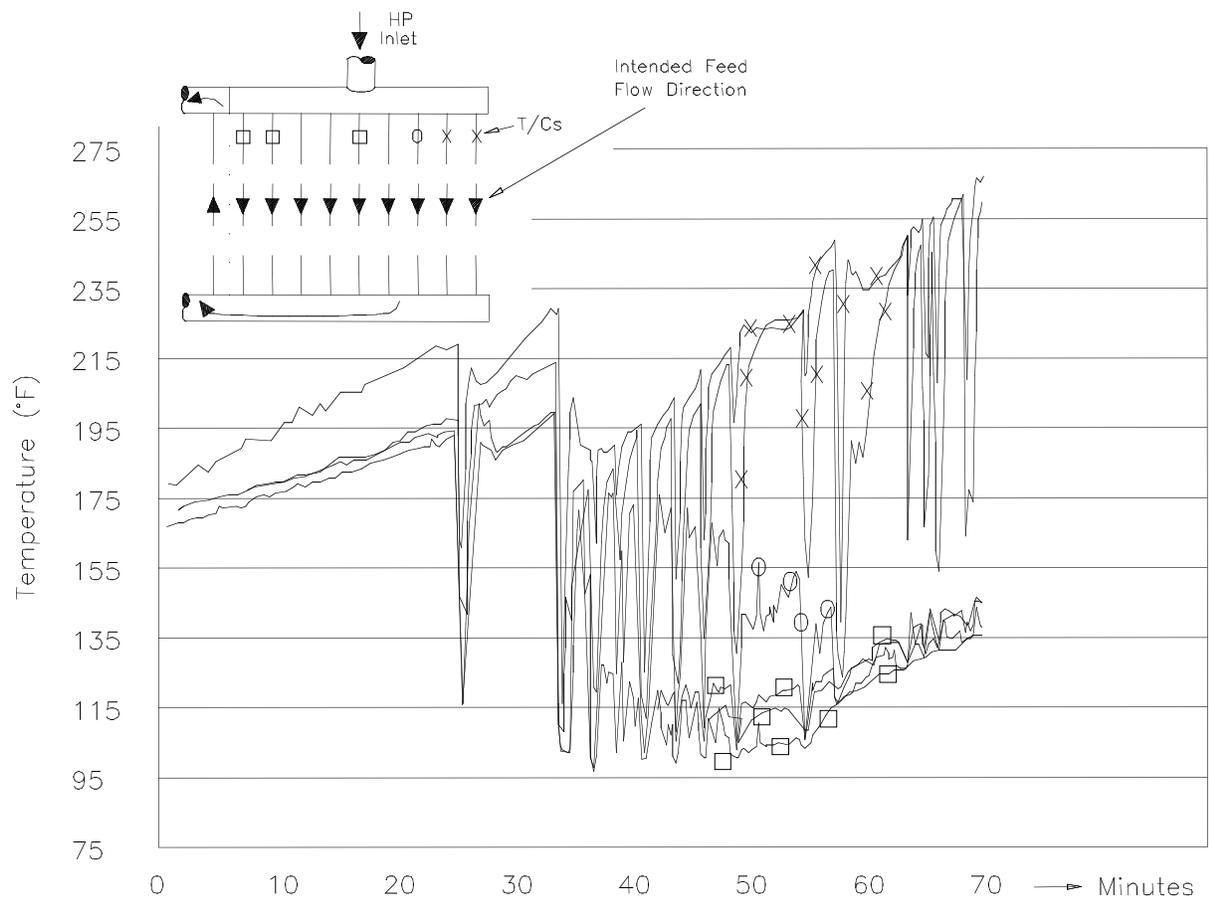
Fig. 18 – Inlet Pass Tubes of HP Economizer with Flow Recirculation in Tubes

Temperature measurements at the top and bottom of tubes in the first downflow pass of serpentine-type economizers have highlighted that buoyancy effects cause some tubes to reverse flow direction and recirculate feedwater from the lower return header back to the upper inlet header. Figure 18 highlights that immediately after HP feedwater flow commenced 32 minutes after CT startup the tube at the end of the header adjacent to the duct sidewall started to recirculate heated feedwater back to the inlet header. The same behavior is evident to a slightly lesser extent in the adjacent tube and, to a progressively reducing extent, also in the third tube from the header end for about 20 minutes after HP feedflow commenced. The feedwater recirculation phenomenon disappeared after feedwater flowrate increased above 50% of baseload flow provided also that rapid fluctuations in HP feedwater flow rate remained below +/-25%. The phenomenon occurs in tubes which have lower pressure drop between tube inlet and outlet, being furthest from the second pass in the lower header and also from the inlet branch on the upper header. Thus flow rate through these tubes is lower, and temperature rise and upward buoyancy forces higher. It is suspected that an air pocket may remain trapped at the blind end of the header and increases the system resistance from inlet branch to end tubes. Tubes adjacent to the duct sidewall may also pick up more heat from leakage of hot gas between tubes and duct wall.

In this case, the difference in average temperature of recirculating tubes and tubes flowing in the intended downward direction is about 65°F, being half the temperature difference measured at the top of the tubes. Although this is lower than tube temperature differences developed between economizer tubes by other undesirable design features, there are nevertheless concerns that the large number of thermal cycles experienced during each startup may lead to thermal fatigue failures in the affected tubes when the operating regime for the unit changes from baseload to cycling service.

Practical options to attempt to eliminate this design deficiency on installed units are limited. Improved baffles to reduce leakage of hot gas between tubes and duct sidewall and the installation of small vents on all upper headers of economizers may mitigate the problem. For new installations more attention must be given to ensuring that pressure drops through all downflowing tubes have adequate margin to be certain they overcome the upward buoyancy forces after account is taken of pressure gradients along upper and lower headers.
