Assessing and Controlling Corrosion in Air-Cooled Condensers

R. Barry Dooley, J. Denis Aspden, Andrew G. Howell, and Francois du Preez

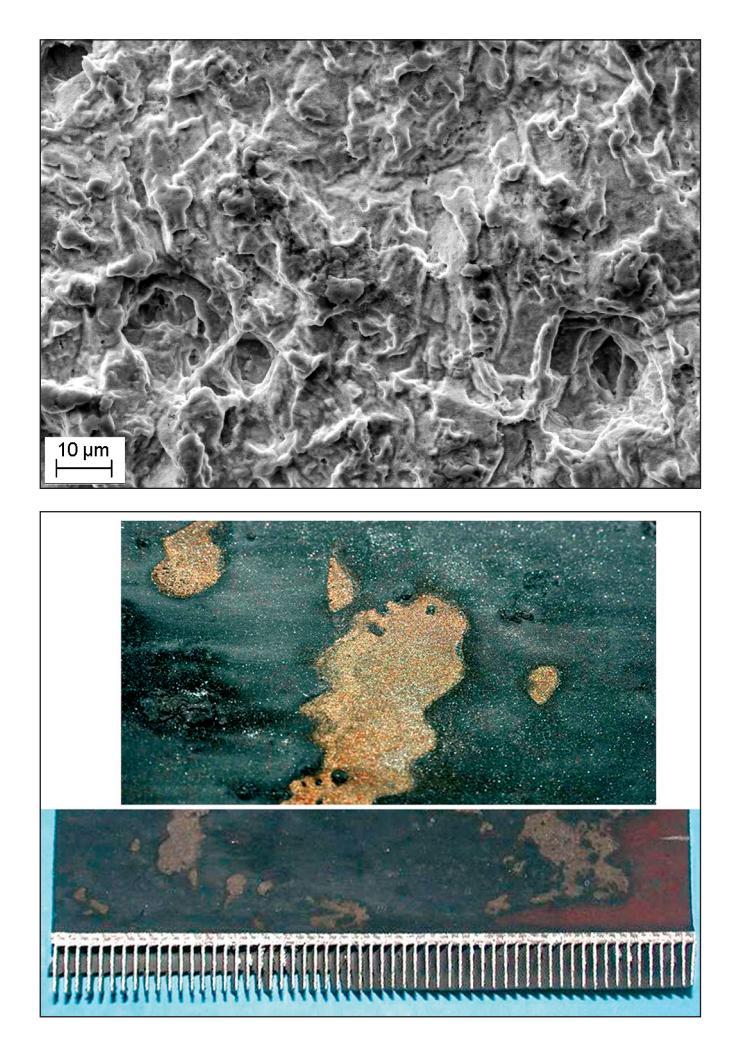
Figure 1 shows one of the two ACC tubes which have been subjected to a metallurgical analysis. The low magnification photograph of the surface of the ACC tube near to the tube entry clearly shows the adjacent black and white areas. The other two parts of the figure show details of the black areas, which are essentially deposited magnetite (upper part, left), and the white bare metal area, which has an intergranular appearance (upper part, right).

Details from the examination of an ACC tube section within about 38 cm (15 in) from the tube entry in the upper duct. The lower photograph shows the adjacent white and black areas on the tube surface. The two upper parts of the figure show surface metallographs of the black area after cleaning of the surface (left) and white bare metal (right).

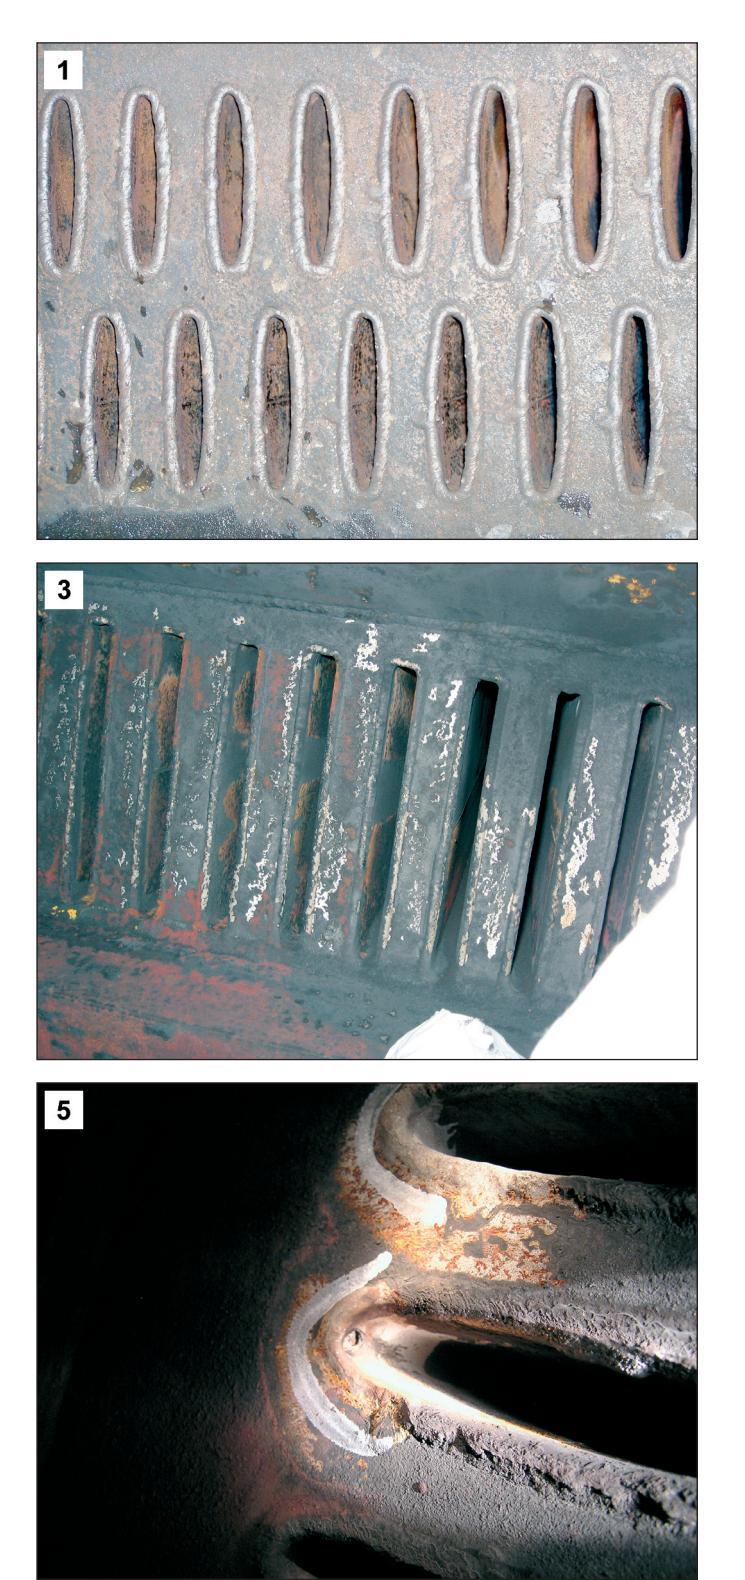
<u>Upper Section</u> (upper duct/header, ACC A-frame tube entries). Index: 1, 2, 3, 4 or 5. Examples are shown in <u>Figure 2</u>.

- 1. Tube entries in relatively good shape; possibly some areas with dark deposits in first few inches of tube interior. No corrosion or FAC.
- 2. Various black/grey deposits on tube entries as well as flash rust areas, but no white bare metal areas. Minimal corrosion/FAC.
- 3. Few white bare metal areas on a number of tube entries. Some black areas of deposit. Mild corrosion/FAC.
- Serious white (bare metal) areas on/at numerous tube entries. Extensive areas of black deposition adjacent to white areas within tubes. Serious corrosion/FAC.
- 5. Most serious. Holes in the tubing or welding. Obvious corrosion on many tube entries.

Figure 2: Montage illustrating DHACI indices 1–5 for the upper ducts and tube entries.

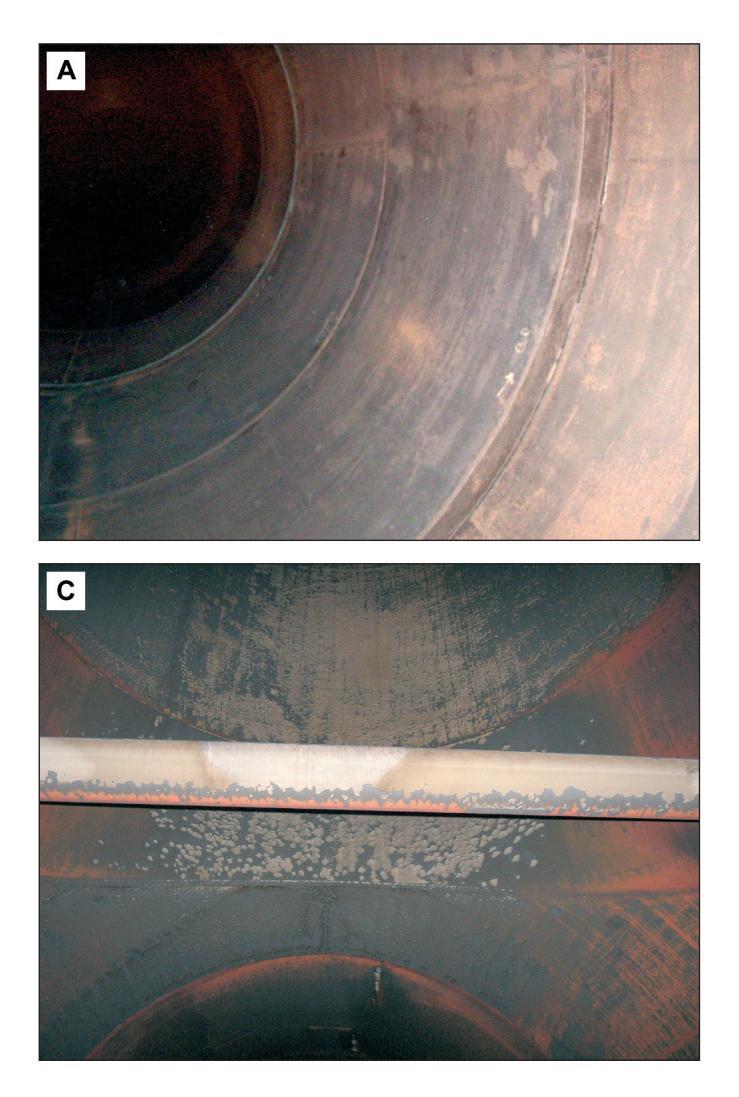
<u>Lower Section</u> (turbine exhaust, lower distribution duct, risers); rate A, B or C. Examples are shown in <u>Figure 3</u>.

- A. Ducts have no indication of damage and are grey in color.
- B. Minor white (bare metal) areas on generally grey ducts. Some 'tiger striping' appearance with darker grey/ black areas demonstrating two-phase flow-accelerated damage. Overall assessment is 'mild damage'.
- C. Multiple, widespread areas of bare metal in the turbine exhaust and at abrupt changes in flow direction (e.g. where steam flow enters vertical riser from lower distribution duct). White (bare metal) areas are evident indicators of metal loss. Severe local damage exists.

Montage illustrating DHACI indices A–C for the lower ducts from the steam turbine to the vertical risers to the upper duct.

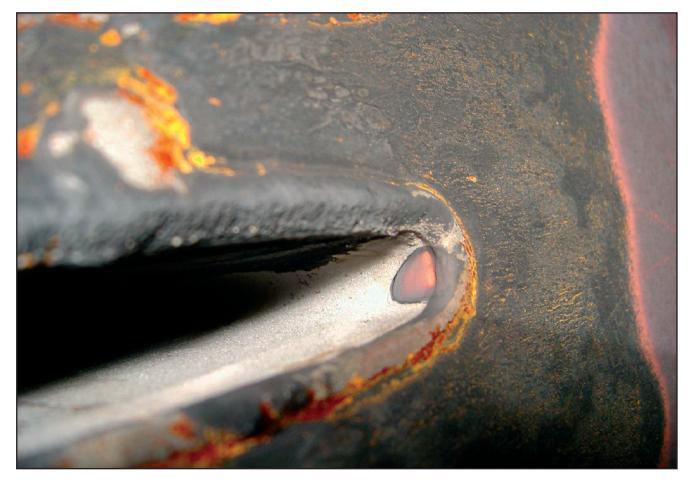
Figure 9:

Of immediate concern during the initial Matimba inspections was the perforation of the relatively thin wall, 1.5 mm (0.059 in), of the elliptical fin tube at the tube entry. Any perforations would result in an air leak into the vacuum space with an adverse effect on condenser performance. <u>Figure 9</u> shows a perforation in a tube entry surrounded by a large white corroded area. This white area is the same as the "bare metal areas" described in the introduction and is shown in more detail in Figure 1.

Through-wall penetration of the tube wall immediately below the seal weld at the tube entry. Also note the loss in material of the seal weld. This is recorded as DHACI 5.

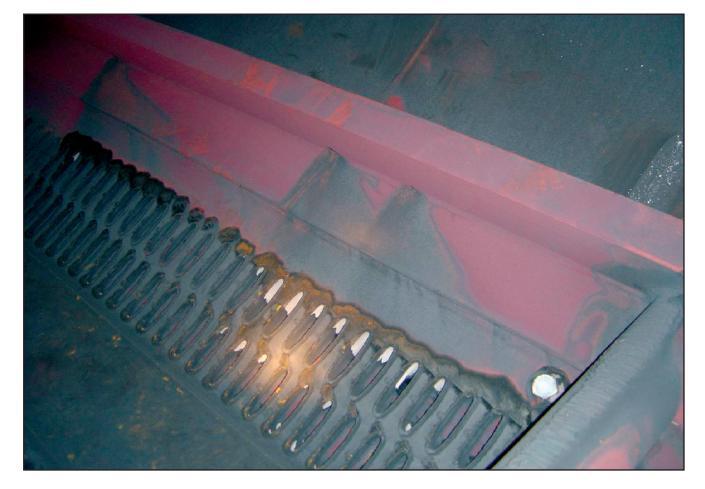
Figure 10 shows patches of white corroded areas in a number of tube entries in a location of high liquid concentration caused by the two drain holes in the channel immediately above the tube entries. These white areas have

White bare metal areas at a number of tube entries which are immediately below a drain hole in a channel on the duct surface. This is recorded as DHACI 3.

been described in the introduction and are shown in Figure 1. The surrounding dark grey areas are the same as the black deposited areas also described in relation to Figure 1.

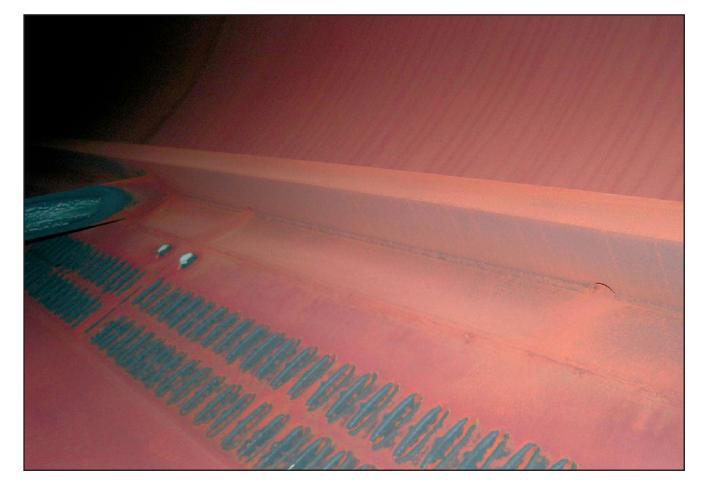
Figure 11:

Well-protected tube entries with no white bare metal areas and a well passivated red duct surface in an ACC operating with a pH between 9.6 and 10. This is recorded as DHACI 1.

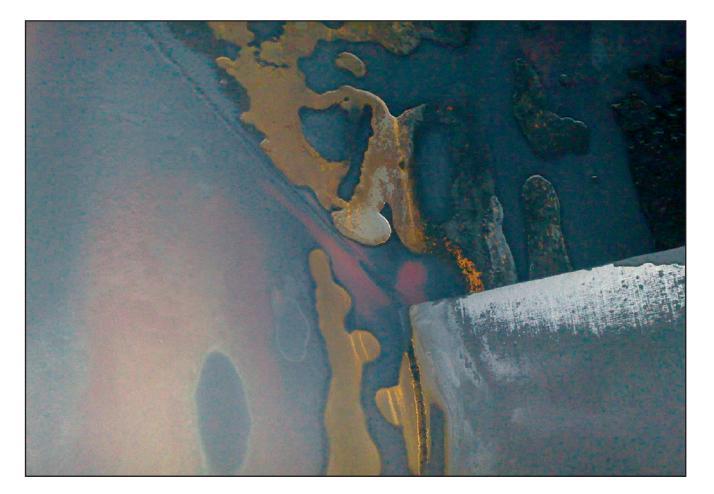
Figure 12:

boundary of the ACC but will contribute to the iron transport in the condensate. However, in localized areas significant material loss can be experienced, generally in areas of highly disturbed flow or high liquid phase concentration. An example of such an area in the lower ducting, immediately downstream of the trailing edge of a guide vane in a bend, is shown in Figure 12. The figure shows a corroded area where material loss of about 3 mm (0.117 in) is experienced after a total exposure of 146 000 operating hours.

Localized area of significant wall loss in the lower exhaust duct. DHACI C.

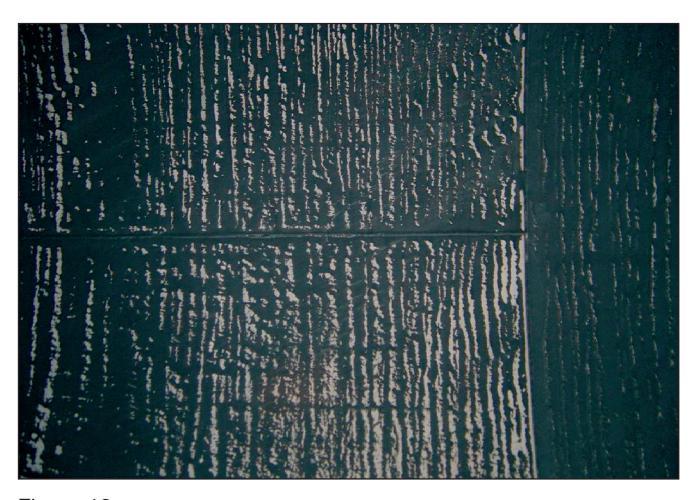
Figure 13:

The corrosion in Figure 12 is an exception, and generally minor wall loss is associated with the corroded areas. Such an example is given in Figure 13, which shows some 'tiger striping' appearance with darker grey/black areas demonstrating two-phase flow-accelerated damage.

Minor bare metal (white) areas on black background as observed in the duct section H1 (see Figure 6). DHACI B.

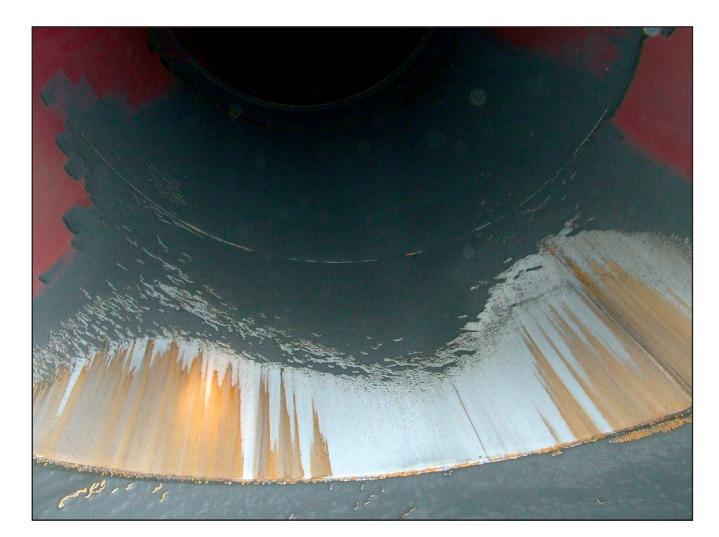
Figure 14: Corrosion pattern in branch H2-V3 (Figure 7). DHACI C.

The effect of the moisture content in the exhaust steam is well illustrated in Figure 14, which shows the branch H2-V3. On the downstream side of the branch a large bare metal area is visible with patches of flash rust, while the rest of the branch circumference is well protected with a stable oxide layer. Due to centrifugal action the free moisture in the exhaust steam impinges on the downstream side of the branch, resulting in the corrosion pattern shown in the figure.
