Continual vigilance required

ATTEMPERATORS

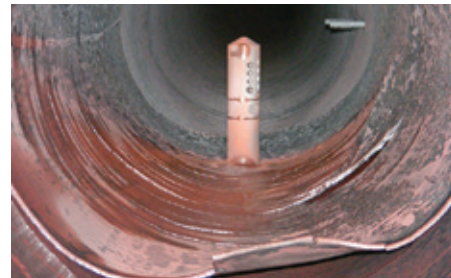
2. Spray-nozzle failures are relatively common in cycling units for some designs of mast-type attemperators (left). Cracking and separation of the liner from the steam pipe downstream of the spray nozzle can occur when relatively cool spray water is allowed to contact the liner (right)

- Overshoot the desired outlet temperature.
- Overspray, or the introduction of unvaporized spray water into downstream harps, causing damaging thermal transients. Overspray is generally defined as an attemperator outlet steam temperature of less than 50 deg F above the prevailing saturation temperature.
- Defective spray pattern
- Equipment malfunction—such as leaking valve, clogged or worn spray nozzles, failed nozzle, failed thermal liner in downstream piping (Fig 2).
- Failure of downstream pressure part—such as pipe fittings, heat-transfer tubes, etc (Fig 3).

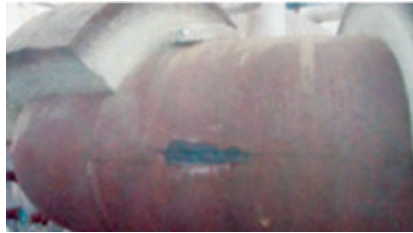
3. Elbow cracked in cycling unit after repeated contact with spray water

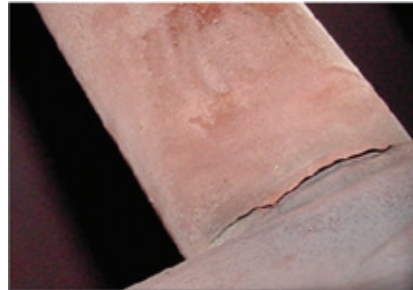
4. Repeated quench of hot tube caused by leaking attemperator control valve resulted in cracking from thermal-mechanical fatigue

Today half of the plants have piping arrangements that allow unvaporized, or leaking, spray water to flow directly into harps during low (or zero) steam-flow conditions, down from 82% three years ago. If such leakage occurs while the harp is hot, severe thermal-mechanical fatigue damage, and sometimes immediate tube failure results (Fig 4). Anderson paused to mention that straight tubes are more tolerant to fatigue damage than bent tubes.

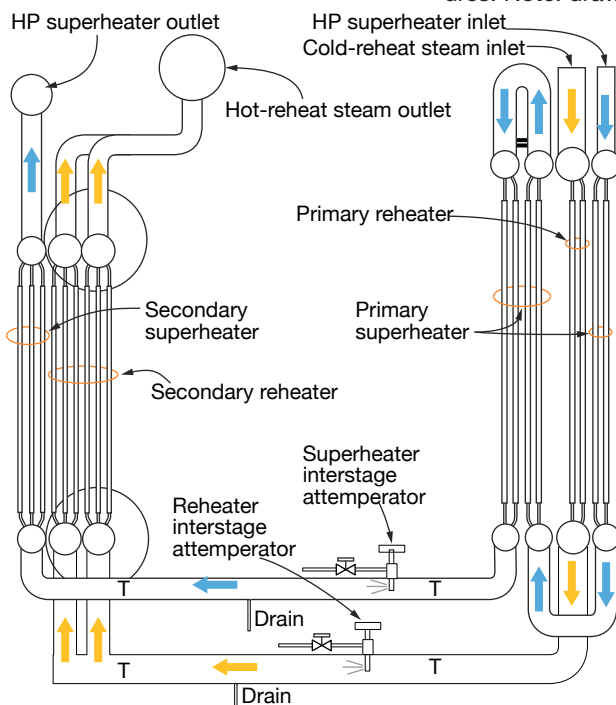
5. Long runs of piping connecting primary and secondary superheaters and reheaters have only one drain each. If these pipes suffer thermal humping, water will not drain. Instead, it will accumulate below the lower headers and possibly flow up into the harps—a condition conducive to extensive tube failures. Note: drawing is not to scale

There are scores of superheater and reheater surface arrangements, many unique. Anderson showed the group nearly a dozen, pointing out the pros and cons—mostly the latter (Figs 5-7). In Fig 5, the long runs of piping connecting primary and secondary superheaters and reheaters have only one drain each. If these pipes suffer thermal humping, water will not drain. Instead, it will accumulate below the lower headers and possibly flow up into the harps—a condition conducive to extensive tube failures.

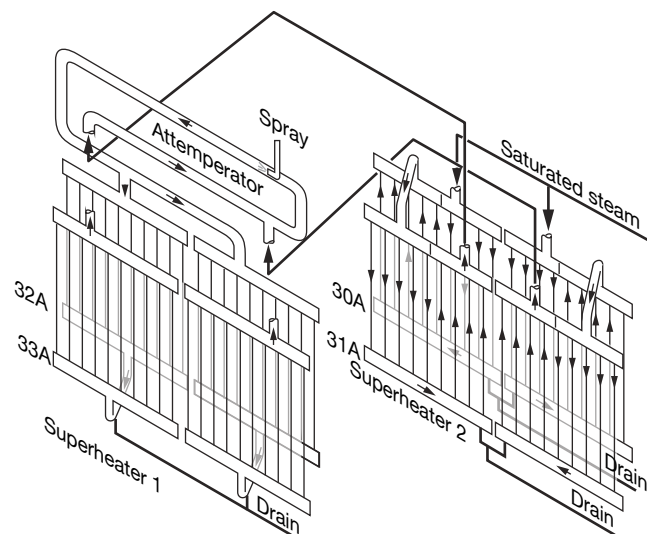
6. Problem waiting to happen. There is no drain between the attemperator and the superheater harps, so any leaking spray water (expected from valve wear and tear) must run into either the primary or secondary superheater, depending on which way the pipe slopes

Fig 6 illustrates a problem waiting to happen. Note that there is no drain between the attemperator and the superheater harps, so any leaking spray water (expected from valve wear and tear) must run into either the primary (superheater 2) or secondary superheater, depending on which way the pipe slopes. As previously men-

tioned, the ASME Code now prohibits attemperator arrangements without automatic drain pots on the interconnecting piping.

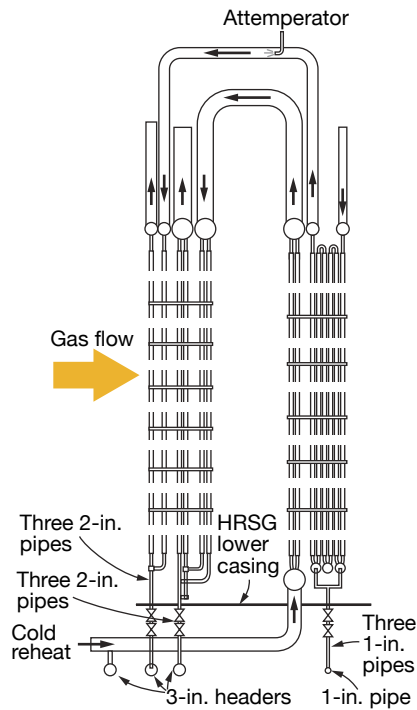
7. No drain between the attemperator and the superheater 2 harps as in Fig 6. However, here the pipe where the attemperator resides is too short to permit adequate residence time for evaporation at high spray flows

In Fig 7, there is no drain between the attemperator and the superheater 2 harps as in Fig 6. However, here the pipe housing the attemperator is too short to permit adequate residence time for evaporation at high spray flows. A reheater attemperator is not shown, although one exists.

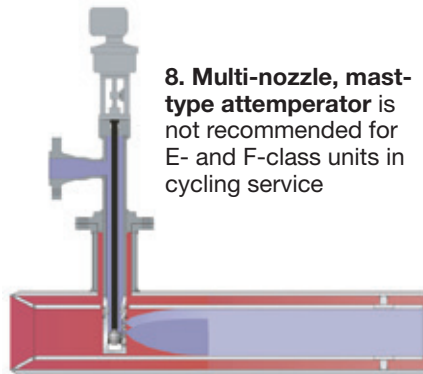
8. Multi-nozzle, mast-type attemperator is not recommended for E- and F-class units in cycling service

Variable-area probe-style attemperators were a popular choice for low- to medium-flow applications (and sometimes still are) when orders for plants powered by gas turbines surged in the late 1990s (Fig 8). On paper, these desuperheaters having spray-water control-valve trim in the steam flow stream, offered excellent turndown by virtue of their numerous spray nozzles, Anderson said. But cycling and the high steam temperatures associated with F-class engines, in particular, caused bending and cracking of the probes (a/k/a masts) in many units, rendering the desuperheaters useless.

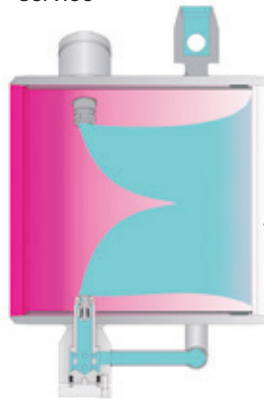
12. Ring-style attemperator improves atomization by injecting spray water perpendicular to steam flow

An alternative is the ring-style attemperator which admits spray water normal to the flow of steam (Fig 12), thereby offering better secondary atomization than the mast type, which sprays in the direction of steam flow. The ring design also ensures distribution of spray flow across the entire cross section of steam flow.

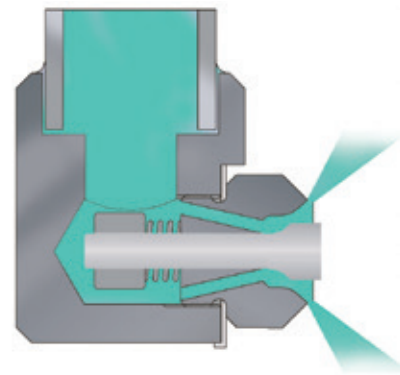
9. Variable-area nozzle provides efficient primary atomization regardless of steam flow

Anderson said that best attemperation results in E- and F-class combined cycles, based on his experience, are being achieved by variable-area spring-loaded spray nozzles (Fig 9). Fixed-orifice nozzles are not suitable for this service, in his opinion (Fig 10).

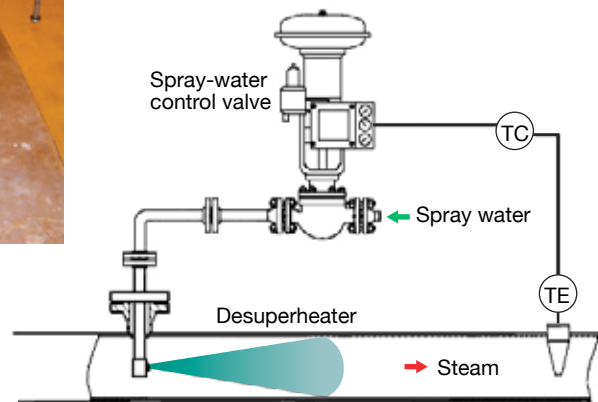
11. Mast-type attemperators having their control valves located outside the steam pipe generally work satisfactorily in combined-cycle plants

The variable-area nozzles can be used in mast-type systems providing the moving parts of the control valve are located outside the pipe (Fig 11). Several attemperator manufacturers have adopted this concept with satisfactory results.

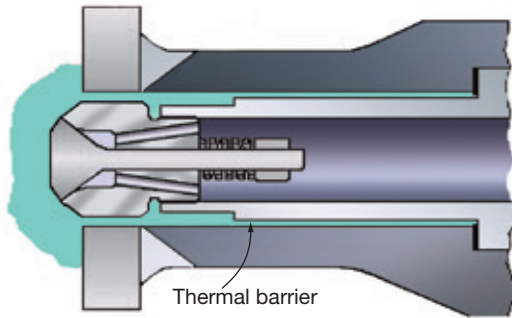
13. Thermal barrier separates hot and cold working elements to mitigate the intensity of thermal cycles experienced by critical components (left)

Attemperation system design. In addition to specifying that the spray-water flow-control element be located outside the hot steam environment, engineers at Control Components Inc, Rancho Santa Margarita, Calif, suggest adding a thermal barrier to separate the hot and cold working

elements to mitigate the intensity of thermal cycles experienced by critical components (Fig 13).

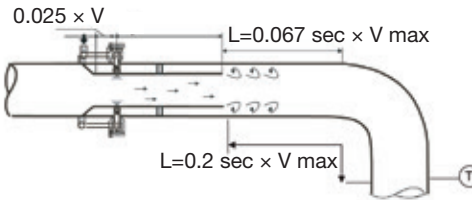
14. Liner protects steam pipe from thermal sock, helps improve secondary atomization (below)

A proper liner is an important element in every desuperheating station. In addition to protecting steam piping against thermal shock, it increases steam velocity to improve secondary atomization, creates vortices that improve atomization and enhance mixing, and assist with heat transfer and evaporation. CCI has done considerable research to ensure complete evaporation of spray water and predictable performance to avoid damage experienced by many owner/operators. Fig 14 presents the details.
