## **Measurement of Damaging Thermal Transients in F-Class Horizontal HRSGs**

Presented at: ETD International Seminar on Cyclic Operation of Heat Recovery Steam Generators (HRSGs), June 24 2005, in London, UK.

Authors: Michael Pearson, J. Michael Pearson & Associates, Ontario Canada  
Robert Anderson, Progress Energy Corporation, USA

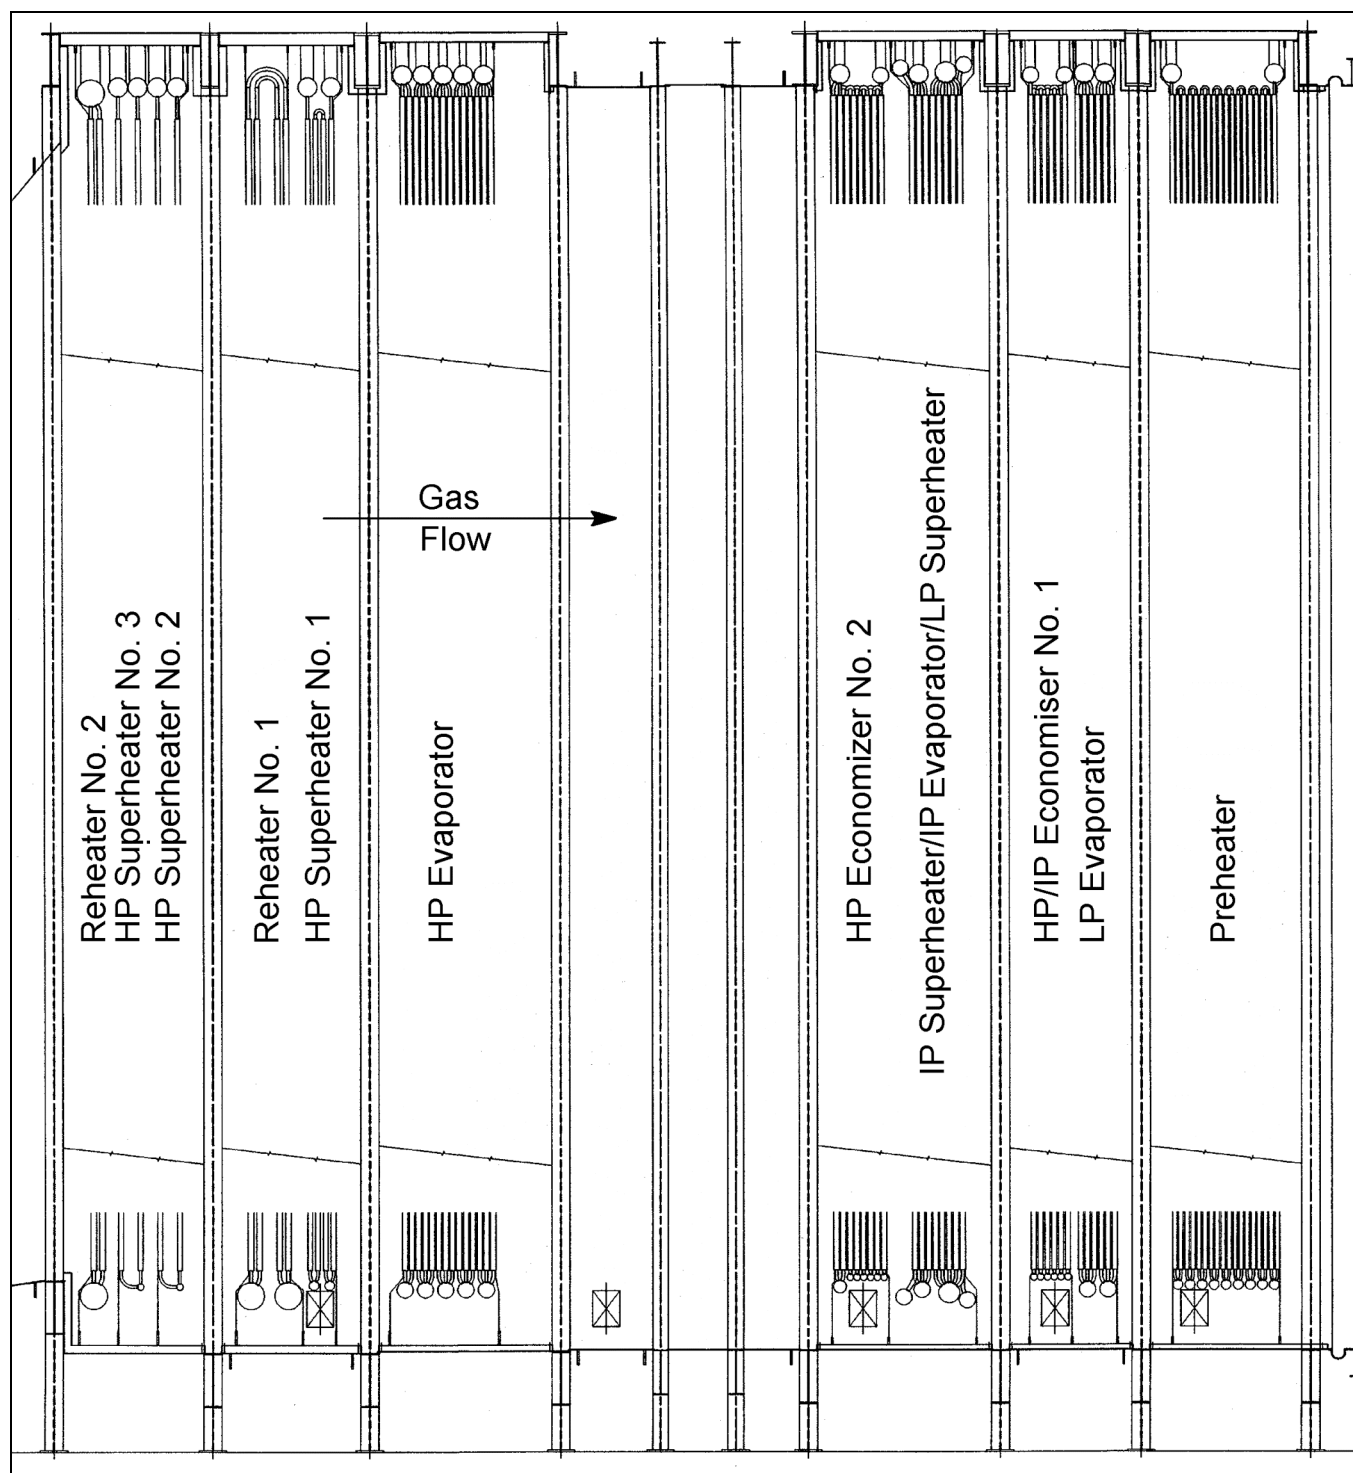
Figure 1 illustrates the tube and header arrangements and disposition of the different steam and feedwater heating sections of the subject HRSG. The heating surfaces are assembled into top-supported bundles, each bundle comprising several rows of tubes and headers. Transversely across the duct, the heating surfaces are split between two notionally identical bundles. Because heating surfaces in the laterally adjacent tube bundles are identical, in general TCs were concentrated in the left hand bundles viewed from CT to stack. The exception is RH2 where, because the RH attemperator is located on one side of the HRSG, TCs were installed on RH2 tubes in both bundles to investigate for any tube temperature variations across RH2 caused by possible non-uniform steam conditions at inlet to the RH2 tubes. Approximately 450 thermocouples were installed on tubes throughout the HRSG.

**HRSG Side Elevation**

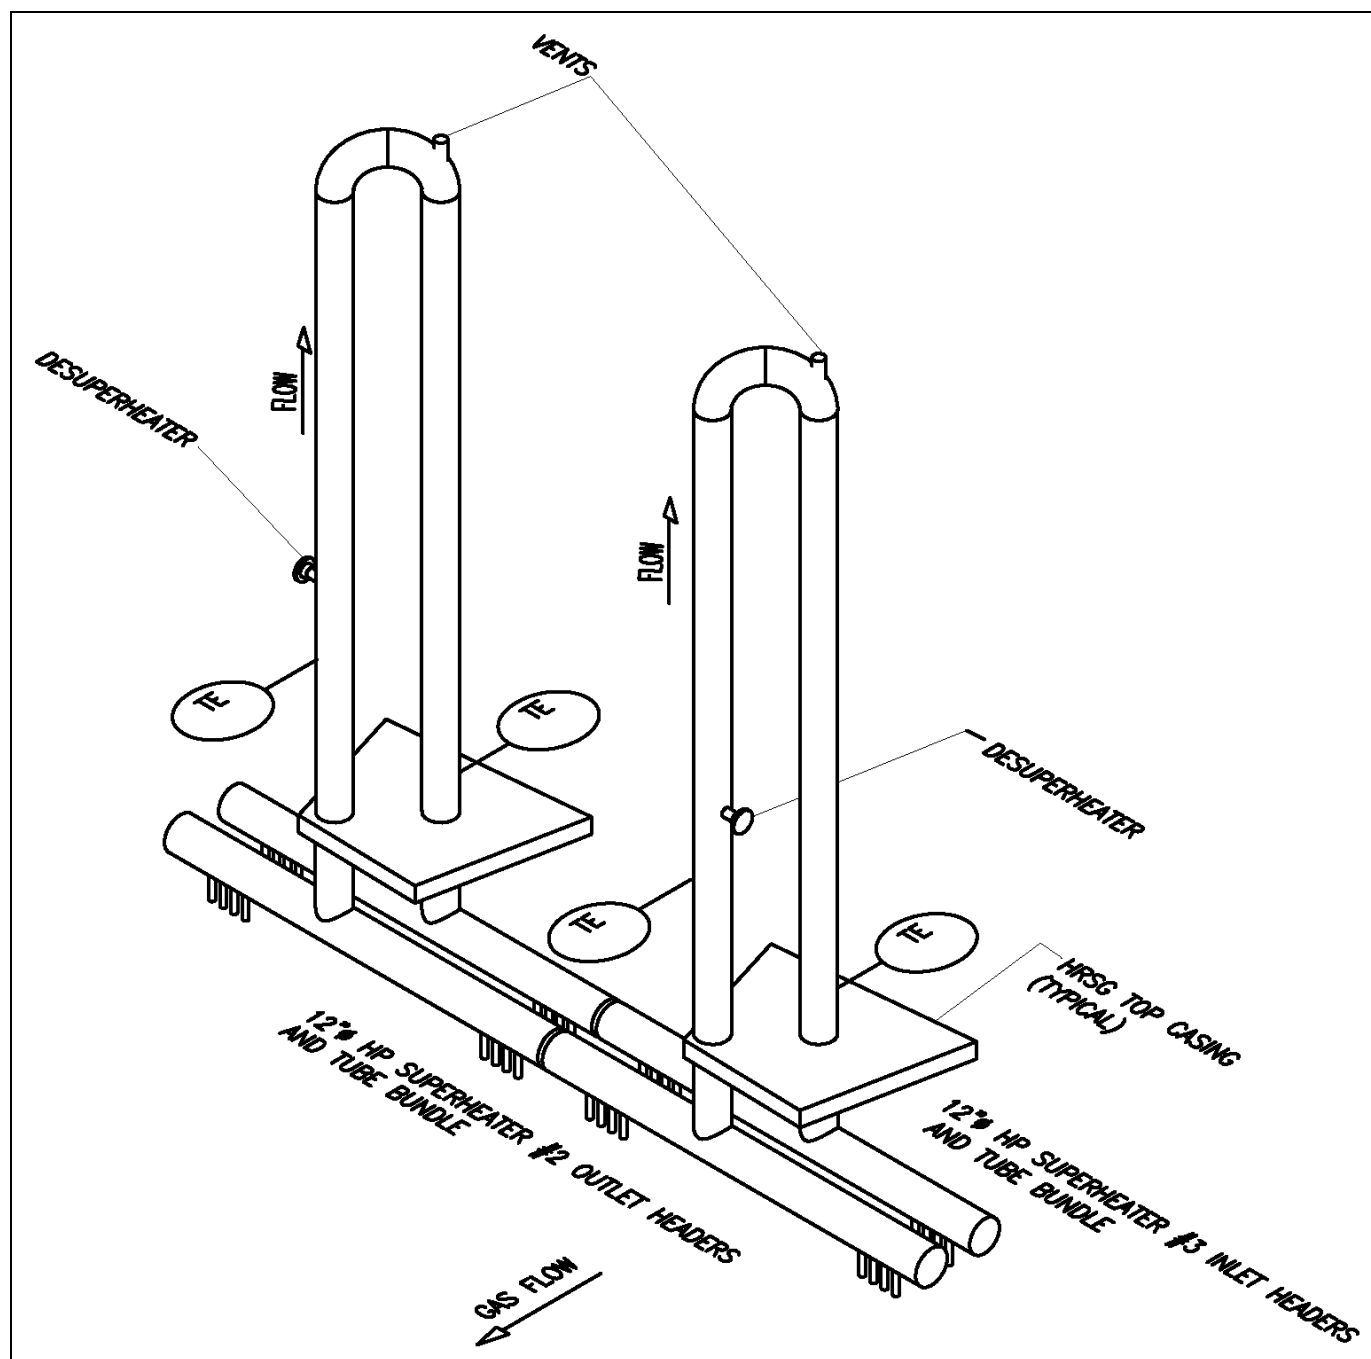
Figure 2

The HPSH comprises three sections. HPSH1 receives saturated steam from the HP drum and discharges its steam through interconnecting pipes to HPSH2. Secondary superheating of steam is performed in HPSH2 and then discharged through one of the parallel-path interconnecting pipes on top of the HRSG, in each of which is located one of the two HPSH interstage attenuators. The steam then enters HPSH3 for final superheating before it enters the main steam manifold. The attenuator designated as A in the associated DCS indications is in the left side interconnecting pipe between the HPSH2 and HPSH3 sections installed with the temporary TCs, Figure 2.

HPSH2 – HPSH3 Interconnection Piping and Attenuators

Each HPSH attenuator spray water nozzle is located in the vertical section of the interconnecting pipe between the outlet header of HPSH2 and the 180° hairpin bend, Figure 2. Thus, any leakage of spray water when steam flow is low causes the water to drain back into the HPSH2 outlet header and thence into the tubes below the outlet pipe branch. However, when overspraying occurs with significant steam flow through the attenuator, then the unflashed water collects on the extrados of the hairpin bend causing erosion of the internal surface of the extrados of the 180° bend, and causing the fine droplets to collect as a film on the pipe surface at the bend from where they are stripped off as much larger droplets by the turbulent steam flow from the bend. These enlarged drops of water then quench the HPSH3 inlet header pipe nozzle and the tubes opposite. When the overspraying is gross, quench cooling of tubes and headers through to the final outlet headers has been observed on several HRSGs of different design.

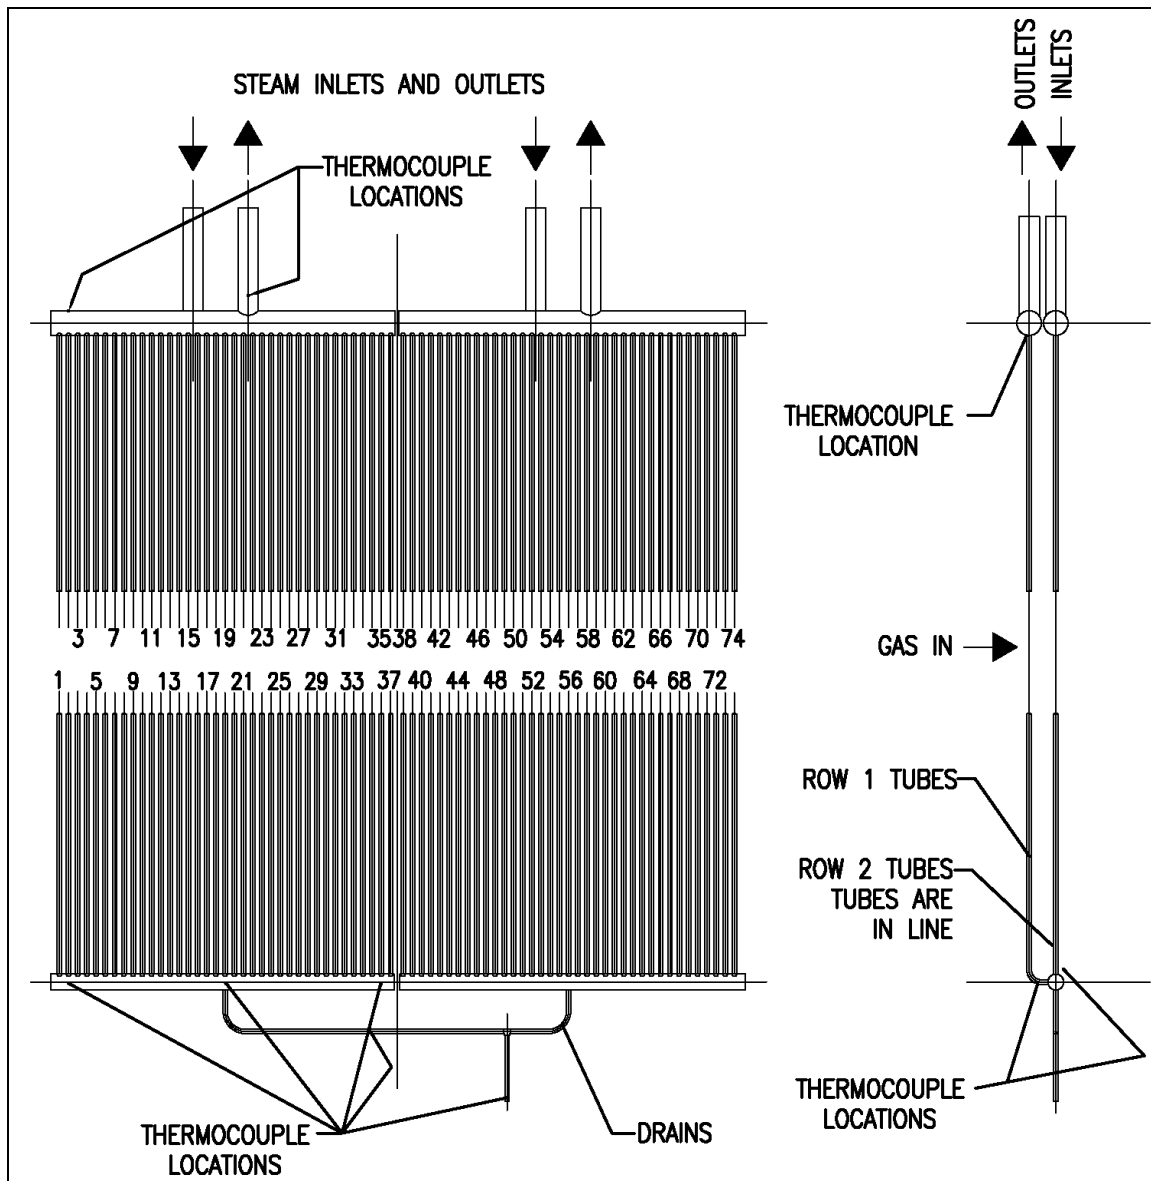
Figure 3

**HP Superheater #3 Tubes and Headers Arrangement**

The TCs in HPSH3 are located at the bottom of row 1 and row 2 tubes and at the top of row 1 tubes. There was no access available to install TCs at the top of any row 2 tubes. The TCs in HPSH2 are located at the bottom of row 1 and at the top and bottom of row 2 tubes, there being no access available to install TCs at the top of any row 2 tubes in HPSH3 or row 1 tubes in HPSH2. However, the measured steam temperatures before and after the HPSH attenuators provides an indication of average tube temperature at outlet of HPSH2 and inlet to HPSH3, respectively.

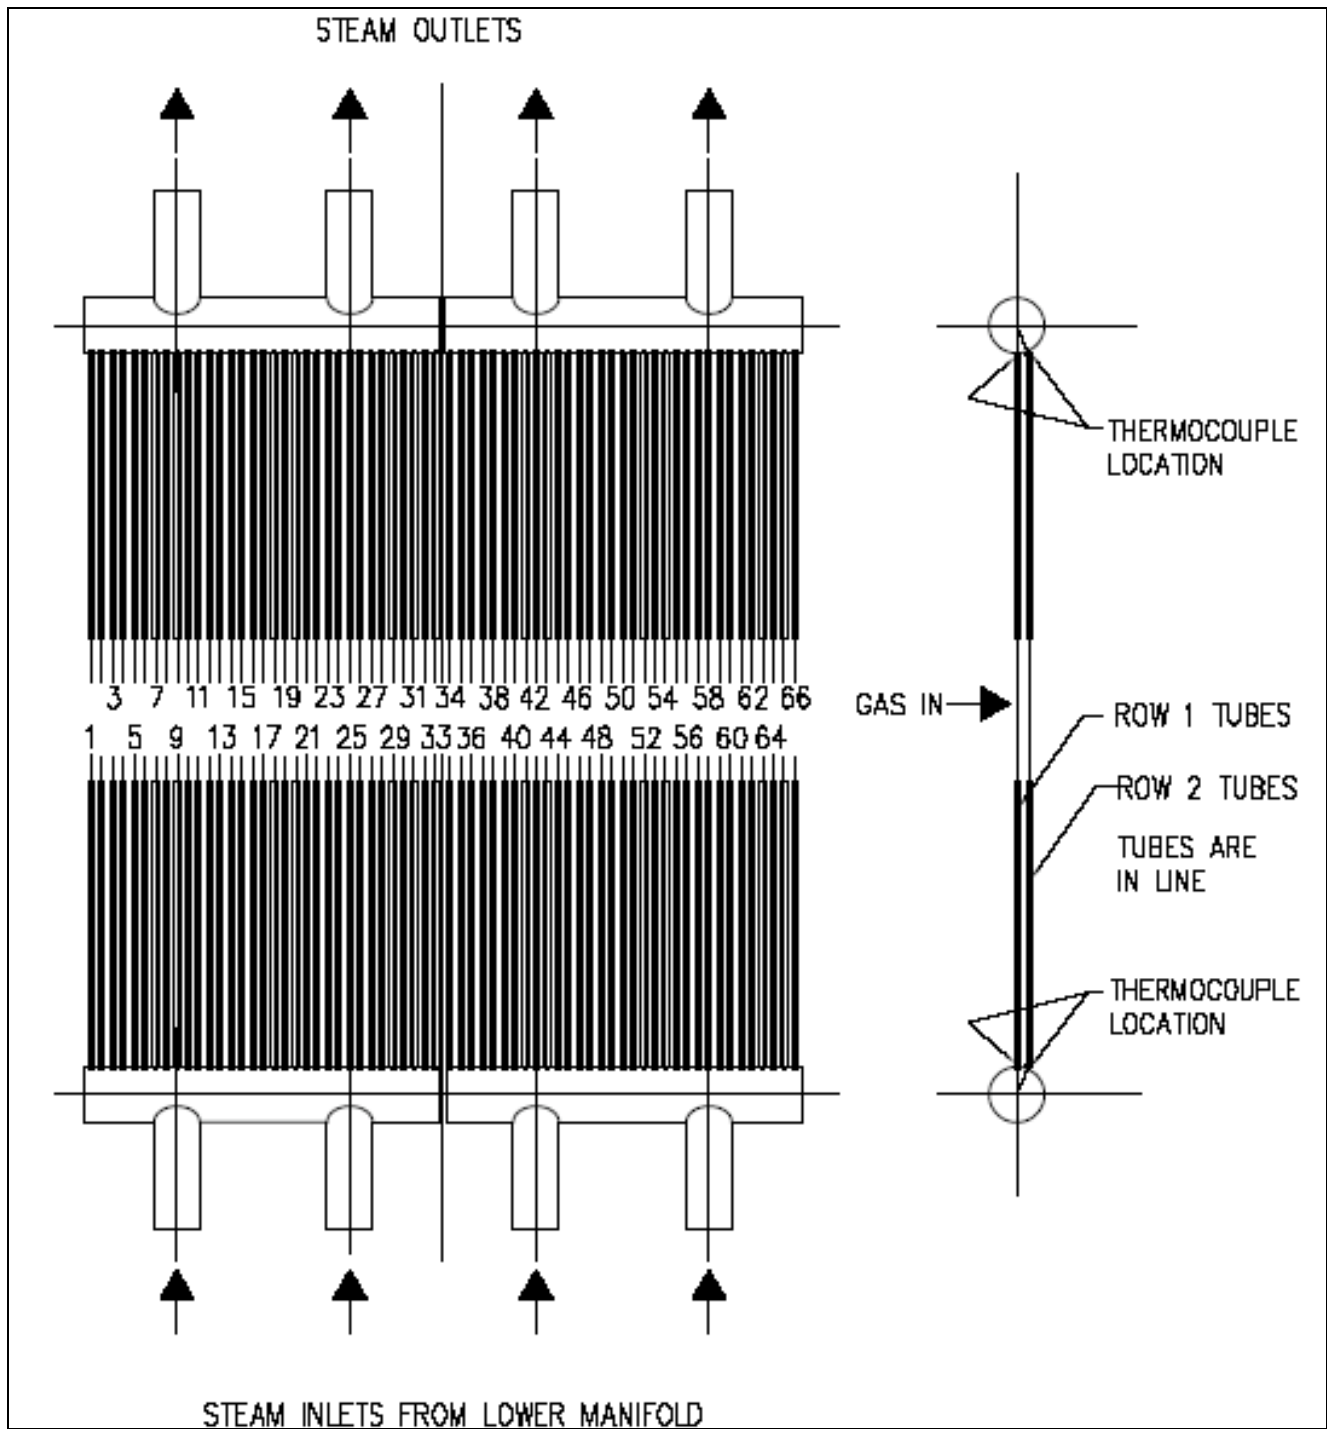
Figure 5

**RH2 Tubes and Headers Arrangement**

RH2 has two tube rows attached to the same upper and lower headers, Figure 5. Row 1 tubes are straight and the row 2 tubes have a bend at each end to connect the tubes to the headers.

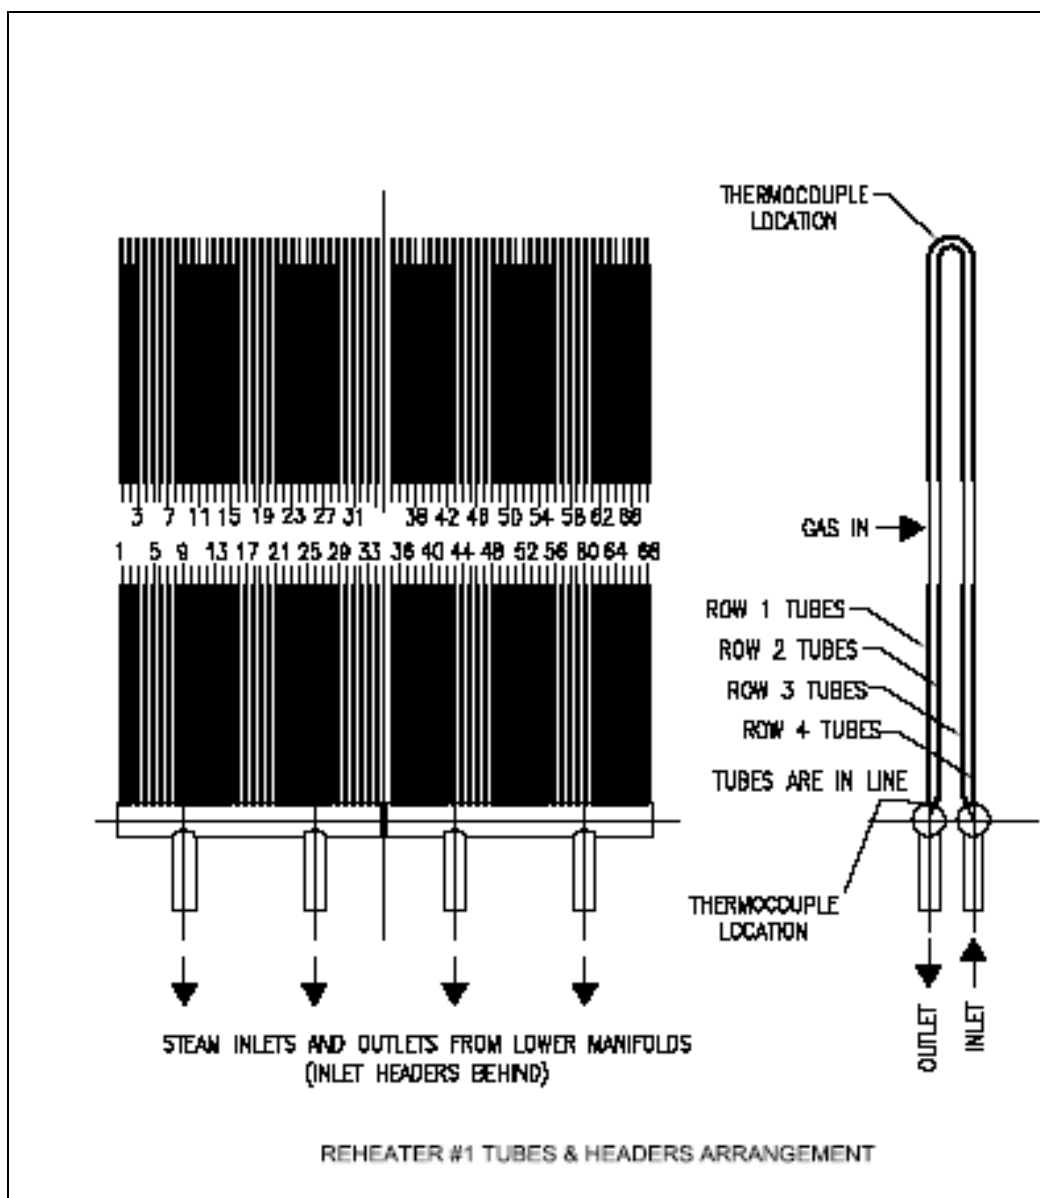
Figure 6

RH1 has four rows of tubes arranged in two parallel passes with shared bottom inlet headers, a 180° inverted hairpin bend at the top and shared bottom outlet headers. The first and last row of RH1 tubes in the gas flow, (respectively rows 1 and 4), have straight tubes attached at top dead center of the inlet and outlet headers, while the tubes in rows 2 and 3 have a bend attaching them to their respective headers. RH1 is divided into identical left and right modules, each with its own inlet and outlet header. Each inlet and outlet header has two pipe nozzles. Both the inlet and outlet pipe nozzles are located opposite tubes 9 and 25 in the left module and tubes 43 and 60 in the right module, Figure 6.

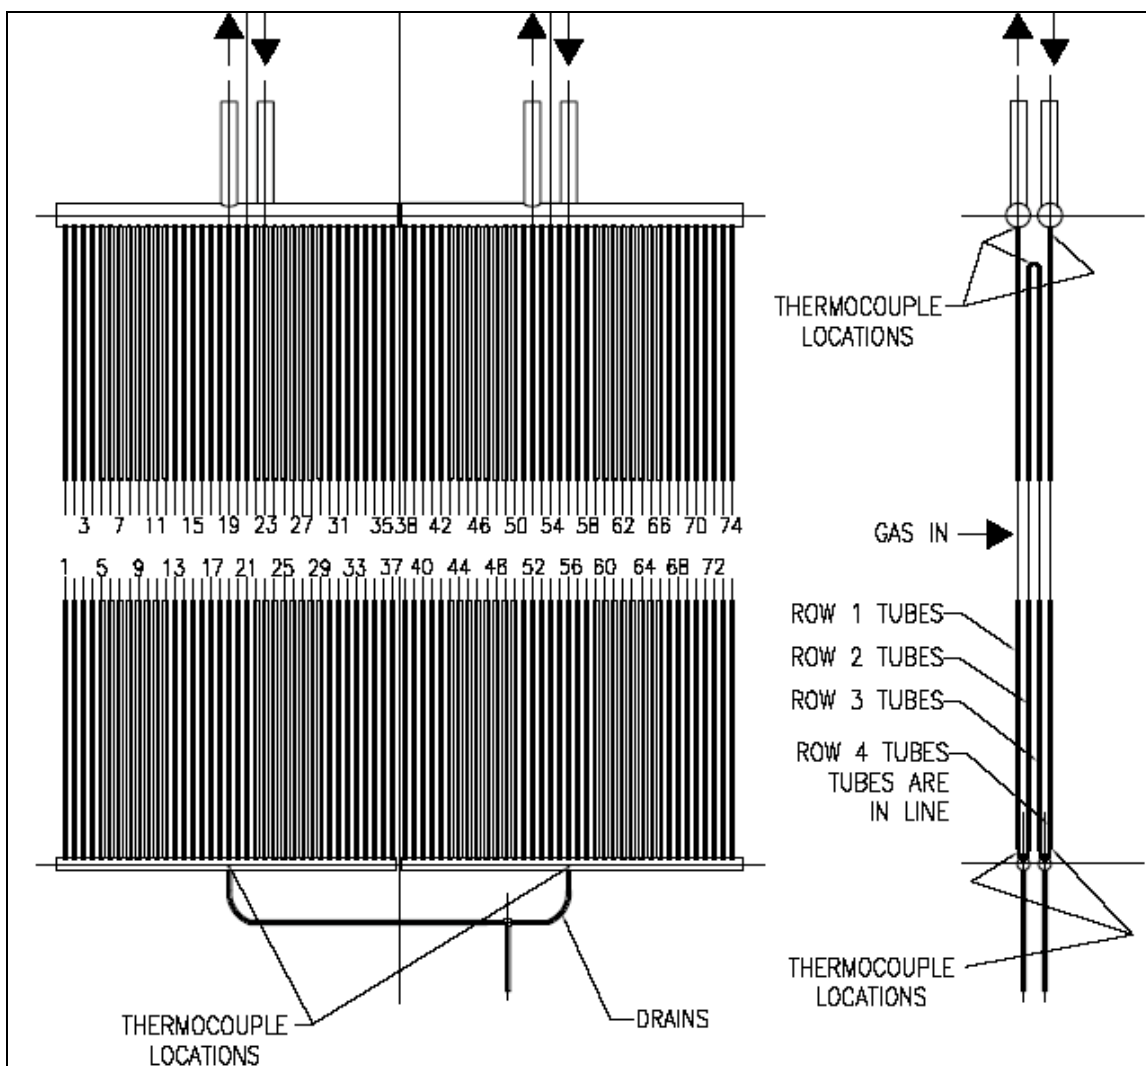
Figure 26

**HPSH1 Tubes and Headers Arrangement**

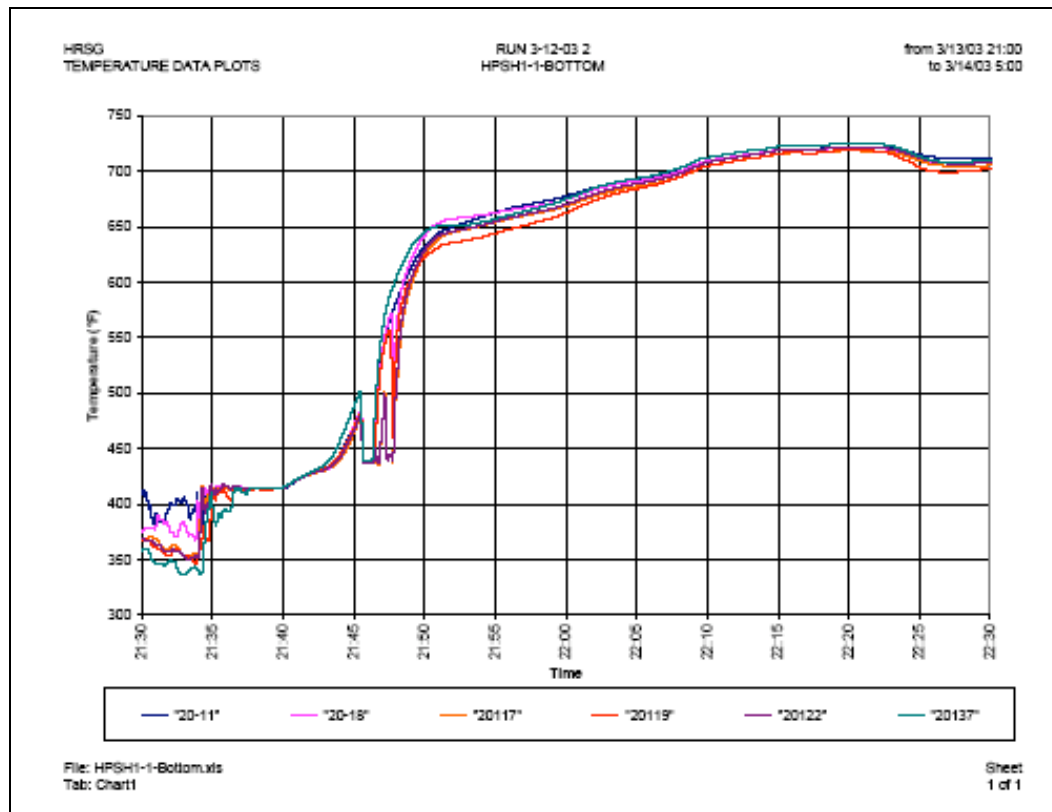
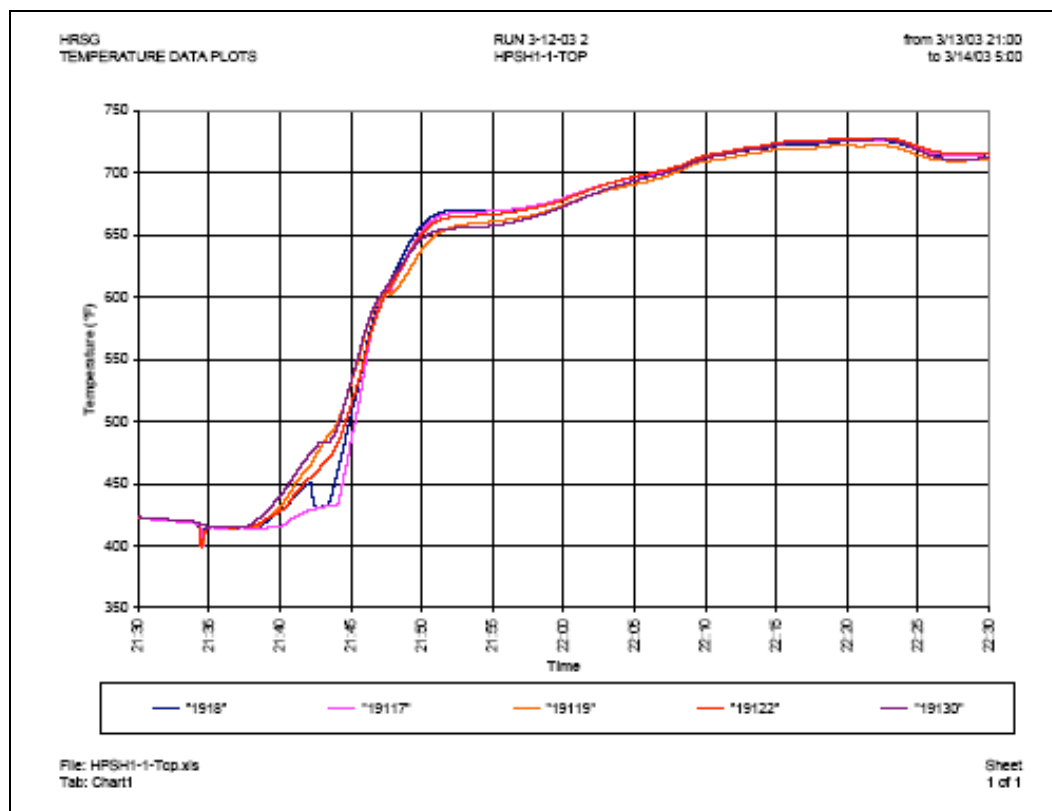
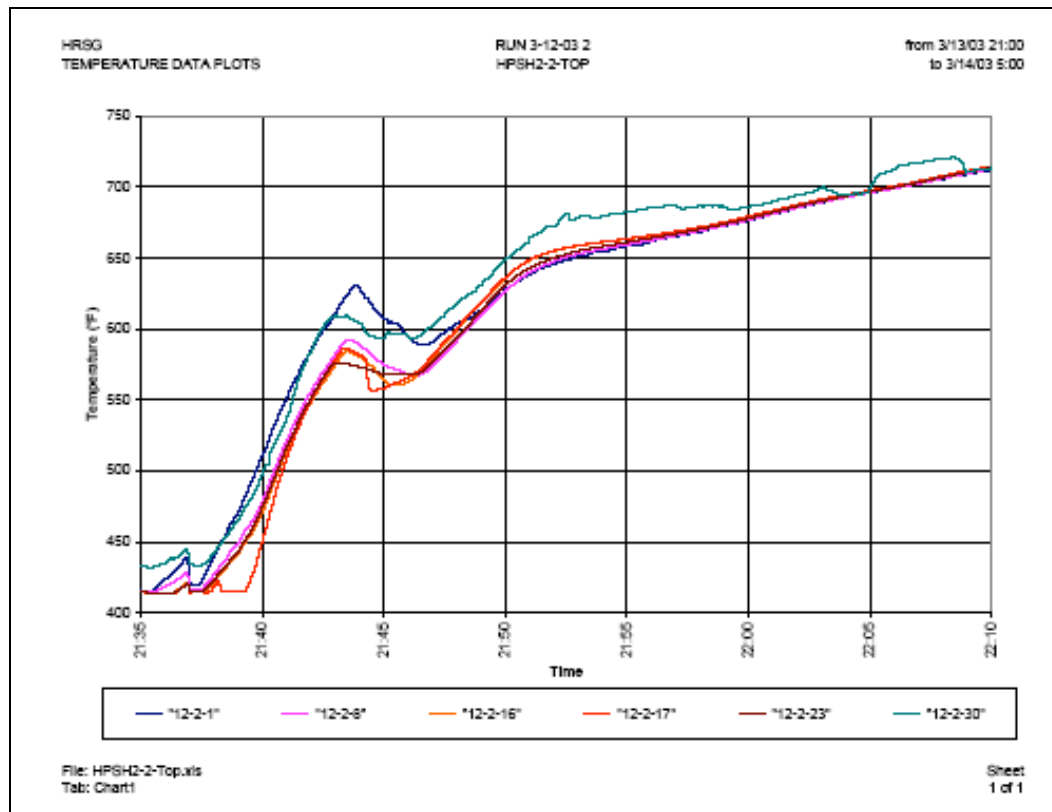
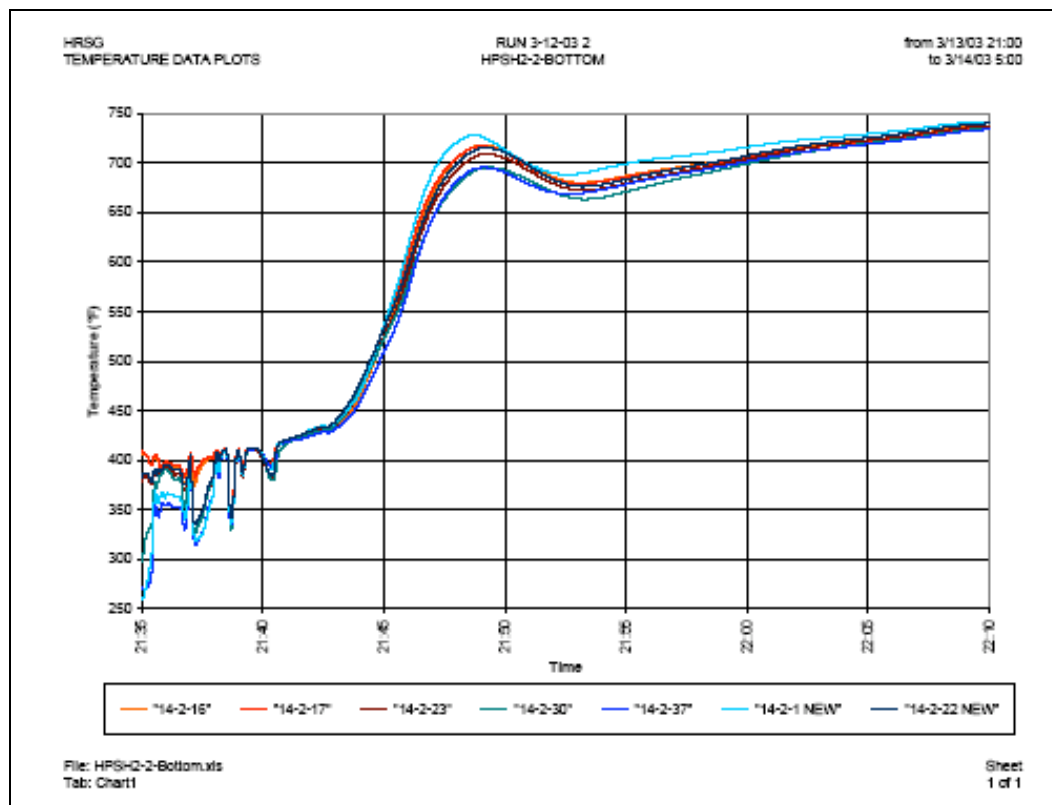
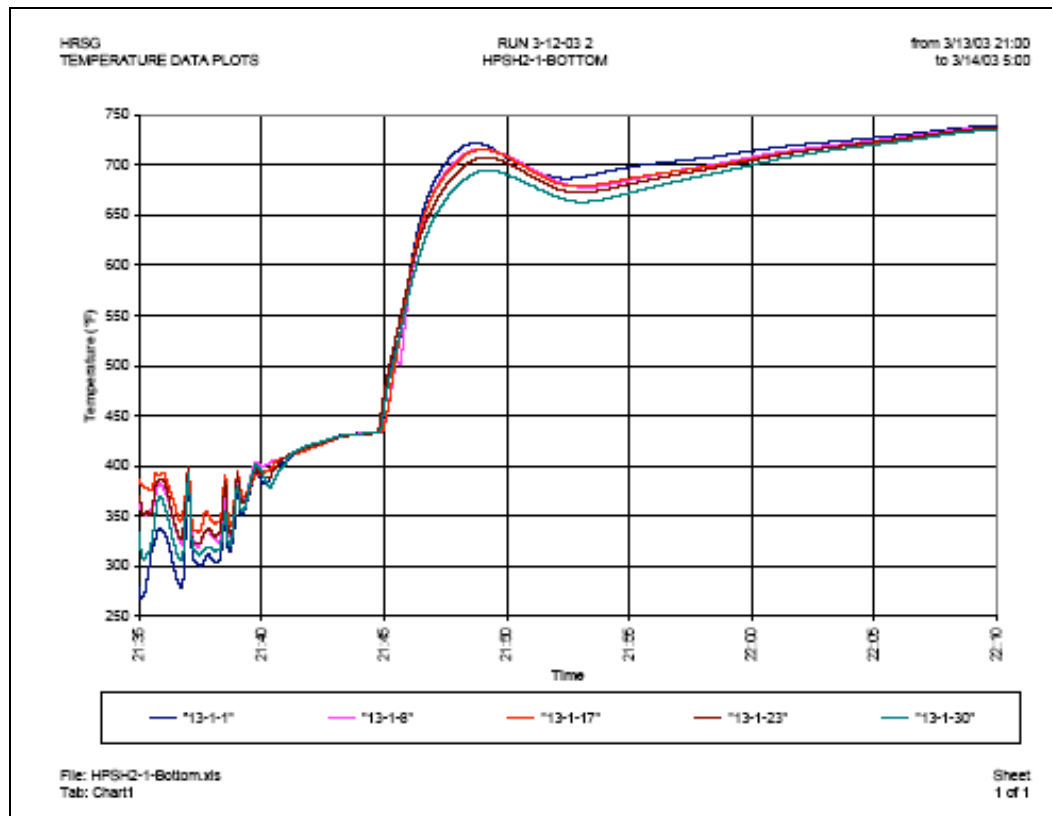
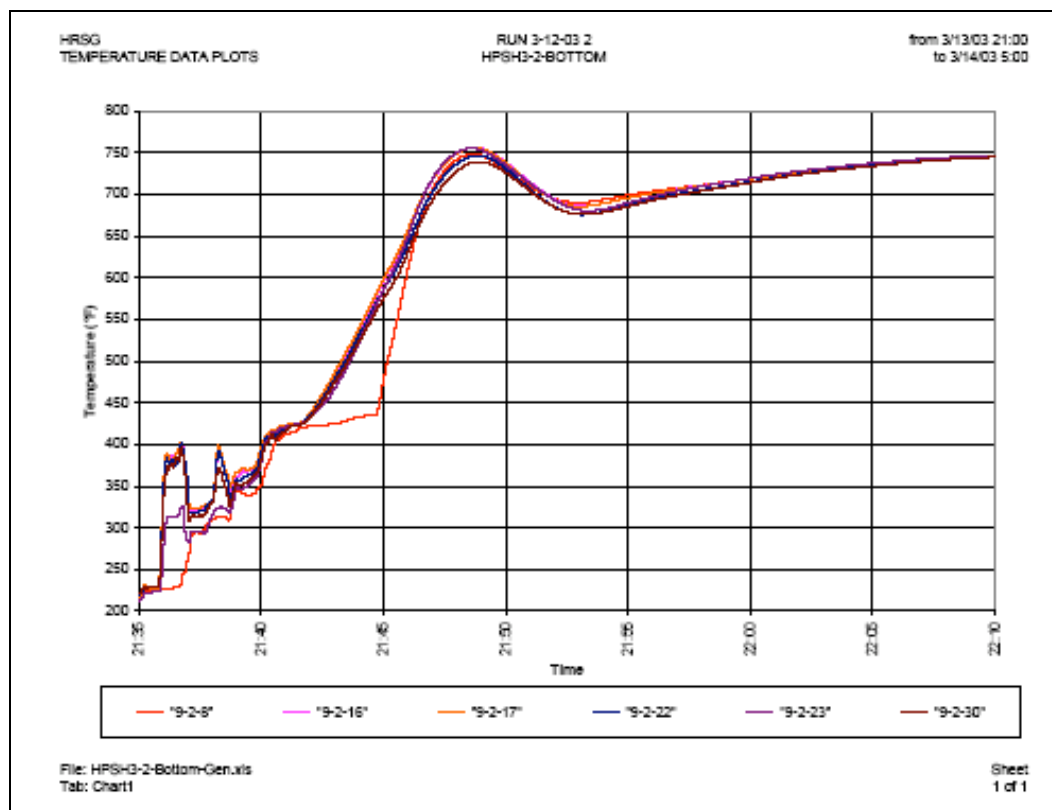
Tube temperatures measured at top and bottom tubes of HPSH3, HPSH2 and HPSH1 are provided in Figures 27 to 34, inclusive, from a warm, almost hot, start from an initial HP drum pressure of 320psig on 3-13-03 using CT ETM with a setpoint for exhaust gas of 760°F (404°C) when at CT minimum load.

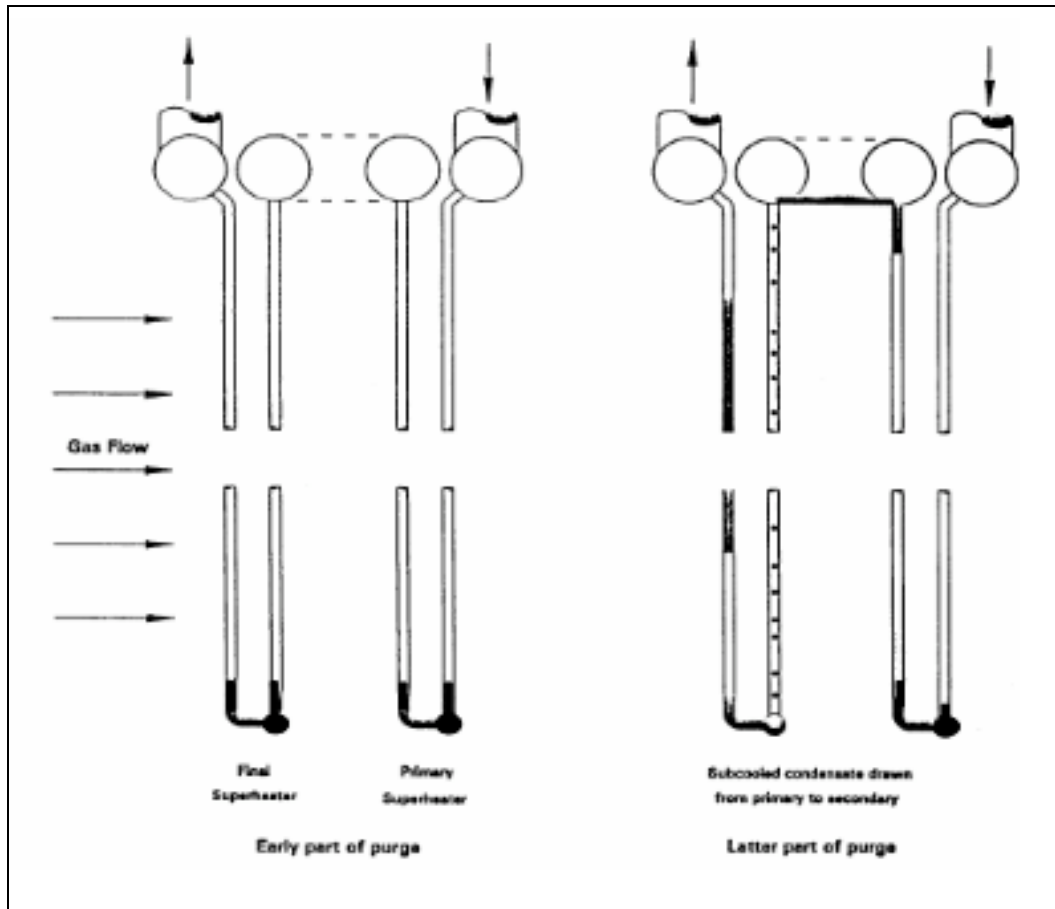
Figure 37

When, during the purge cycle, the gas turbine exhaust air temperature blown through the superheater/reheater is below the HP drum saturation temperature, large quantities of condensate form in the finned tubes of each tube row. If this condensate is not removed as quickly as it forms and floods the lower headers a partial vacuum is formed in the tubes. This vacuum, along with any pressure developed in the drum, draws/pushes the condensate up the tubes and over the top <sup>\*5</sup>, Figure 37.

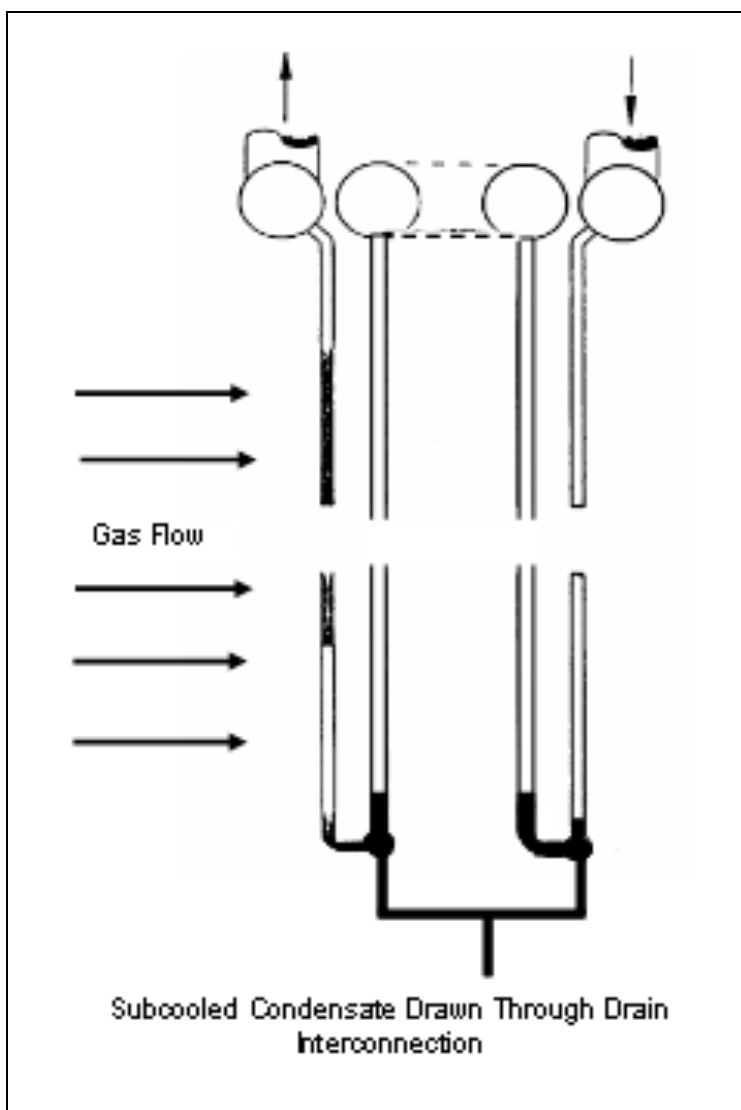
Figure 38

If drains, or drain cooling interconnections, provide a path between headers operating at even slightly different pressures when steam flow is established, the condensate will migrate from the lower to the higher pressure superheater, Figure 38.

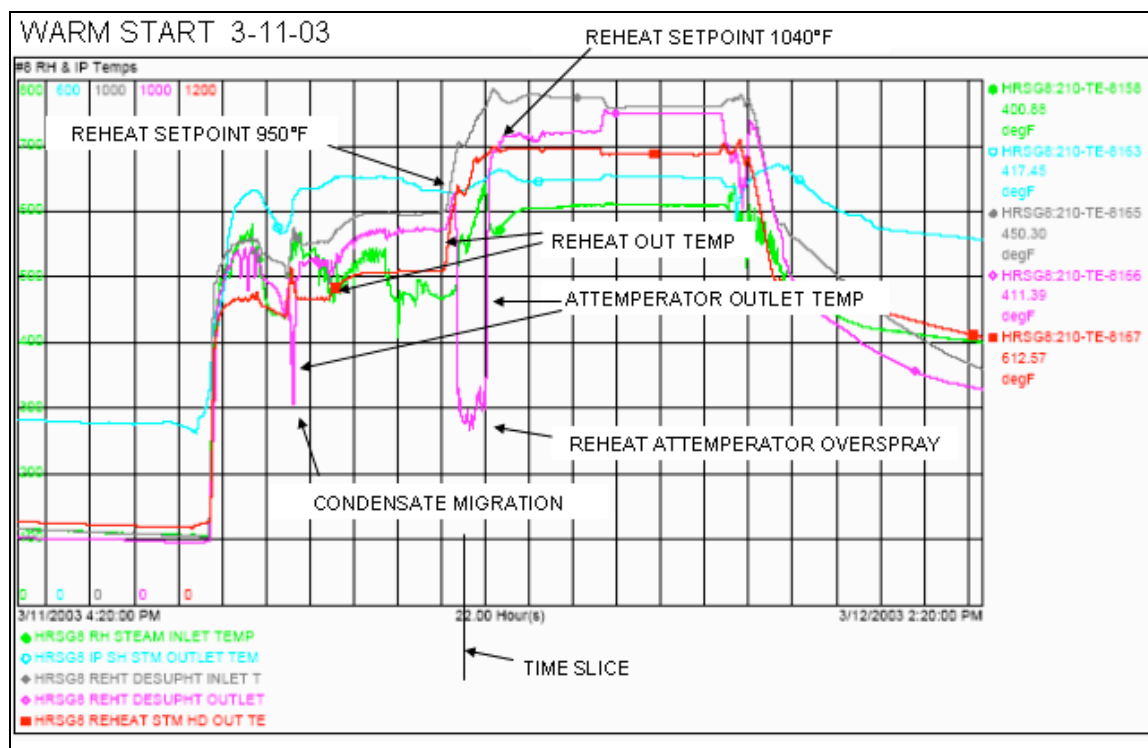
Figure 39

A warm restart was executed at about 22:30 on 3-11-03 - less than 1 hour following a trip from 18MW. The RH attemperator sprayed down to saturation temperature between about 02:21 and 03:05 on 3-12-03 because RH outlet steam temp set point was lowered to about 950°F (510°C) during the period when the CT was ramped up from 16MW to 100MW and CT exhaust gas temperature raised from about 770°F (410°C) to 1200°F (649°C), Figure 39.

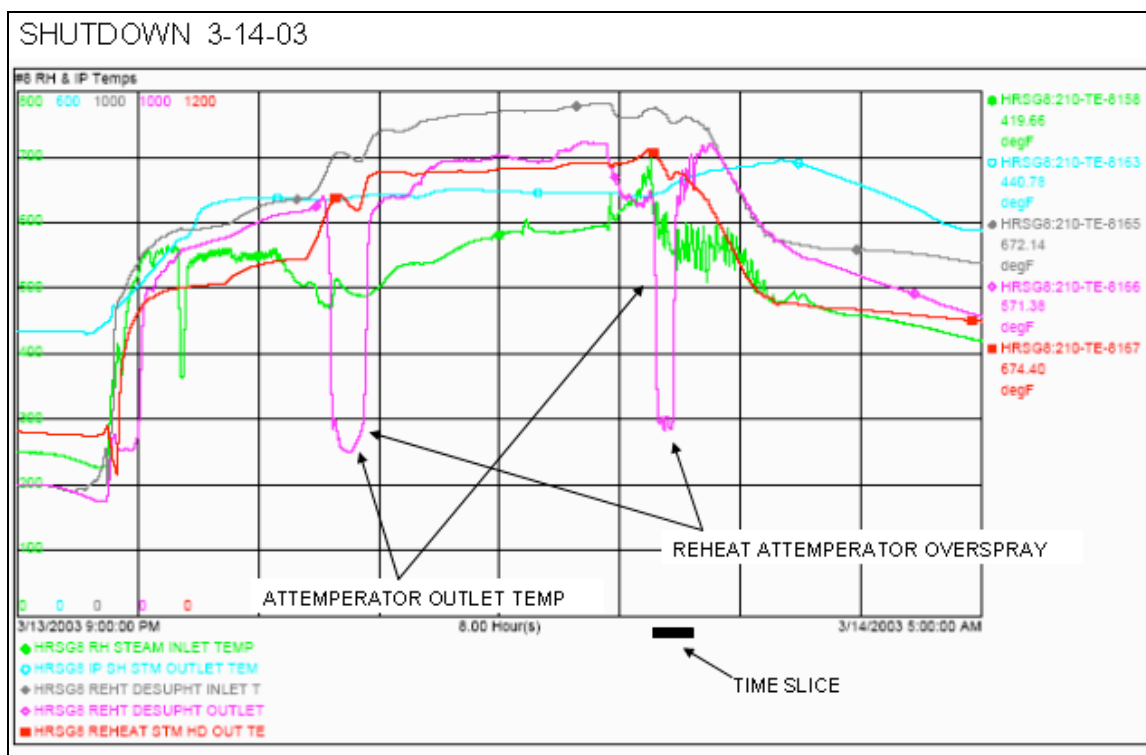
Figure 41

A similarly severe overspray event with very damaging steam temperature downshock-upshock cycles was recorded during both the startup and shutdown performed on 3-14-04, Figure 41. Note the sudden drops in RH attemperator outlet temperature. The steam temperature drop on the left is during startup, similar to that in figure 39, while the steam temperature drop on the right is during shutdown. This overspray event again occurs when the gas turbine load transitions the range below 100 MW in which exhaust temperature is still at the isothermal maximum while the steam flow rate is simultaneously reducing.

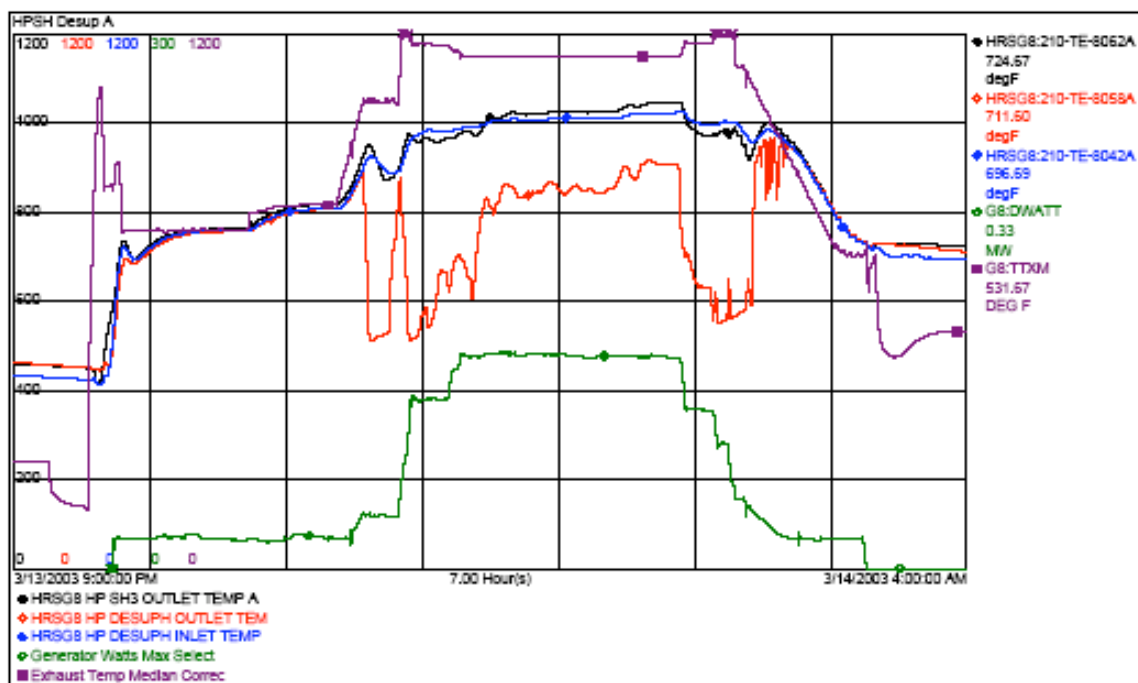
Figure 44

PI charts from the warm to hot HRSG startup on 3-13-03, Figure 44, show that attemperation initially commenced at about 9:36 pm when HPSH3 outlet steam temperature exceeded the initial lowered setpoint value selected by the operator of about 900°F which occurred with the CT at a stable generator load of 30MW. There was an initial overshoot in HPSH3 steam temperature of about 50°F before attemperation commenced due to the time lag in sensing the actual steam temperature and also interlocks in the attemperator control logic that inhibits opening of the TCV until the steam flow and calculated attemperation flow demand exceed the minimum permissible for attemperation. When attemperation commenced, the temperature at the outlet of the attemperator dropped severely by about 370°F to saturation temperature of about 510°F. It appears that just prior to initiating a ramp of CT load from 30MW to 50MW at 10%/min, the operator raised the HPSH3 outlet steam temperature setpoint in the attemperator controls to about 970°F, which caused the attemperator to shut, resulting in a severe increase in steam temperature at outlet of the attemperator. The large, virtually step changes down and then up of steam temperature at outlet of the attemperator cause very damaging tensile followed by compressive thermal stresses, at the inner surfaces of the inlet header of HPSH3 at both the inlet pipe and ligaments between tube connections.

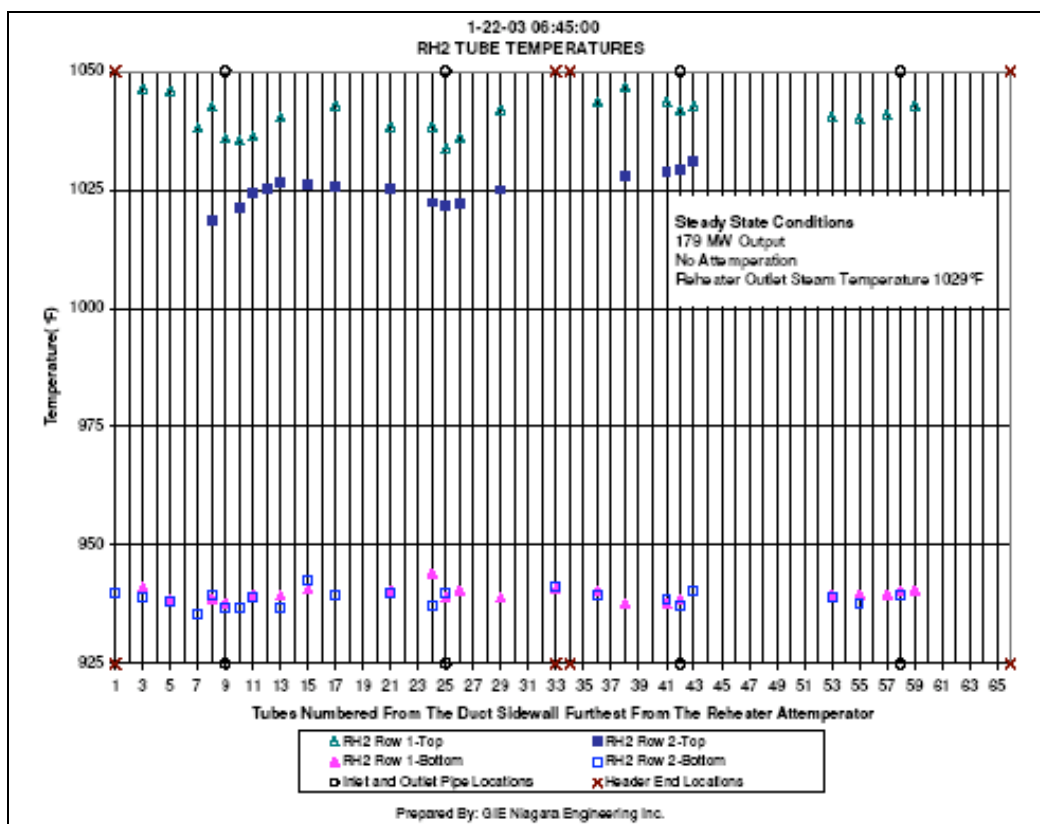
Figure 47 presents a TSD plot during full load (179 MW) steady state operation with no RH attemperation. The temperature at the bottom of almost every tube in both RH2 tube rows across the duct width is within +/-5°F of 940°F (504°C). Temperature at the top outlet of row 1 tubes ranged between 1035 and 1045°F (557 and 563°C), and of row 2 tubes between 1020 and 1030°F (549 and 554°C). RH steam outlet header temperature was about 1028°F (553°C), which aligns closely with the mean of all RH2 row 1 and row 2 tube temperatures. The mean temperature at outlet of row 1 tubes is about 15°F (8°C) higher than row 2 tubes and the difference in average temperature between row 1 and row 2 tubes is thus about 7.5°F (4.2°C), which is of no concern. Figure 47 demonstrates satisfactory uniform heating across RH2 when it receives steam at a uniform temperature from the interconnecting manifold, Figure 4.
