## **Measurement of Damaging Thermal Transients in F-Class Horizontal HRSGs**

Presented at: ETD International Seminar on Cyclic Operation of Heat Recovery Steam Generators (HRSGs), June 24 2005, in London, UK.

Authors: Michael Pearson, J. Michael Pearson & Associates, Ontario Canada  
Robert Anderson, Progress Energy Corporation, USA

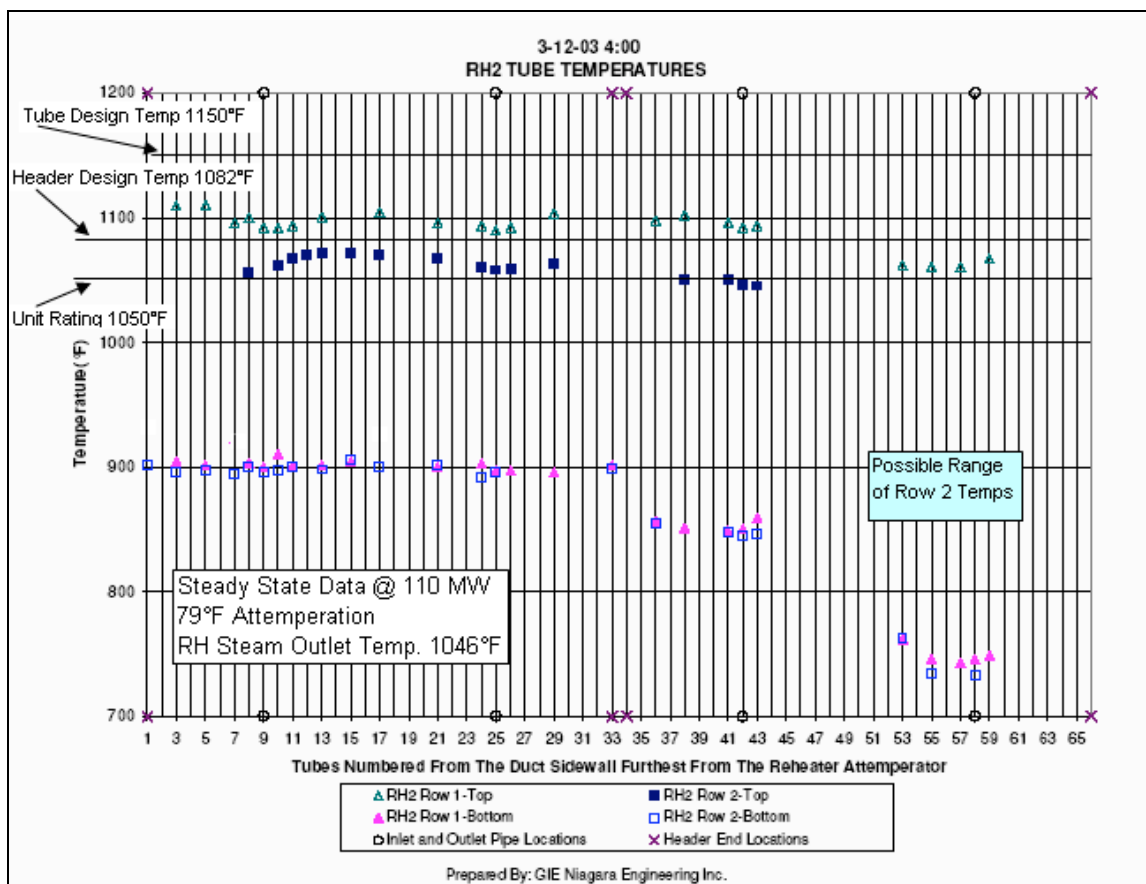
Figure 48 presents a TSD plot at 04:00 on 3-12-03 during stable operation at 110MW with HRH header temperature of 1,046°F (563°C) and desuperheating of about 79°F (44°C). The bottom of all tubes supplied by the 3<sup>rd</sup> and 4<sup>th</sup> RH2 inlet pipe branches operate very close to 900°F (482°C), except for three Row 1 tubes that are about 30°F (17°C) hotter. The bottom of all tubes supplied from the 1<sup>st</sup> and 2<sup>nd</sup> pipe branch downstream of the attenuator operate at about 745°F (396°C) and about 845°F (452°C), respectively; i.e., respectively about 155°F (86°C) and 55°F (31°C) lower than the bottom of the tubes supplied by the two pipe branches furthest from the attenuator. The variation in temperature at outlet of tubes supplied by the different inlet pipes is about 20% of the differences measured at the bottom of the tubes.

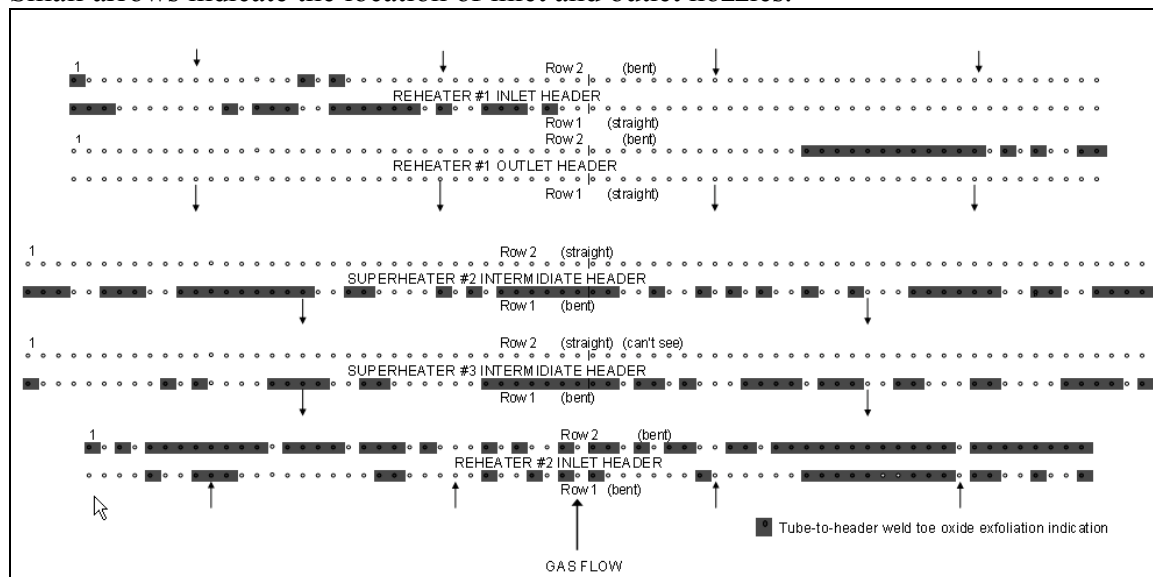
Further evidence that the thermal mechanical stresses resulting from the various tube temperature transients presented in Sections 3.1, 3.2, 3.3 and 3.4 are causing localized plasticity in proximity to the toe of tube attachment welds have been noted as visual indications of external tube oxide spalling adjacent to many tube to header welds at the position of the highest thermal mechanical stress intensity. These indications have been noted in the subject HRSG as well as in five sister units of similar age. It is anticipated that these indications are precursors to near term tube fatigue failure. Solid dark squares in Figure 49 record the pattern of this spalling in the HPSH and RH in one of these units. Small arrows indicate the location of inlet and outlet nozzles.

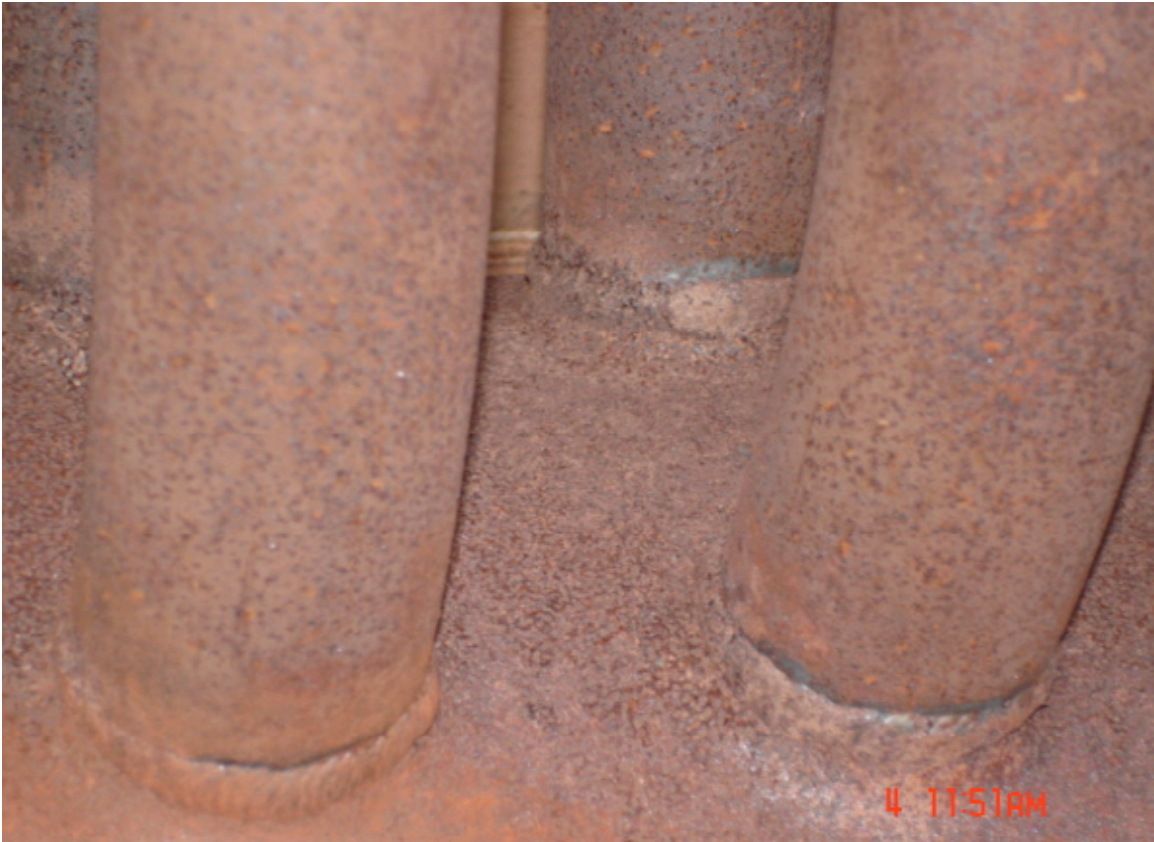
The external oxide that forms at high temperatures on the tubes is relatively more brittle than the tube material. Localized plastic strain in the toe of the attachment weld to the tube surface causes the oxide to fracture from the very localized surface where plasticity occurs. This leaves a visually noticeable linear indication along an arc of the toe of the weld on the tube where thermal mechanical stress intensity is highest, since the underlying substrate material is of a darker color than the outer layer of oxide, Figures 49, 50 and 51. The spalled oxide linear indications are located on the tube directly adjacent to the toe of the tube-to-header welds. This coincides with the location where fatigue cracks are to be expected when the subject welds experience bending moments as would be caused by the tube temperature transients presented in the above Sections of this paper.

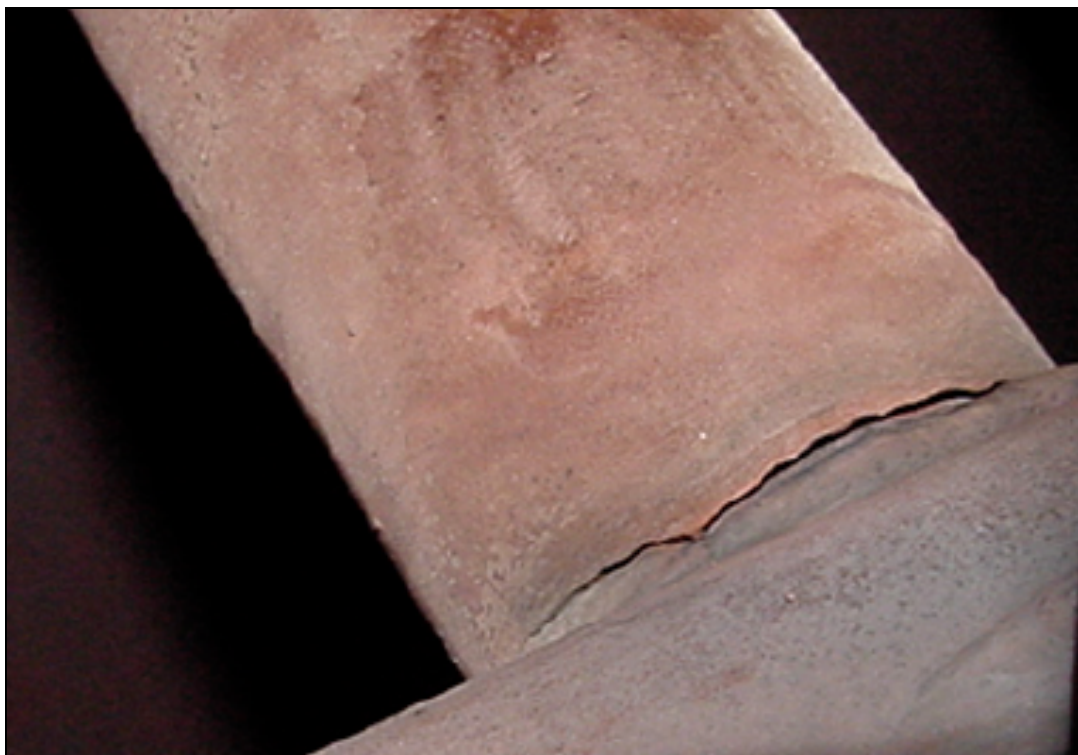
Figure 53

Most recently a through wall crack occurred in one of the inlet nozzles to RH2, Figure 53. The crack was located in the P91 nozzle just above the attachment weld to the RH1 to RH2 interconnection manifold. The failed nozzle is located immediately down stream of the RH attemperator, Figure 4. Metallurgical analysis identified thermal quenching (from repeated overspraying during startups and shutdowns) at the internal surface of the pipe and nozzle as the crack initiation mechanism. However, crack propagation through the wall was probably driven by thermally induced bending stresses induced during startups. During hot starts the bottom of the long, stiff horizontal RH2 inlet manifold is cooled by condensate pooled along the bottom of the much hotter pipe causing the pipe to want to bow. The bowing is restrained by the short stiff inlet connections to the RH2 inlet headers, which develop a high bending moment at the crack initiation site. It appears that the thermal mechanical consequences of the predictable presence of condensate along the bottom of the pipe may not have been considered during pipe stress analysis.

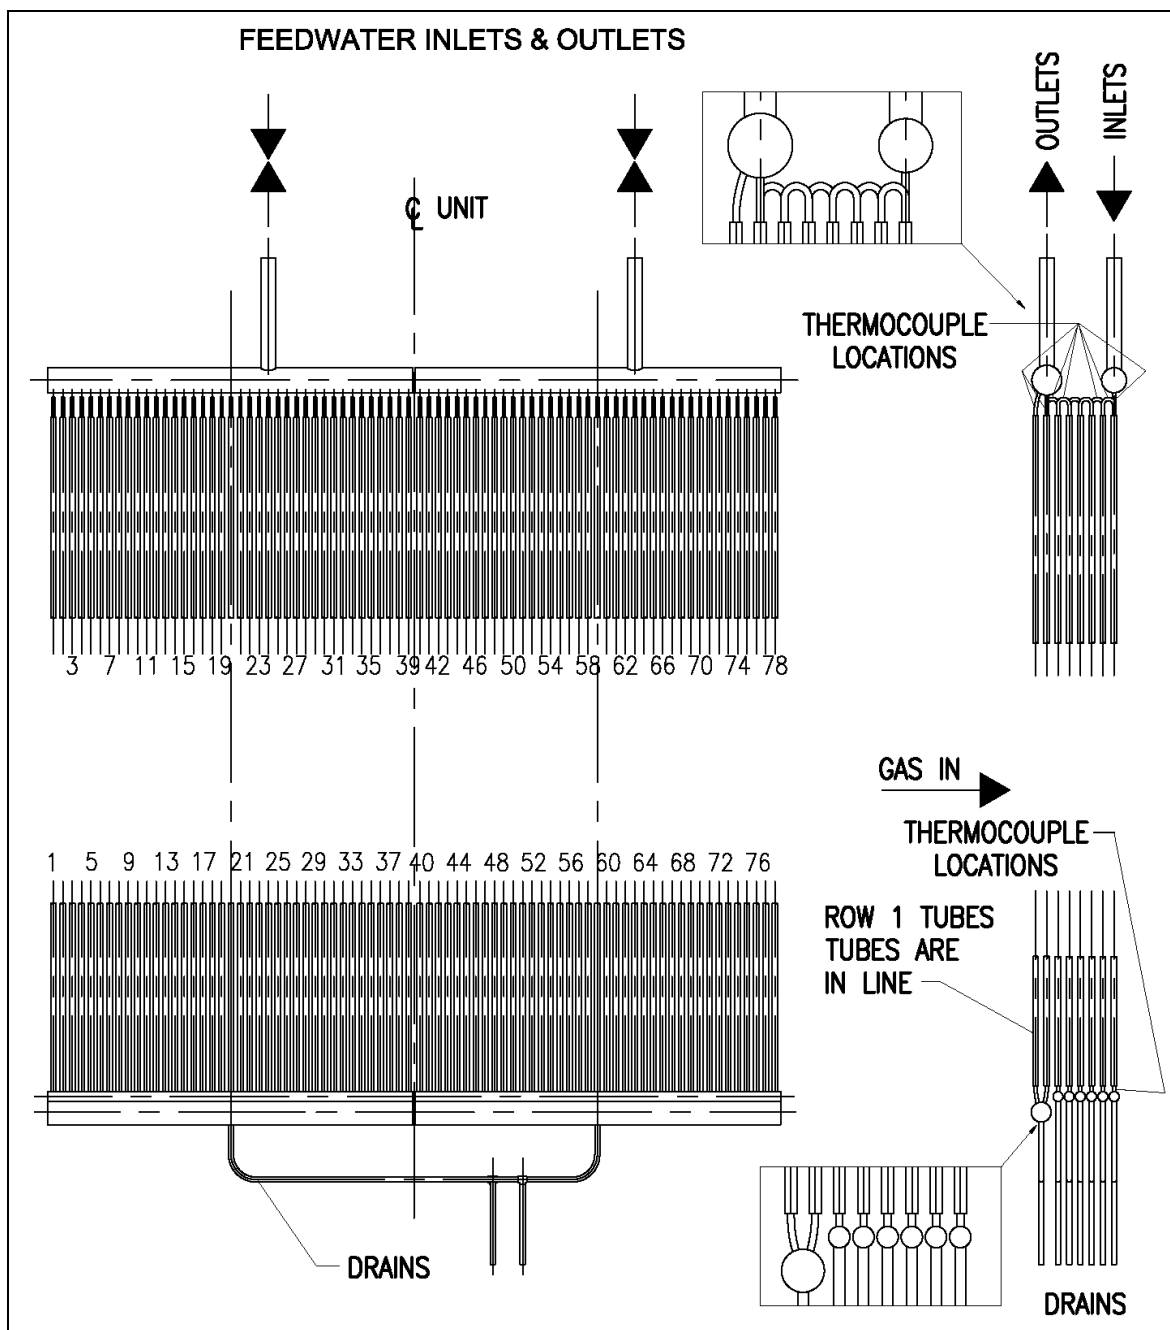
Figure 54

module has 39 tubes in each row; i.e., a total of 78 tubes per row across HPEC2. The location of TCs is shown on Figure 54.

**HPEC2 Tubes and Headers Arrangement**

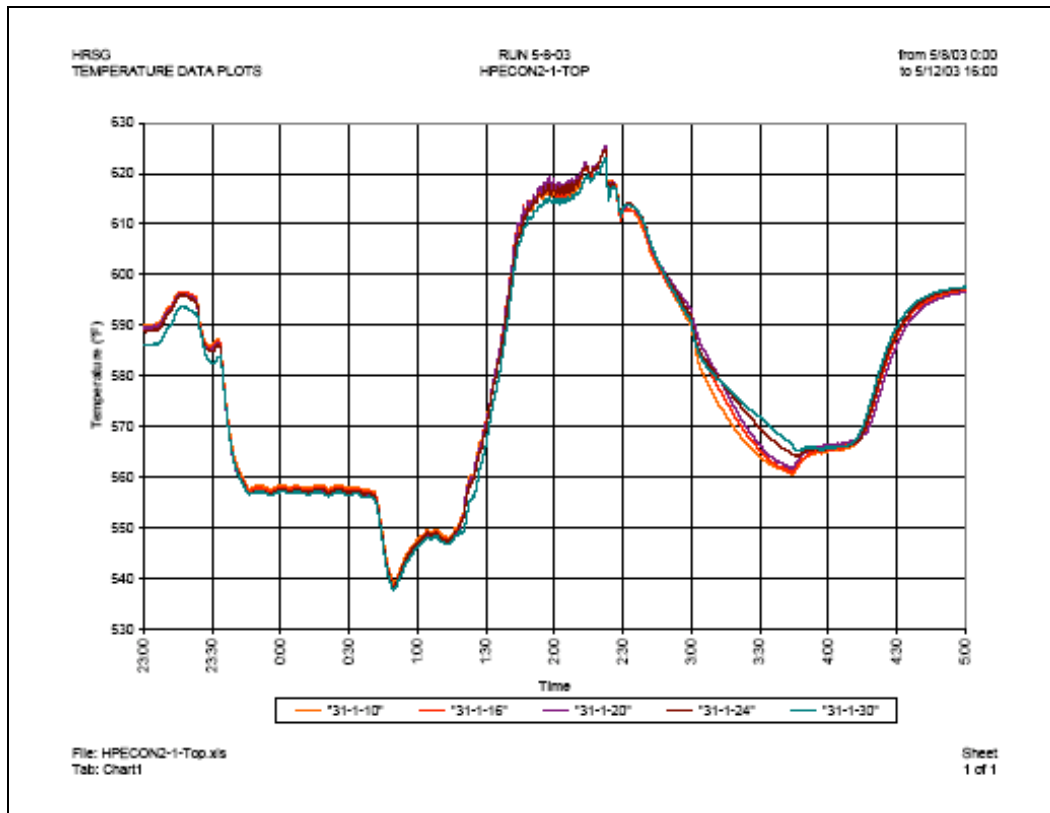
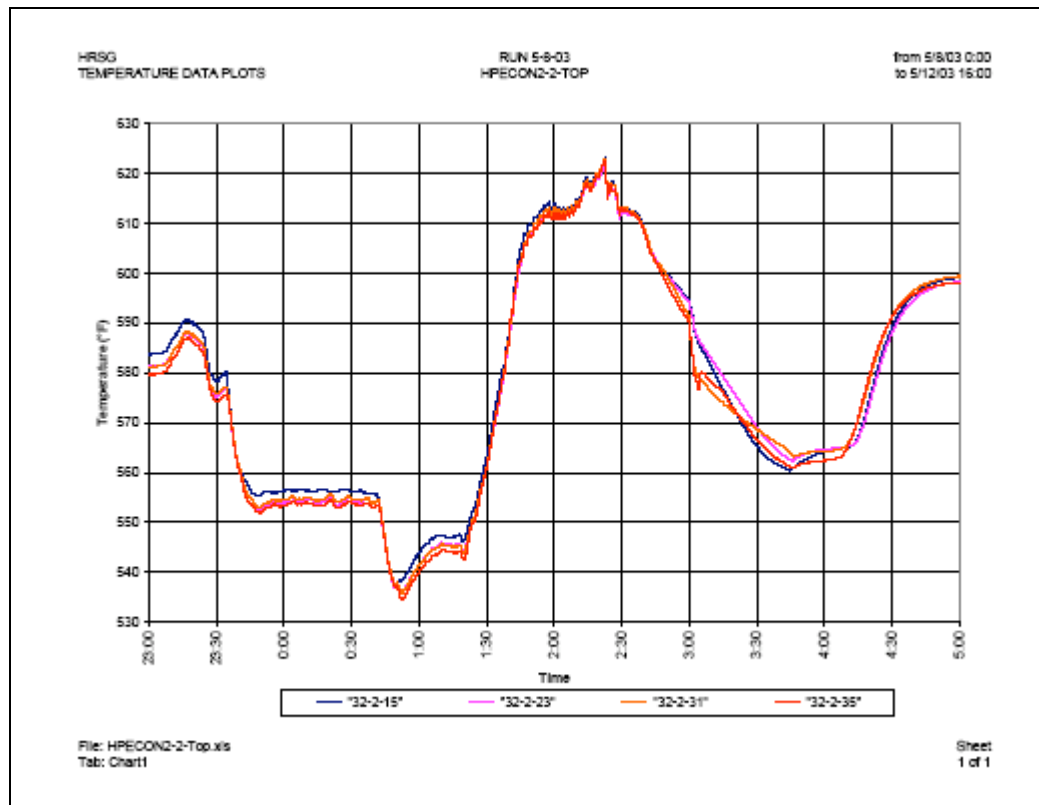
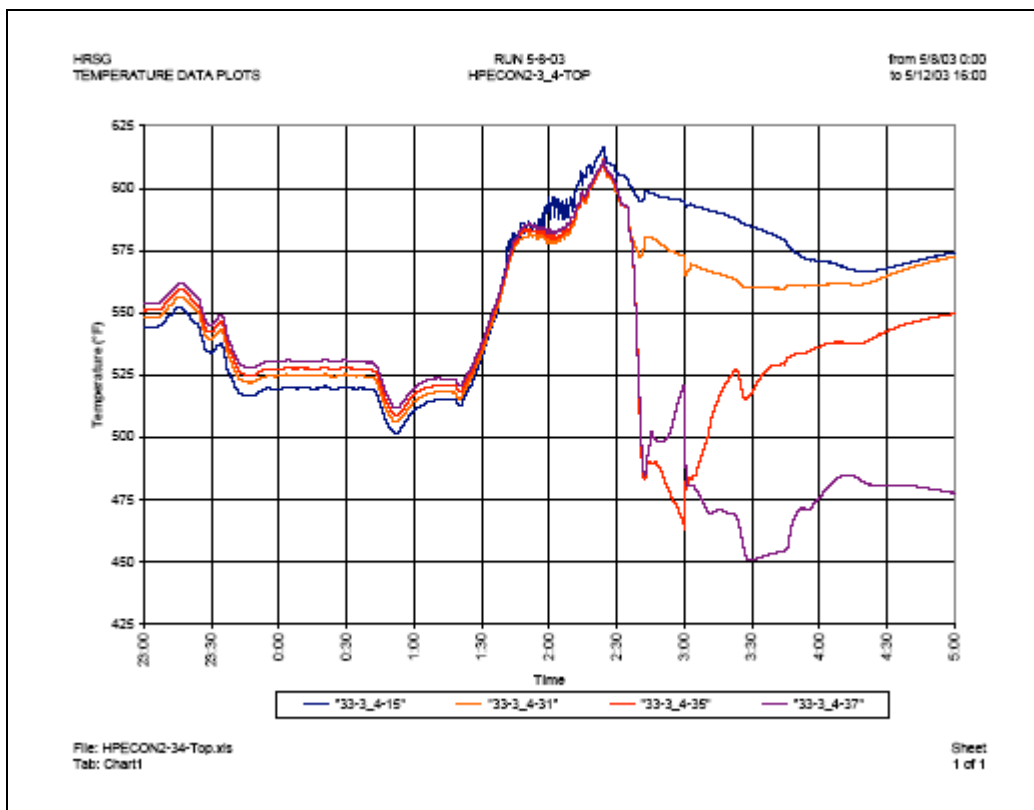
Figures 73 - 80 highlight the behavior of HPEC2 after a normal shutdown at high HP drum pressure as required to limit the thermal cycles on the HRSG and limit critical components' fatigue life consumption. Following shutdown of the CT and when feedwater flow is reduced, large temperature differences develop ( $\pm 100^{\circ}\text{F}$  ( $56^{\circ}\text{C}$ )) between tubes in the same row in all rows except row 7 to 8.

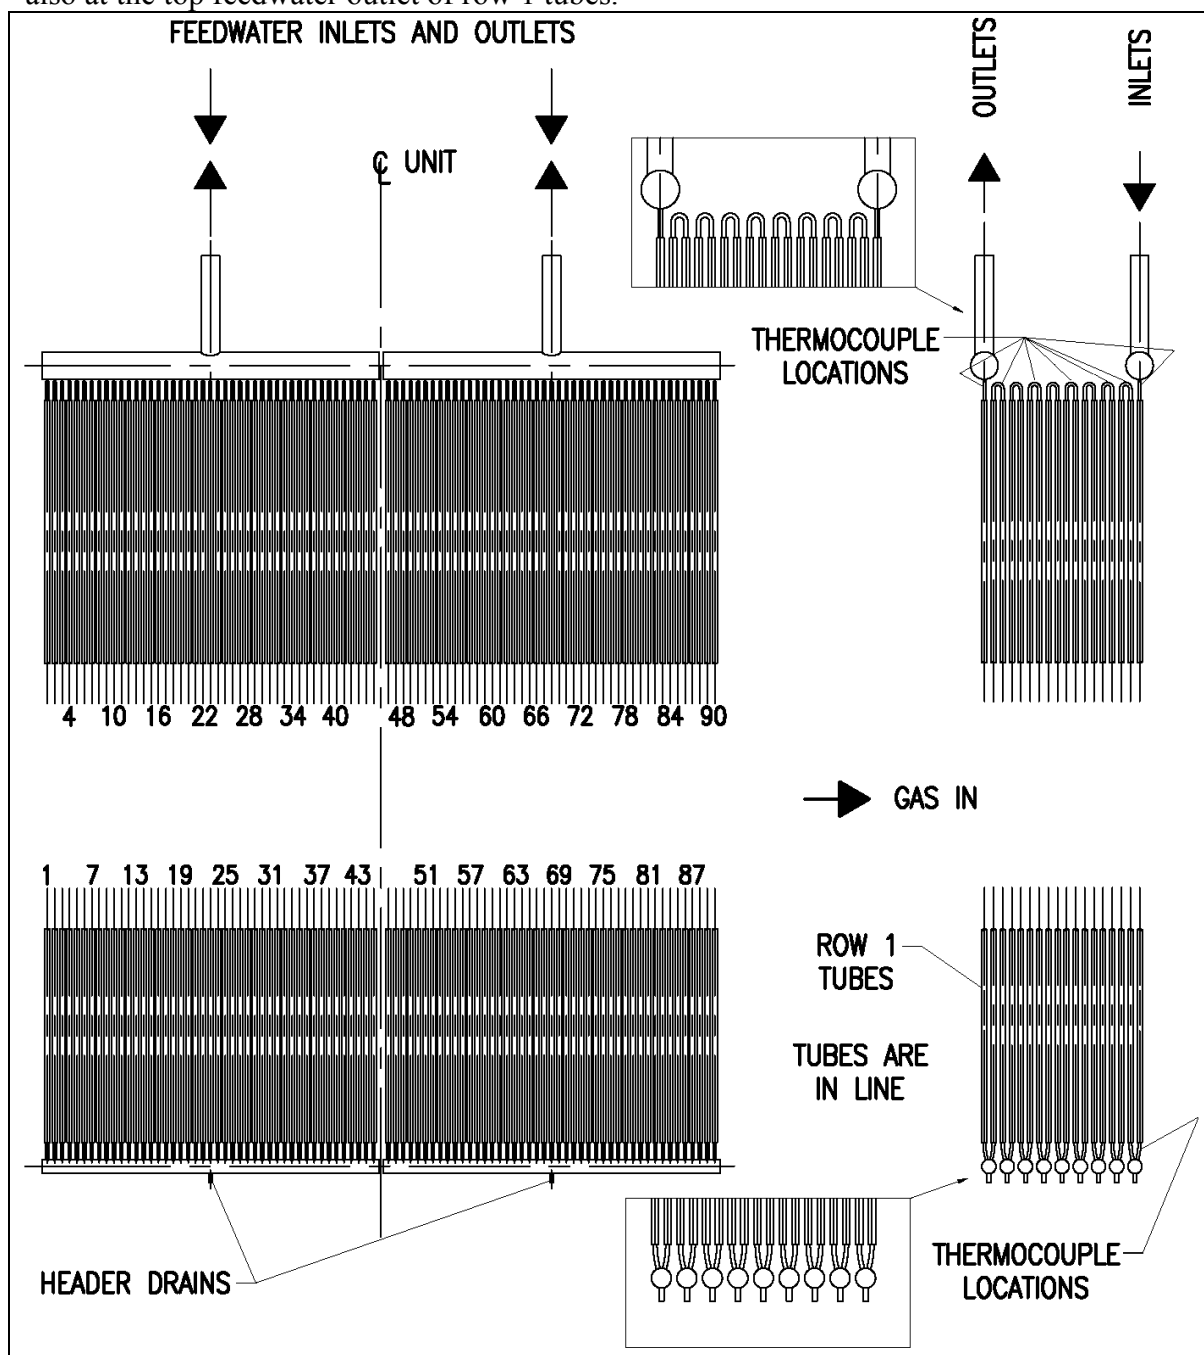
Figure 81

Thermocouples (TCs) were installed at roughly equal tube intervals across each tube row on about 20 to 25% of the 45 tubes in each of the selected tube rows of one of the two preheater modules in this HRSG, Figure 1. TCs were installed at the top feedwater inlet of row 18 tubes and also at the bottom of row 18 tubes. TCs were attached close to the upper hairpin bends between tube rows 16 & 17, 14 & 15, 10 & 11, 6 & 7, and 2 & 3, and also at the top feedwater outlet of row 1 tubes.

**LPPH Tubes and Headers Arrangement**

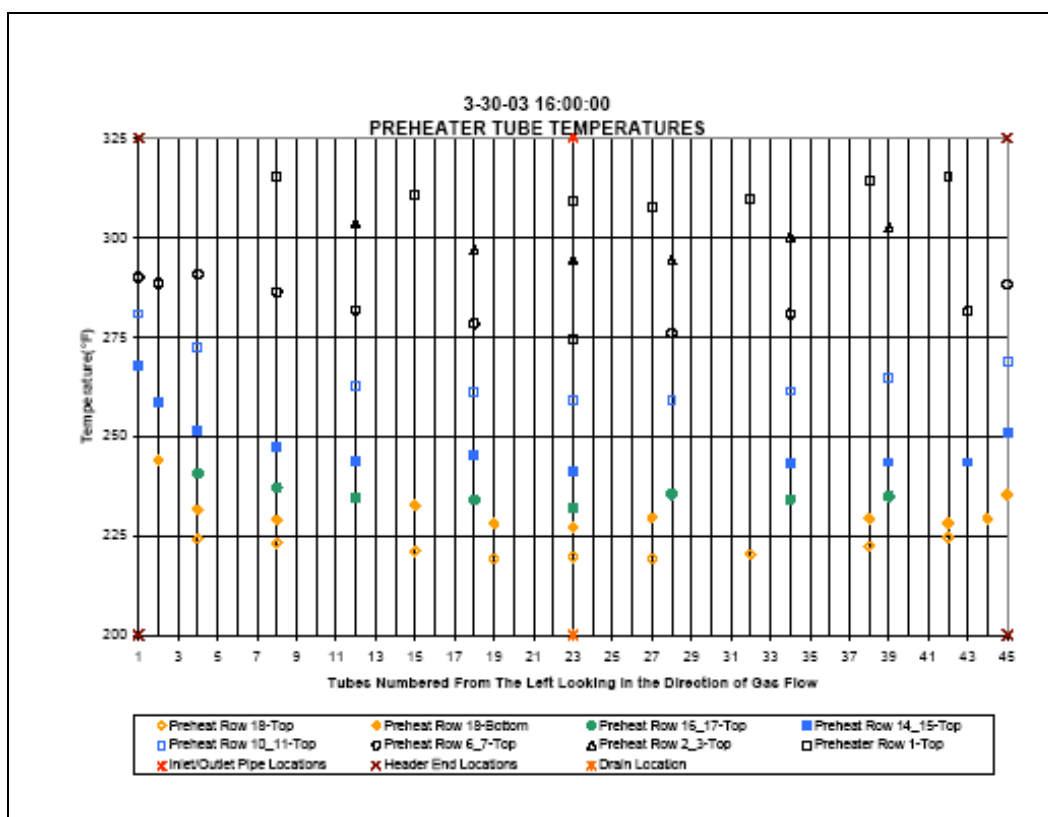
The pattern of temperature variation in temperature at the top of tubes in the same row was quite consistent. Figure 99 is during operation at 16MW with LP drum saturation temperature of 306°F (152°C). Figure 100 is during operation at 100MW with LP drum saturation temperature of 270°F (132°C). Figure 101 provides the distribution of individual tube temperatures at the top of each of the rows installed with TCs during operation at 174MW with LP drum saturation temperature of 313°F (156°C). In general, the tubes in each row that are close to the center of the bundle operate at the lowest temperature. It appears that these tubes, which are closest to the inlet and outlet pipe branch on inlet and outlet headers which are both located opposite tube # 23, have greater flow through them than the tubes more remote from the center of the bundle.

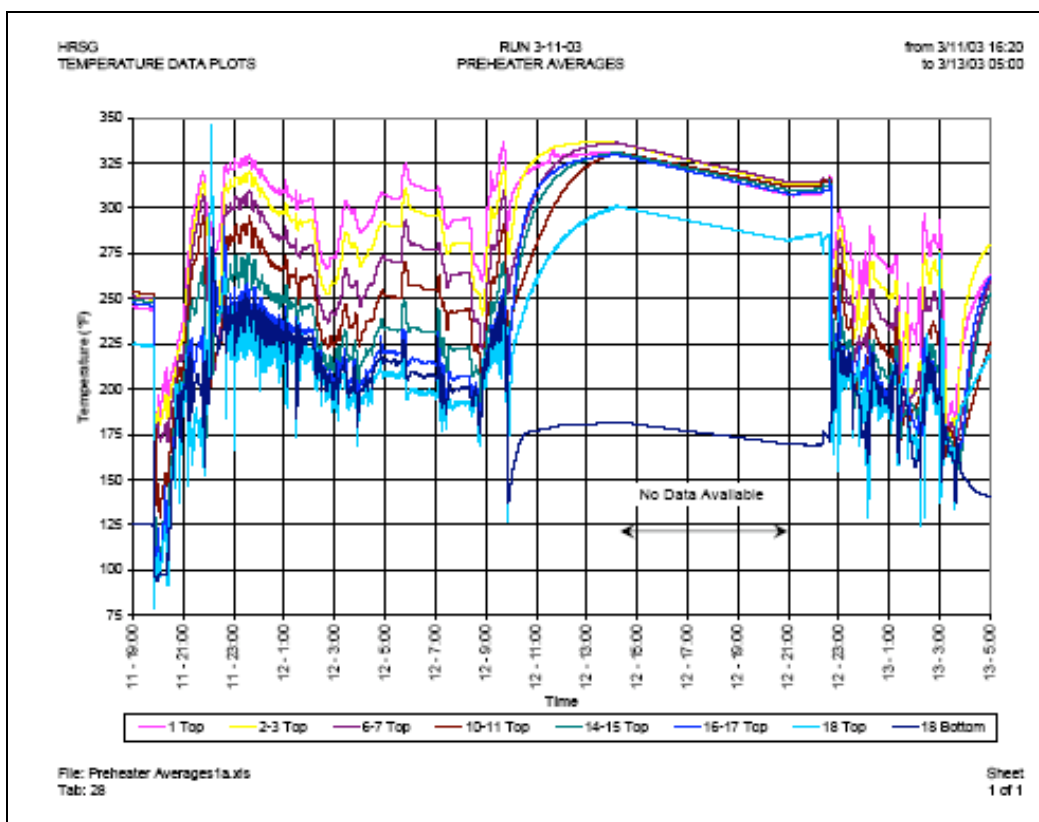
Figure 102 plots the calculated average of measured temperatures in each row during the period from 19:00 hours on 3-11-03 to 05:00 hours on 3-13-03. During this period there was a cool start at about 20:00 on 3-11-03; a trip at 21:46 hours on 3-11-03 and restart less than one hour later. After a period at baseload there was a normal shutdown between about 08:00 and 10:00 hours on 3-12-03. The unit then performed a warm to hot start about 12 hours after the shutdown after 22:00 hours on 3-12-03.

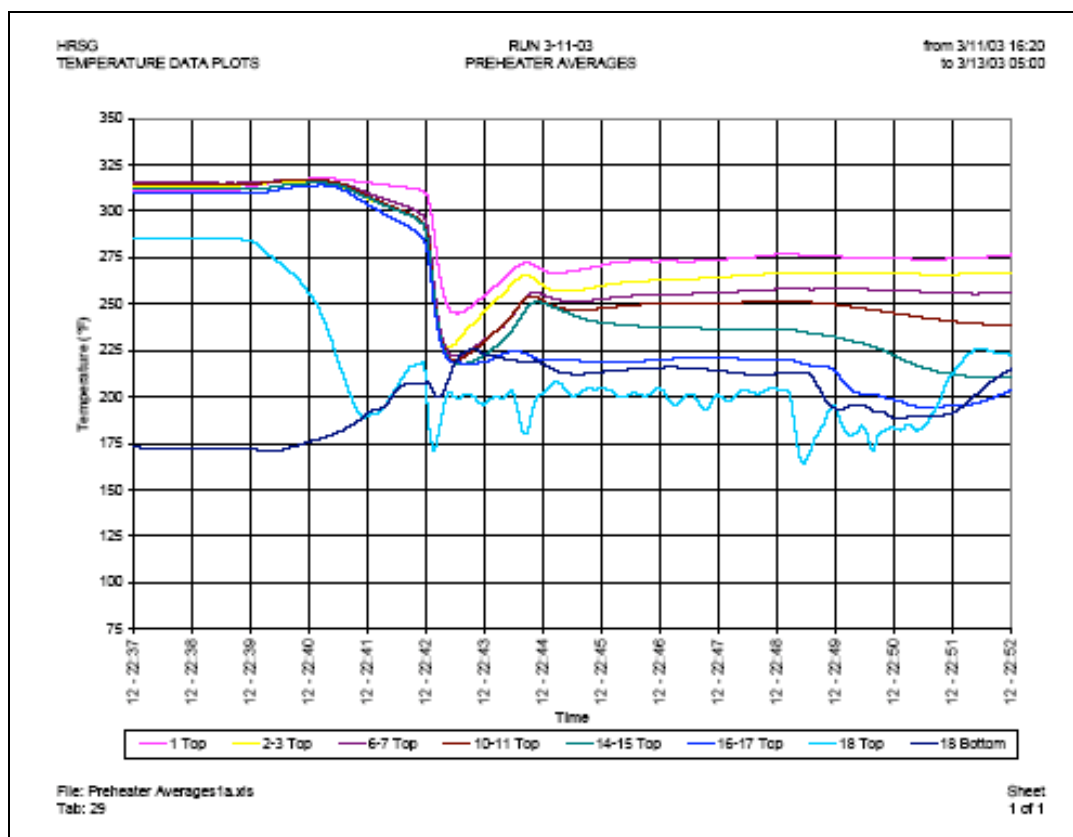
Figure 103 expands the time scale for the period during the warm-hot start on 3-12-03 when LP feedwater flow was established and the LPPH experienced significant temperature differences between tube rows. The temperatures plotted for each measurement location are the average of all temperatures measured for that location in the LPPH bundle. CT ignition occurred at 22:36 hours and LP feedwater flow commenced at 22:39 hours. The minimum mean of row 18 top and bottom temperatures was about 188°F (87°C) and occurred 3 to 4 minutes after a small LP feedwater flow commenced, (about 15 seconds before 22:43 hours), when the cool feedwater reached the bottom of row 18 tubes, pushing ahead of it into the row 17 tubes the hotter water that had until then been stagnant in the row 18 tubes. At this time point all other tube rows had cooled barely 5°F (3°C) from 315°F (157°C) to which they had slowly cooled during the off load period.

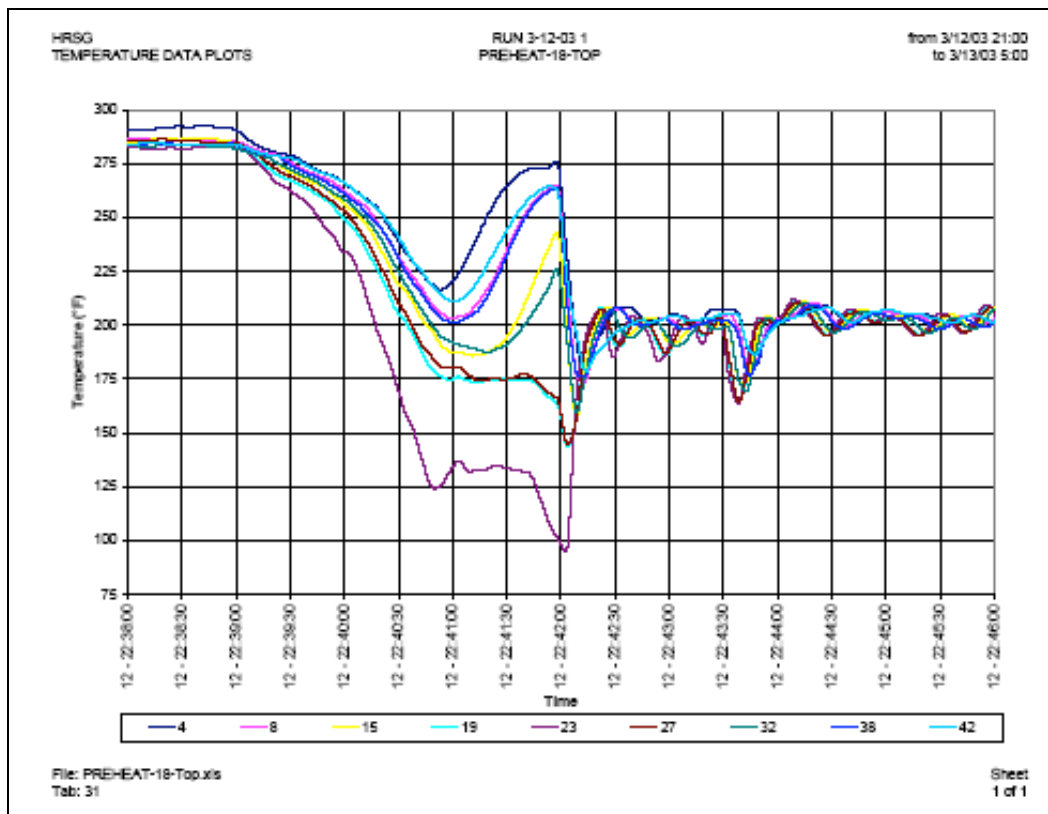
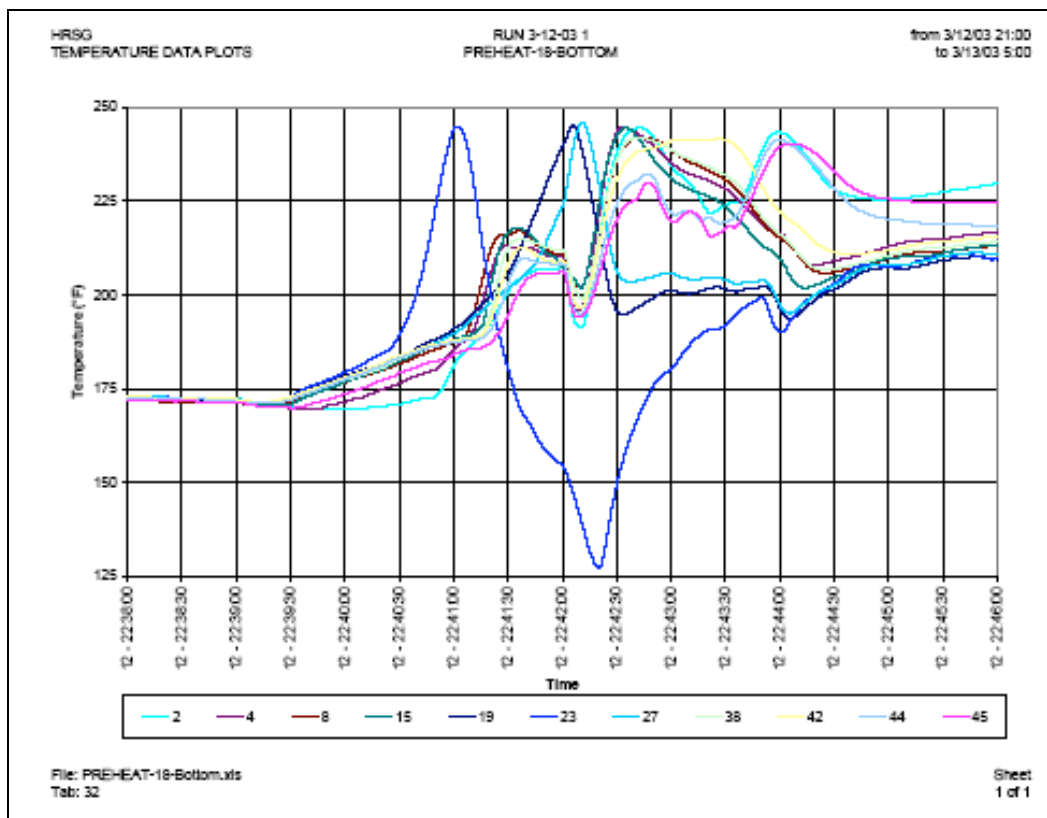
Figures 104 and 105 provide the tube temperatures measured in the individual tubes at top and bottom of the feedwater inlet pass, row 18, tubes. These highlight that when feedwater flow is low, or when the LP feed pump is on and the flow control notionally shut but passing, that flow is concentrated through the tubes in the center of the header which are closest to the top inlet pipe branch. At about 22:42 hours on 3-12-03, the measured temperature difference between row 18 tubes is about 175°F (97°C) at the top, Figure 104, and 100°F (56°C) at the bottom, Figure 105. This peak mean temperature difference between row 18 tubes occurs shortly after the peak average row-to-row temperature difference when the temperature difference between row 17 and other tube rows and row 18 tubes still exceeds 100°F (56°C). This phenomenon substantially enhances the thermal stresses and life expenditure rate in the row 18 tubes closest to the single feedwater pipe branch in the middle of the LPPH inlet header.
