Trends in HRSG Reliability – A 10-Year Review

Barry Dooley and Bob Anderson

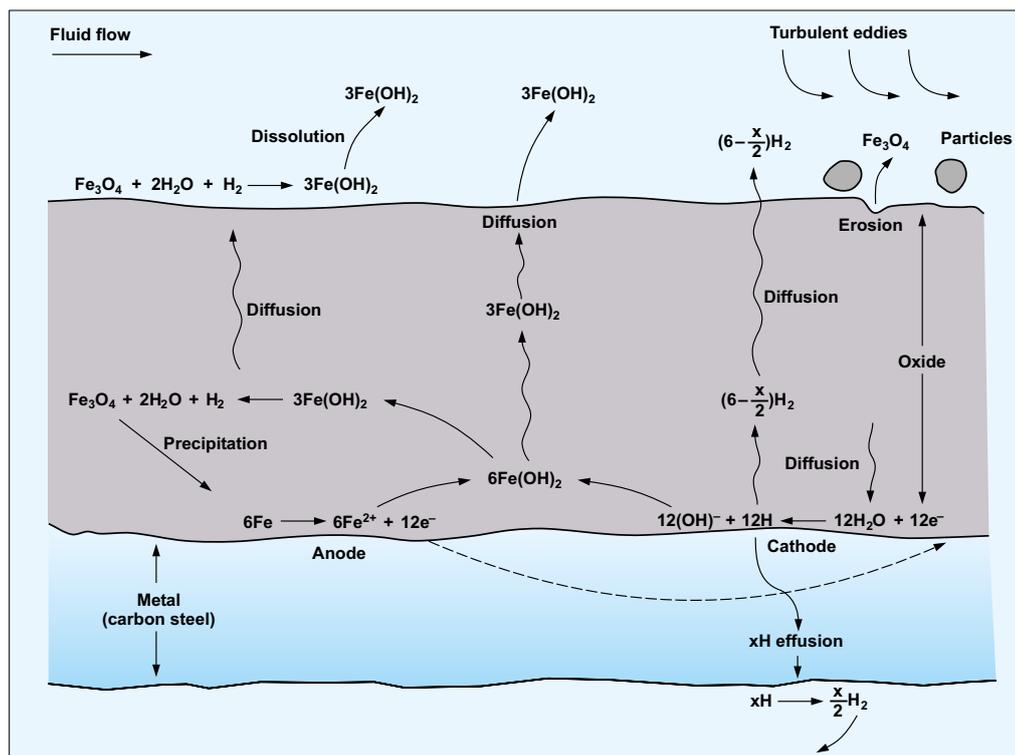
Figure 1: Schematic of the mechanism of FAC at steady-state, showing the associated stoichiometrically balanced chemical reactions and transport processes [4].

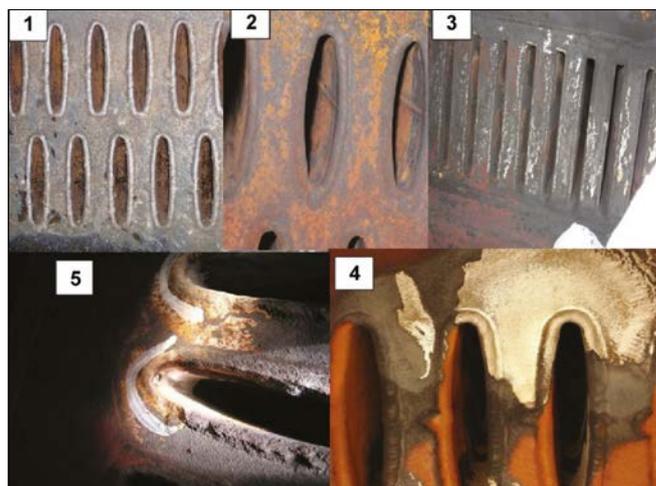
Figure 2: Montage illustrating DHACI indices 1–5 for the upper ducts and tube entries of ACC. The FAC damage increases with number [4,8].

The cycle chemistry influenced FAC damage in ACC can be best described through an index for quantitatively defining the internal FAC status of an ACC. This is known by the acronym DHACI (Dooley Howell ACC Corrosion Index) [8]. This methodology was recently published as a guideline of the ACC Users Group (ACCUG) [9]. The index separately describes the lower and upper sections of the ACC. Examples from the recent FAC review [4] are included in Figures 2 and 3.

In the assessments conducted, the DHACI has been used to describe the status of a particular ACC, which is a useful confirmation of the chemistry and of FAC in the HRSG. It is also a very useful means of tracking changes that occur as a result of making changes in the cycle chemistry. For instance, a plant that has a relatively poor rating for FAC at a condensate cycle pH of 8.5–8.8 (e.g. with a DHACI of 4C) may increase the pH to 9.4–9.6 and determine whether this change improves its rating (e.g. to a DHACI of 3B). A poor rating indicates the need to consider options to reduce the FAC rate, especially at the tube entry areas and

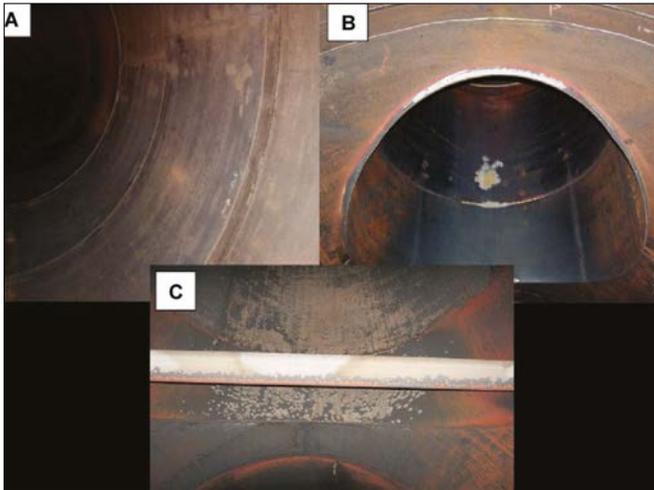
Figure 3: Montage illustrating DHACI indices A–C for the lower ducts of ACC from the steam turbine to the vertical risers to the upper duct. Increasing letters indicate more severe and extensive damage [4,8].

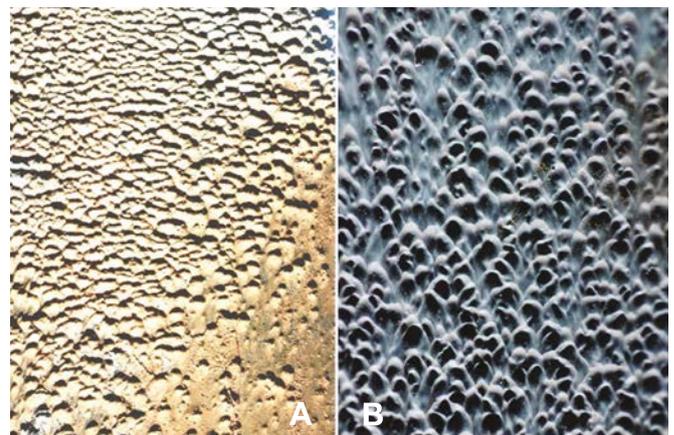
Figure 4: Two views of the visual surface appearance of single-phase FAC. A is a typical detail from an economizer inlet header tube in a conventional fossil plant. Example B is a similar view from the FAC surface near the inlet of an HRSG LP evaporator tube. In both cases the horseshoes or chevrons point in the direction of flow (bottom to top) [4].

Figure 4 provides two examples of the typical surface appearance of single-phase FAC in fossil and combined cy-

cle/HRSG plants. In locations where single-phase FAC is starting, such as towards the bottom of photograph A in Figure 4, individual horseshoes or chevrons can be clearly seen and always point in the direction of flow (bottom to top in photograph). As the turbulence becomes greater downstream of the flow disruption and the FAC rate increases, such as towards the middle/top of photograph A in Figure 4, the chevrons overlap and produce the typical orange peel appearance of single-phase FAC.

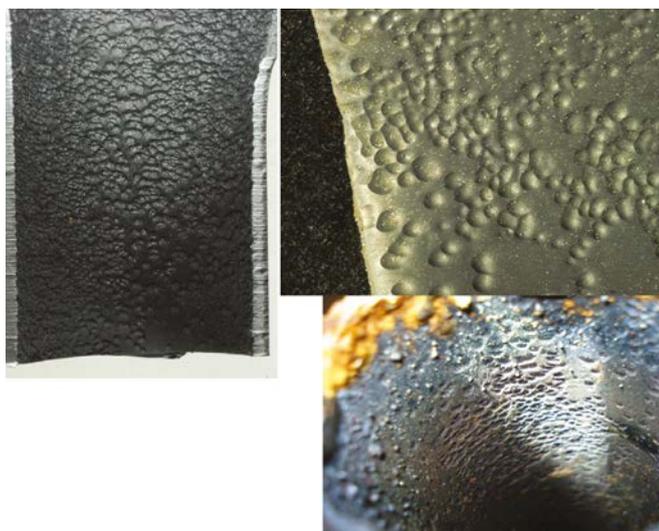
Figure 5:
Three examples of two-phase FAC in HRSG LP evaporator tubing. The left-hand photograph shows the typical black/shiny appearance of established FAC. The top right photograph shows the distinct dimples of initiating FAC without any obvious directionality in respect to the flow. The lower right shows a view looking into a LP evaporator tubing from the outlet header with severe FAC (failure) on the left side of the photograph and initiating damage on the right [4].

Figure 5 provides three examples of two-phase FAC in HRSG LP evaporators where the surface appearance of two-phase damage can be easily seen to be different to that in single-phase situations. This two-phase FAC damage is probably the most misidentified FAC in combined cycle/HRSG plants. This is most important because increasing the oxidizing power of the fluid will have no effect on the damage [4]. Established two-phase FAC always has a black shiny appearance (left photograph) and in areas where it is just starting or at the extreme of the damage there are often "dimples," which are usually misidentified as damage from pitting corrosion on the surface (top right photograph). They most often do not show any directionality like the chevrons of single-phase FAC. As the turbulence becomes established and the FAC wear rate increases, the dimples overlap and sometimes the surface appearance then resembles single-phase FAC (as seen in Figure 4) but is black and shiny.

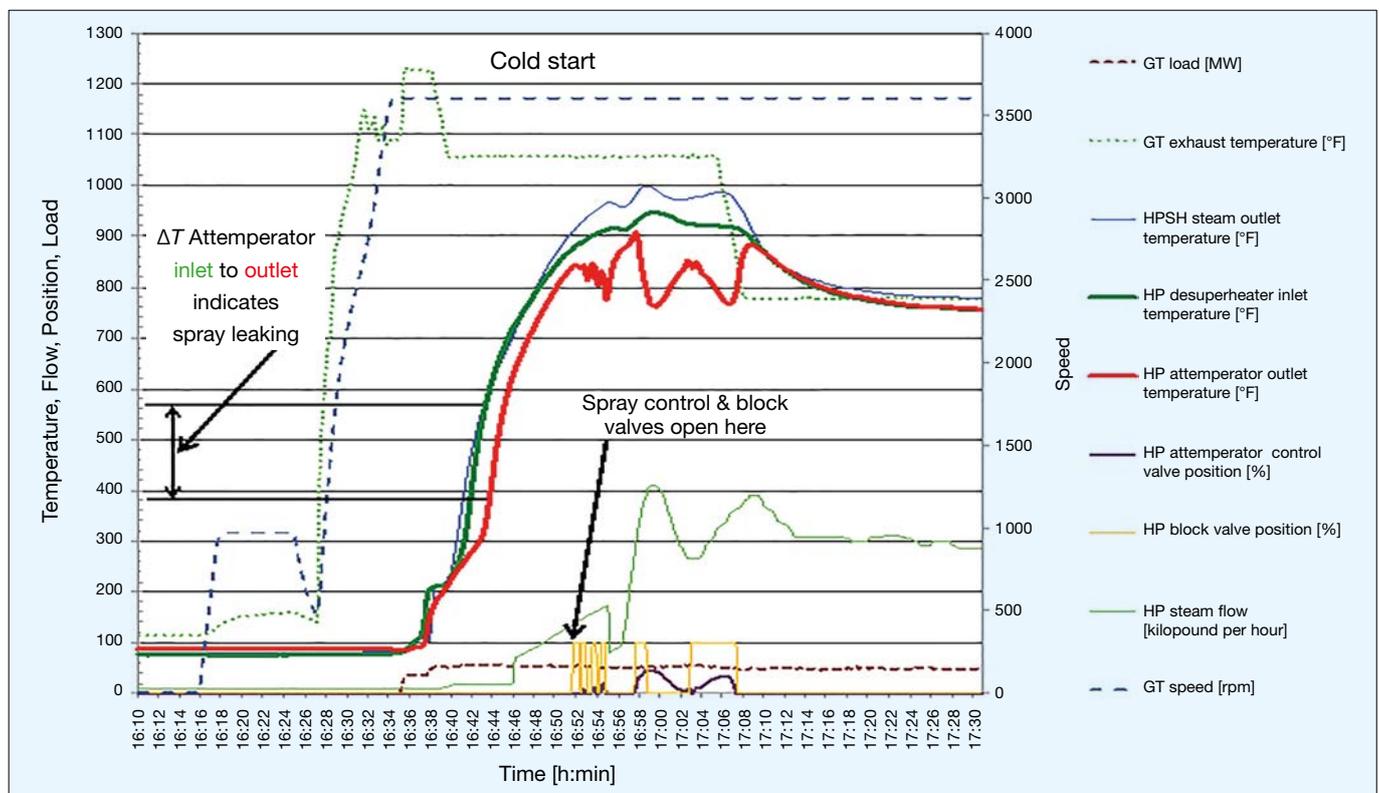
Figure 6: Steam temperature difference between attemperator inlet (green line) and outlet (red line) during early startup with attemperator spray valves (orange and purple lines) closed indicates leaking spray water valves.

ators as demonstrated by DCS data plots. Small to moderate leakage rates have no noticeable impact on thermal performance, so may seem unimportant and not be taken seriously by many operators. However, even a small leakage rate into hot steam pipes during periods of zero and low steam flow causes cracking of thermal liners, at the inner surface of steam pipes and in girth welds. When cooler water contacts the bottom of a hot pipe, a top to bottom temperature differential occurs. This results in transient and/or permanent steam pipe distortion that can result in unanticipated piping system loads, cracking in girth welds, and damage to the pipe's support system. These distortions may cause water to flow away from rather than toward the drain and trap water in undrained low points. Trapped water will later be swept by steam flow into other sections of piping, tubes, and headers. Figure 6 presents plots of DCS data showing evidence of attemperator spray leaking.

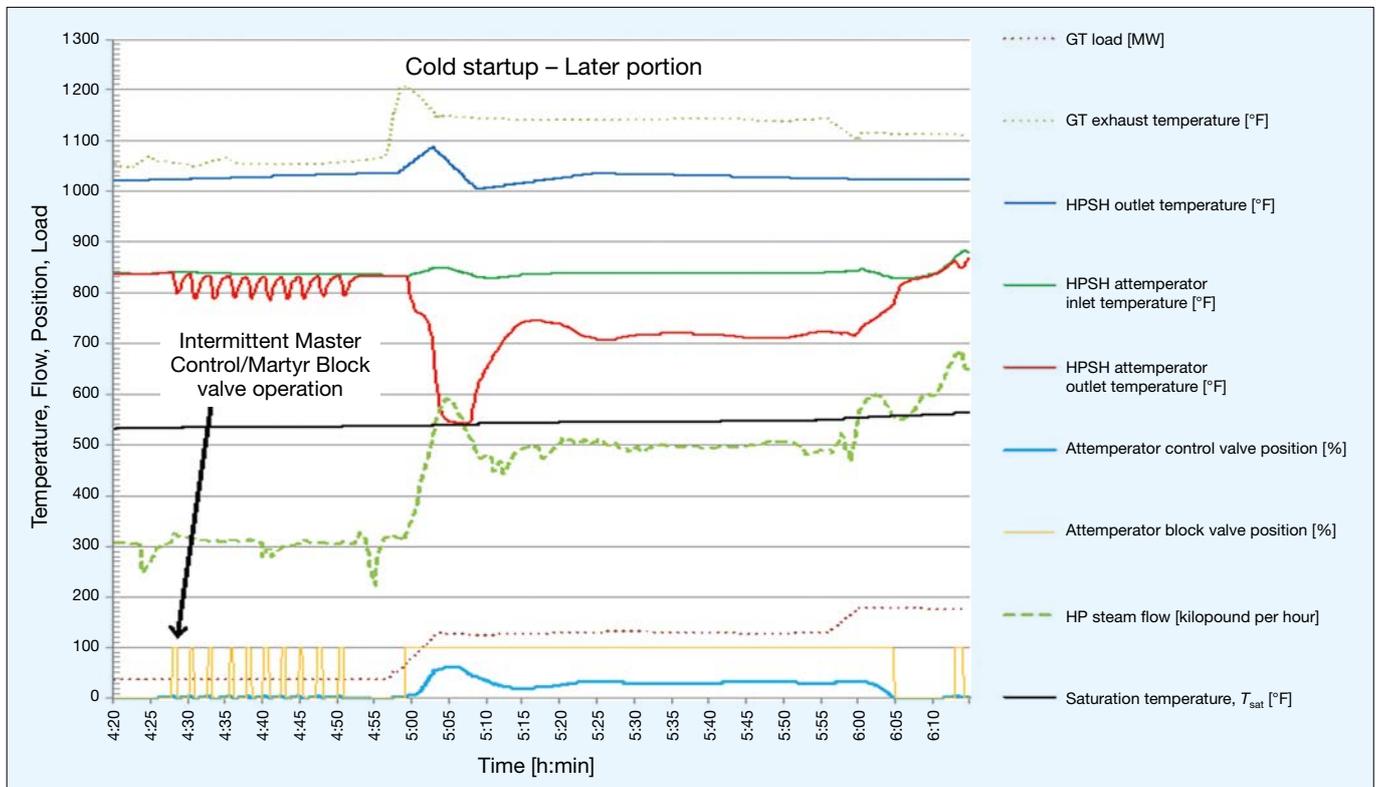
Figure 7:

The spray control valve (light blue line) opens first, then the block valve (orange line) opens each time spray is required. The process reverses each time spray is no longer required. This activity rapidly damages the block valve seating surfaces.

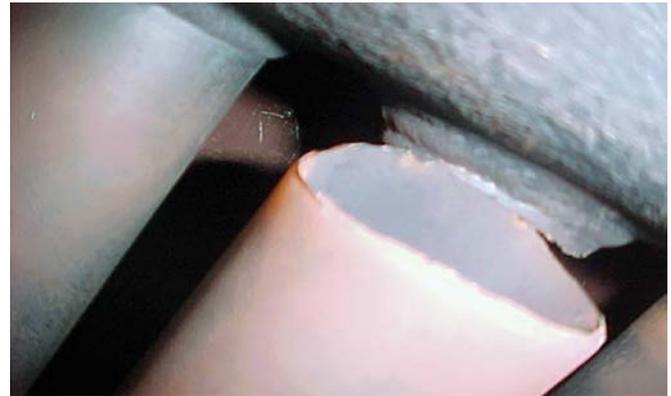
Figure 9: HPSH tube pulled from its header due to manual operation of the attemperator following shutdown.

Like leaking spray water, operation of the attemperator during periods of low or zero steam flow when pipes, headers, and tubes are hot causes accelerated fatigue accumulation in these components. Unlike leaking spray water and overspray, which typically only cause invisible, cumulative damage that eventually results in failure, operation of the attemperator when steam flow is low or zero and pipes are hot has occasionally been known to result in immediate tube failure due to ductile overload. Figure 9 shows a photo of such a failure.

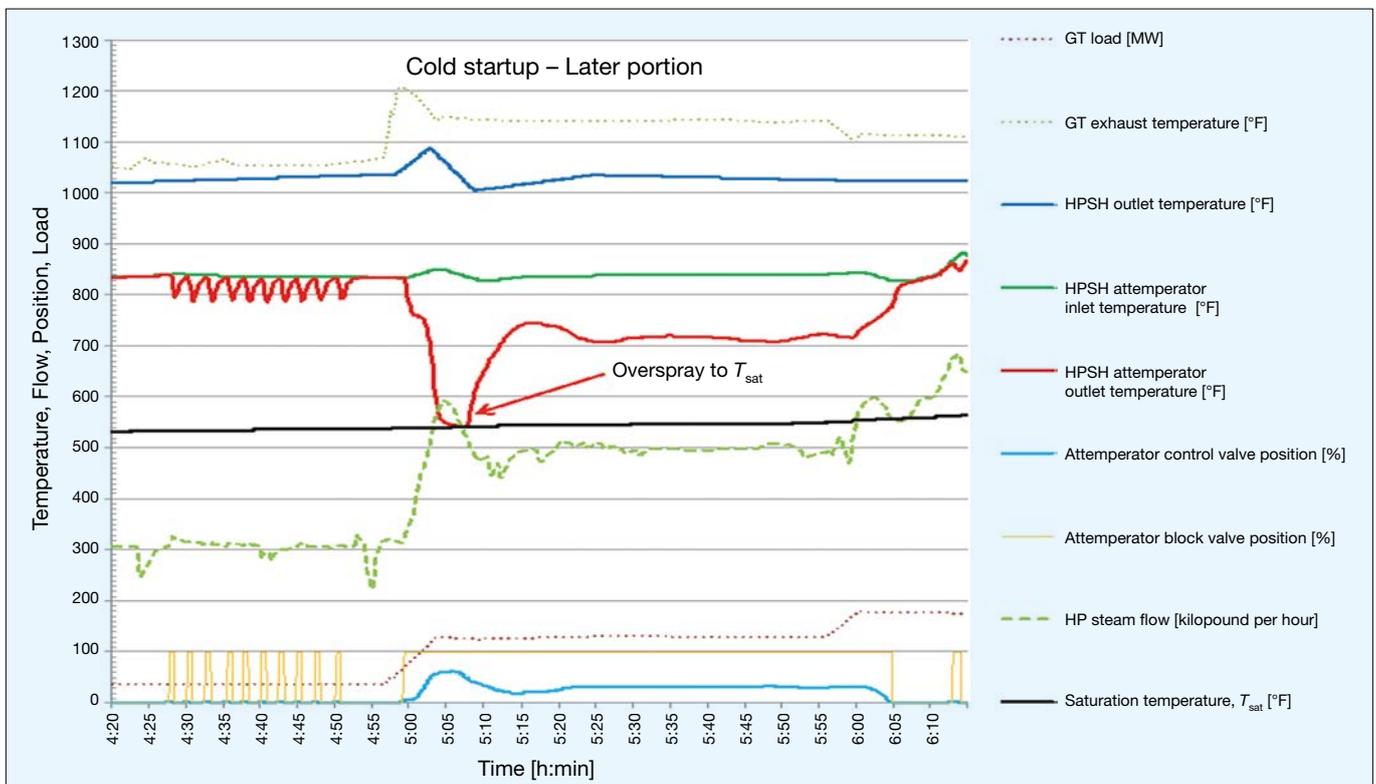
Figure 8: Steam temperature at a thermocouple downstream of attemperator outlet (red line) dropping to T_{sat} (black line) indicates overspray.

damaging thermal transients in downstream pipes, headers, and tubes. Overspray produces severe thermal fatigue damage and cracking in downstream pressure parts. Figure 8 presents the same plots of DCS data in Figure 7 but noting evidence of attemperator overspray.

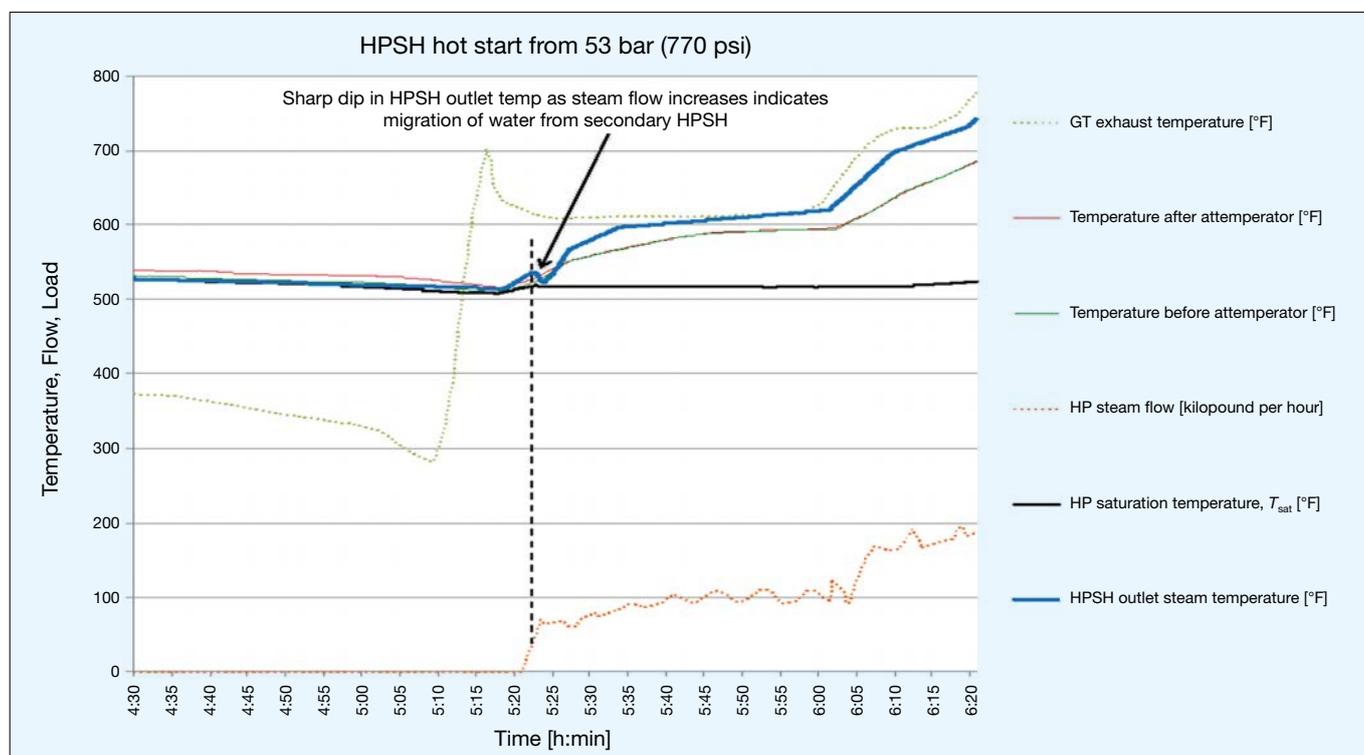
Figure 10: Sharp dips in steam temperature when steam flow increases indicates migration of undrained water.

is critical that this water be drained completely prior to initiation of steam flow in the HPSH and RH. During all types of startups HPSH and RH tubes heat up to near exhaust gas temperature (EGT) between GT light off and establishing initial steam flow through the tubes. Undrained water will migrate selectively through some tubes as steam flow is initiated, quenching (and shrinking) these tubes. Severe quenching sometimes results in global yielding of the tube, thereafter evident as buckling out of line when the transiently quenched tubes return to the same temperature as other tubes in the same row. After shutdown, headers, manifolds, and steam piping remain hot for long periods. During hot starts much cooler water remaining in the HPSH and lower piping is moved upward when steam flow is established and enters the still hot upper headers, collection manifolds, and steam piping. Figure 10 presents plots of DCS data showing evidence of water migration.

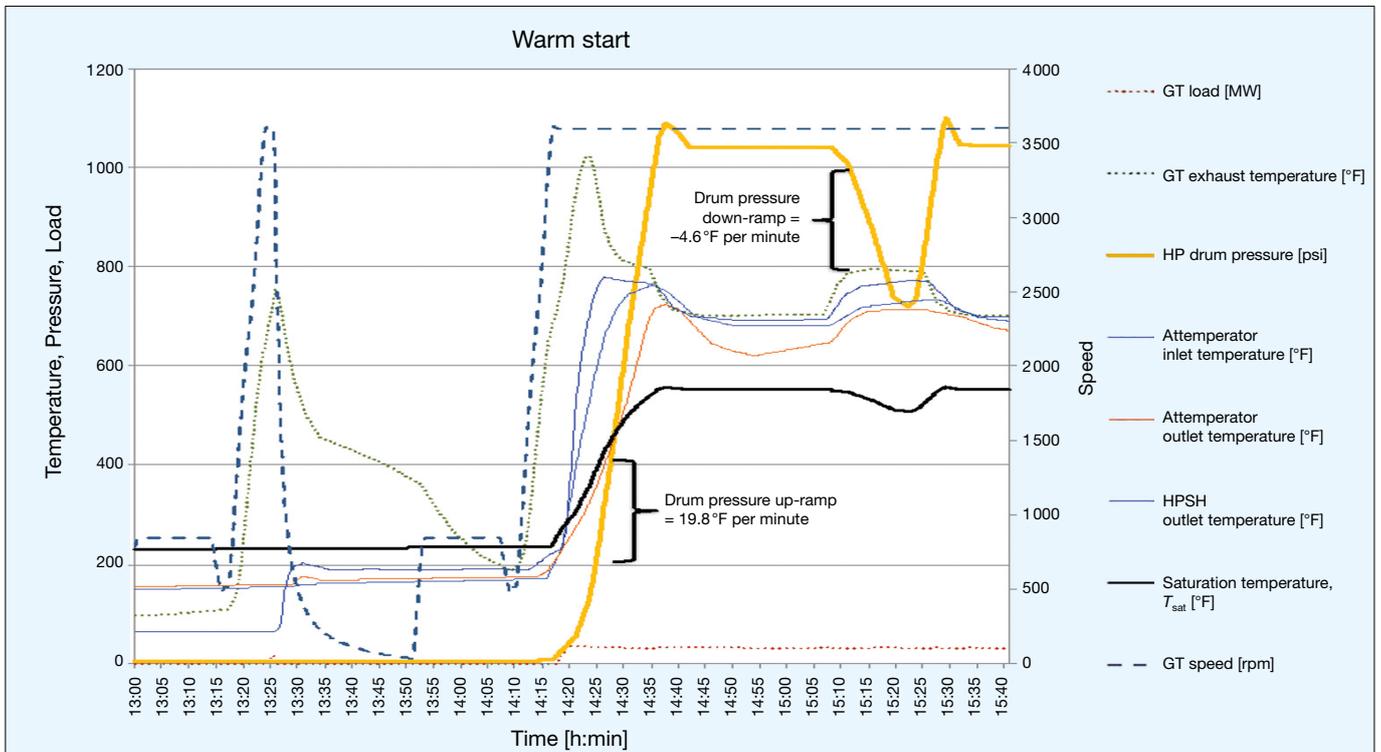
Figure 11: Aggressive startup ramp rate of a relatively thick-walled 121 mm (4.75 in) HP drum.

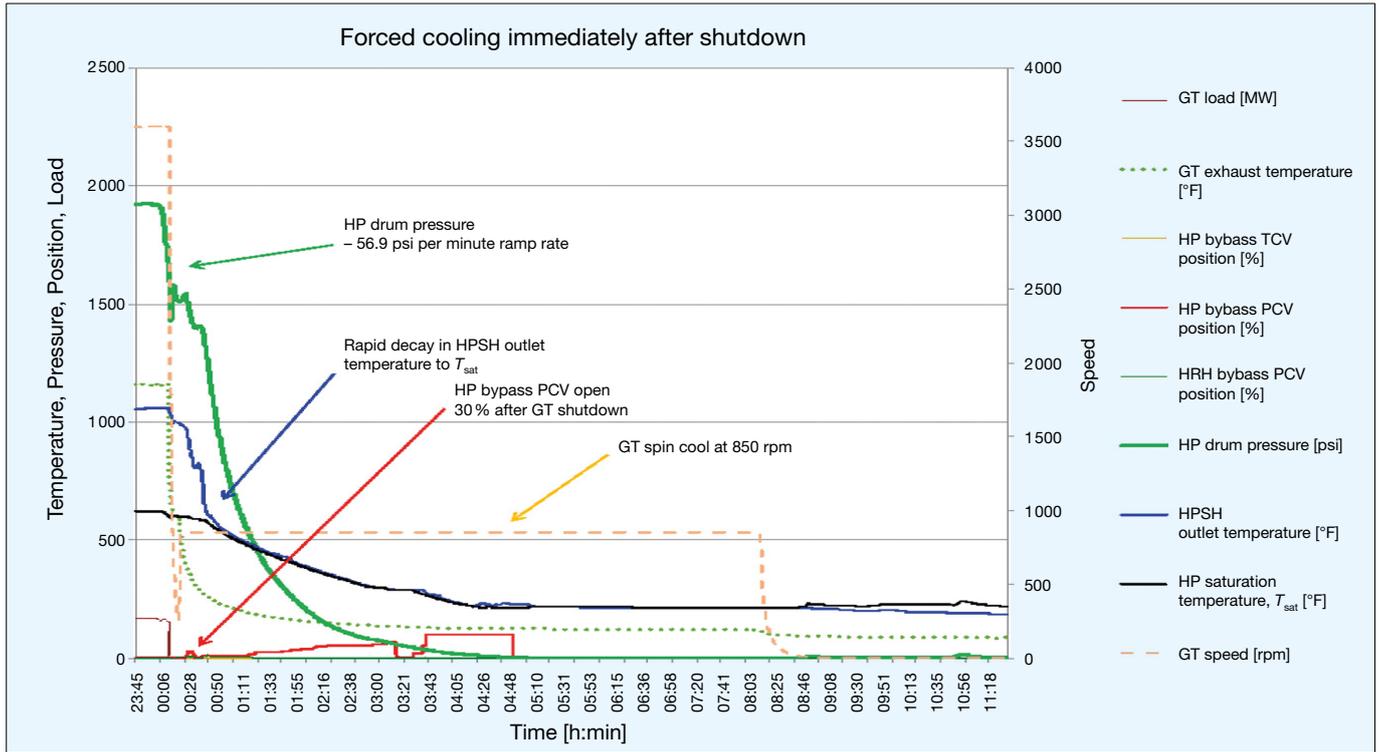
Figure 12: Aggressive depressurization ramp rate of HP drum and rapid cooling of HPSH outlet and main steam pipe.

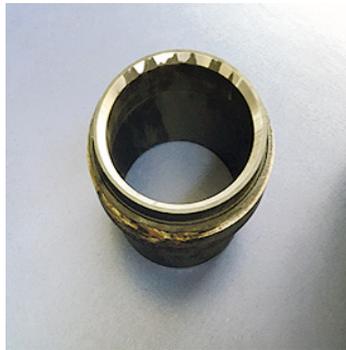
Figure 13: Normal PCV seat wear after 5 years of cycling service.

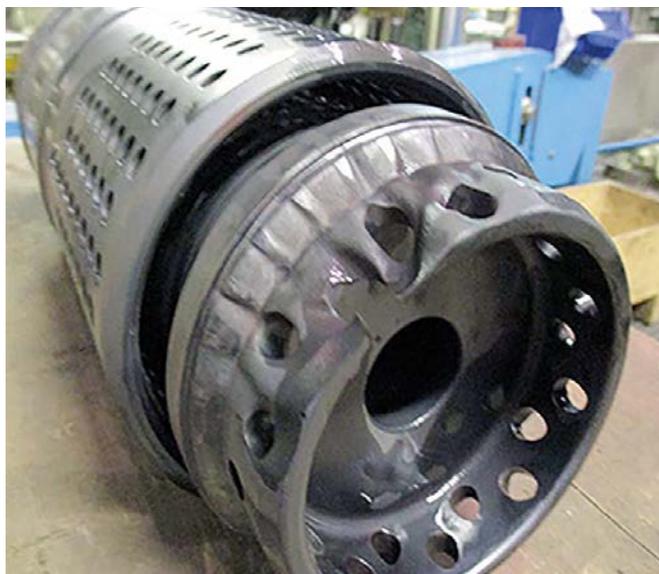
Figure 14: Abnormal PCV plug and cage wear after only a few start/stops.

Figures 14 and 15 show photos of PCV plugs with severe erosion after only a few start/stop cycles and about 1 year of service, respectively.

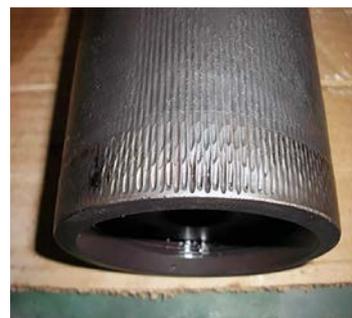
Figure 15: Abnormal PCV plug and cage wear after about one year of service.

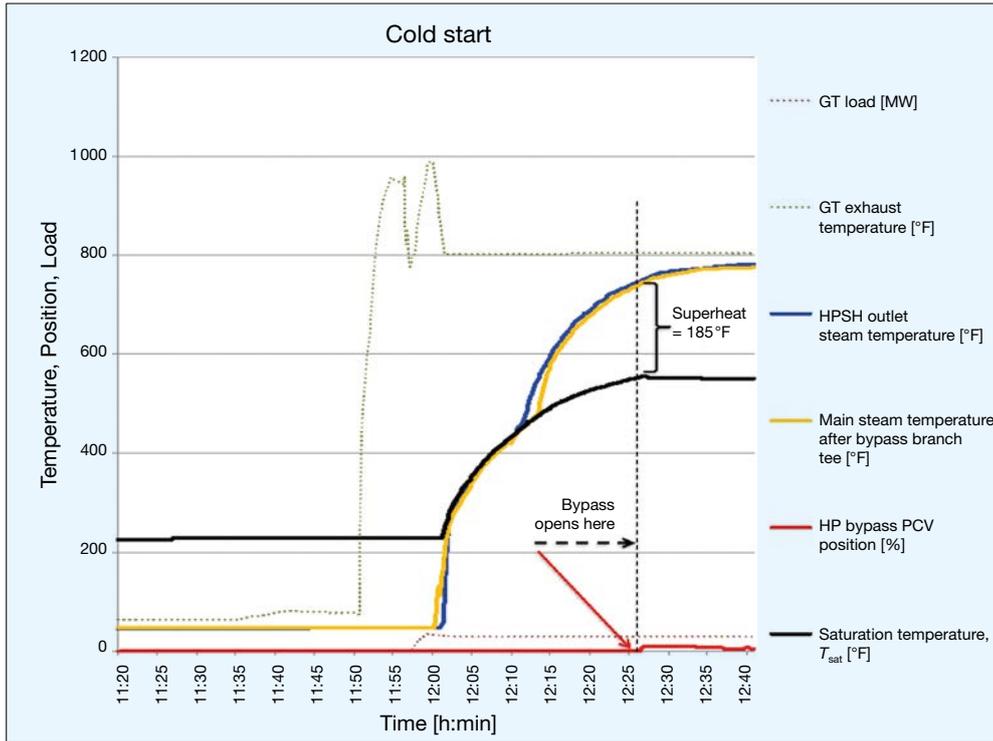
Figure 16: PCV opened after the main steam temperatures measured upstream and downstream of the PCV branch tee indicate superheat.

it is safe to open the PCV. Figures 16 and 17 present DCS data plots of main steam pipe temperature showing a PCV opened during startup after superheated steam is available to the PCV and one opened prior to dry superheated steam becoming available, respectively.

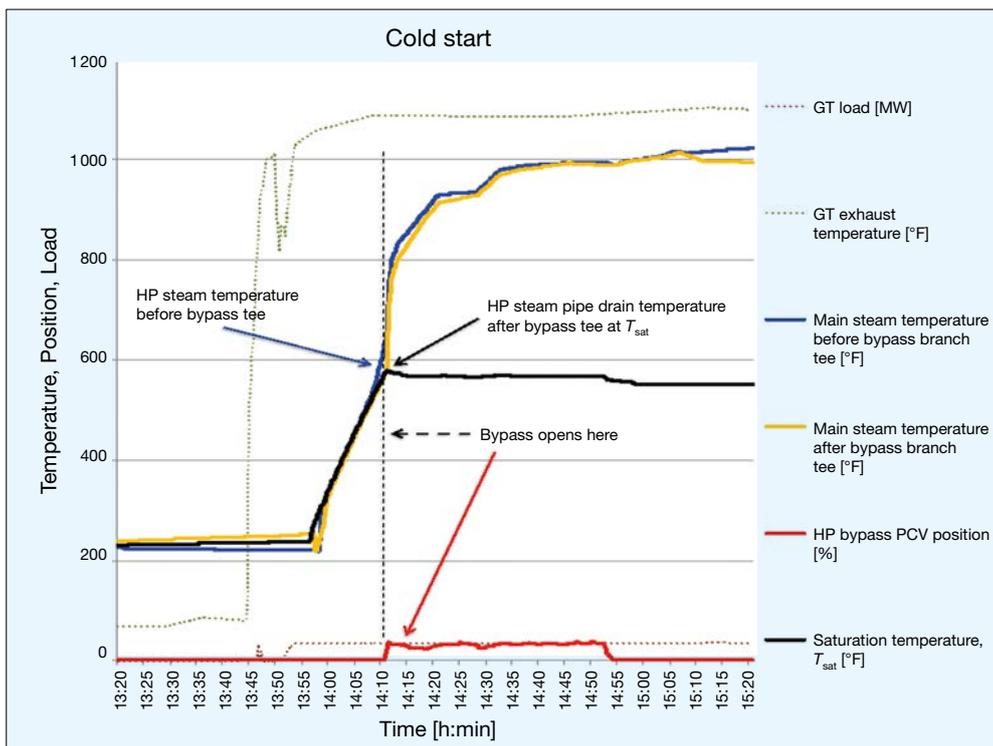
Figure 17: PCV opened before the main steam temperature measured downstream of the PCV branch tee indicates superheat.
