Assessing and Controlling Corrosion in Air-Cooled Condensers

R. Barry Dooley, J. Denis Aspden, Andrew G. Howell, and Francois du Preez

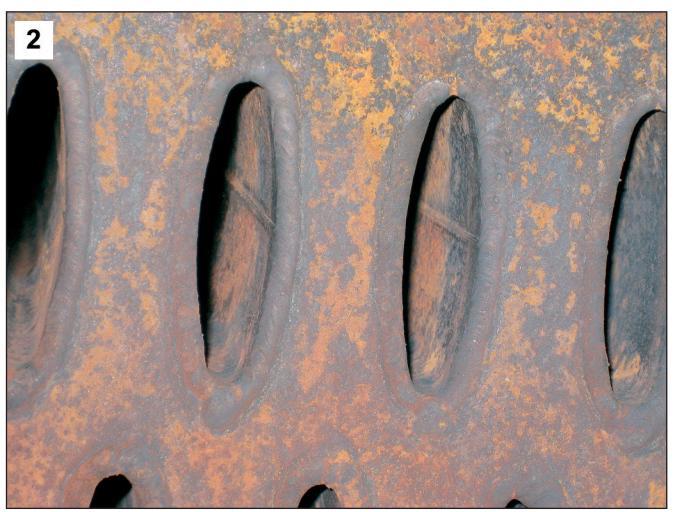
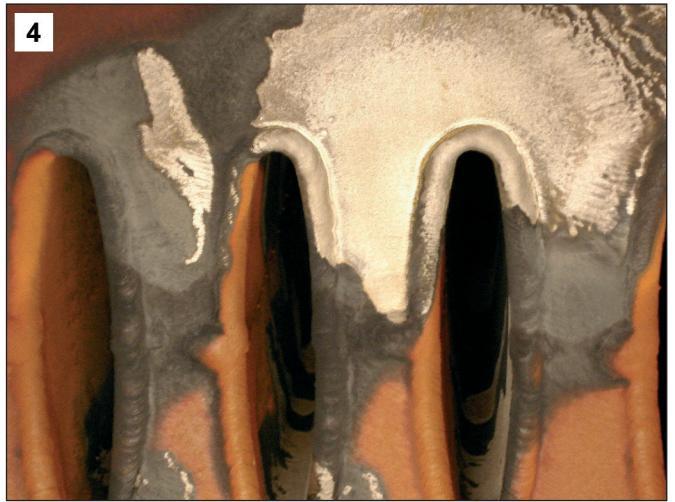
Figure 2: Montage illustrating DHACI indices 1–5 for the upper ducts and tube entries.

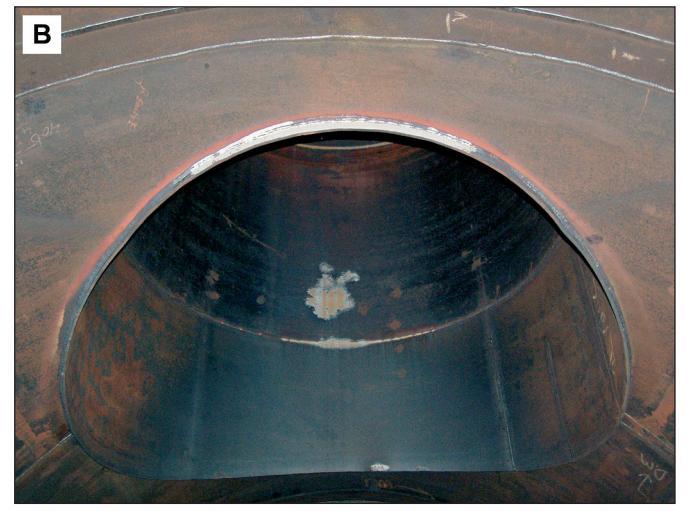
Montage illustrating DHACI indices A–C for the lower ducts from the steam turbine to the vertical risers to the upper duct.

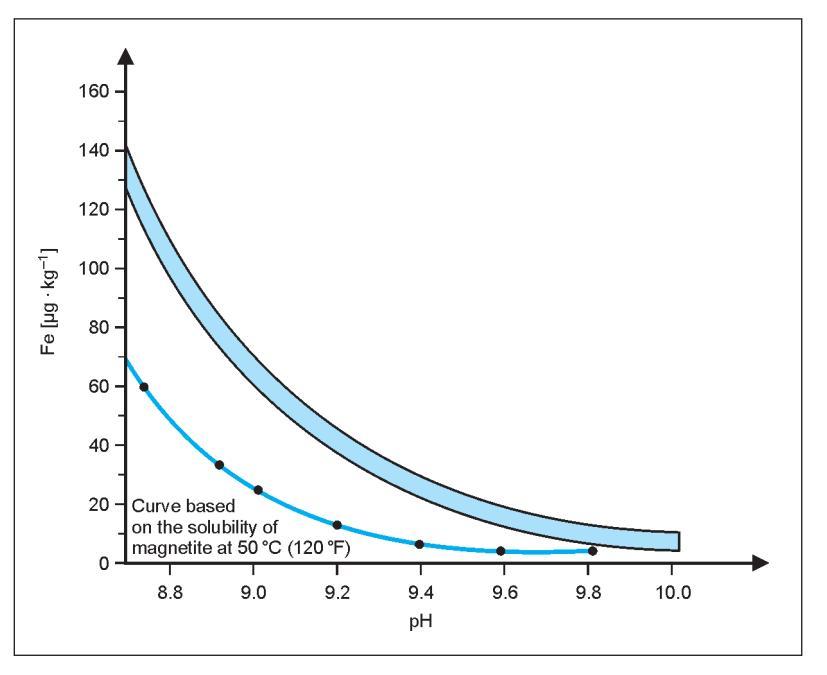
Figure 4:

The band in Figure 4 is about $5 \ \mu g \cdot kg^{-1}$ wide to allow for uncertainty associated with the data from many organizations, but does have a strong track record around the world for units with ACCs using only ammonia conditioning for pH control. The relationship shows that these plants require a condensate/feedwater pH of at least 9.8 to achieve acceptably low iron levels at the condensate pump discharge. Alternatively, operating at the normal pH range associated with normal oxygenated treatment of between 8.0 to 9.0 would be absolutely disastrous for the ACC as has been illustrated [7,8]; high levels of corrosion will ensue at the tube entries and failures in the ACC can be expected. The high levels of iron will also completely over-

Figure 4 also shows the solubility of magnetite extracted from Sturla [6] at the approximate temperature of the tube entries of an ACC (50 °C (120 °F)). The practical corrosion curve in the figure is elevated above this normally accepted magnetite solubility relationship by some considerable amount and shows for instance that at pH of 8.8 the ACC relationship is higher by 40–50 μ g \cdot kg⁻¹ and at pH of 9.2 it is higher by about 30 μ g \cdot kg⁻¹. Only at pH of 9.8 and above do the curves become convergent. This suggests that the corrosion process at the lower pH range is faster or more aggressive than a normal classical two-phase FAC process [9] which may relate to the severe turbulence created by the tube entries.

Iron levels measured at condensate pump discharge on units with ACC and only using ammonia for pH control. The iron solubility data which is extracted from Sturla [6] at 50 °C is shown only as an example as actual operating temperatures at the ACC tube entries may be higher, as discussed in the text.

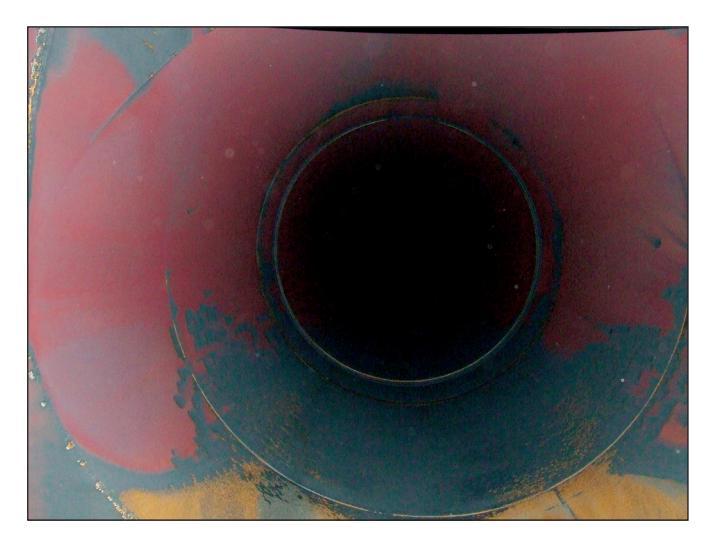
Figure 14: Corrosion pattern in branch H2-V3 (Figure 7). DHACI C.

The effect of the moisture content in the exhaust steam is well illustrated in Figure 14, which shows the branch H2-V3. On the downstream side of the branch a large bare metal area is visible with patches of flash rust, while the rest of the branch circumference is well protected with a stable oxide layer. Due to centrifugal action the free moisture in the exhaust steam impinges on the downstream side of the branch, resulting in the corrosion pattern shown in the figure.
