ROOT CAUSES OF TRANSIENT TUBE TEMPERATURE ANOMALIES MEASURED IN HORIZONTAL GAS PATH HRSGS

J. M. Pearson,
J. Michael Pearson & Associates Co.Ltd.
1 Bela Court, Caledon East, Ontario, L0N1E0, Canada
R. W. Anderson
Florida Power Corporation, St Petersburg, Florida

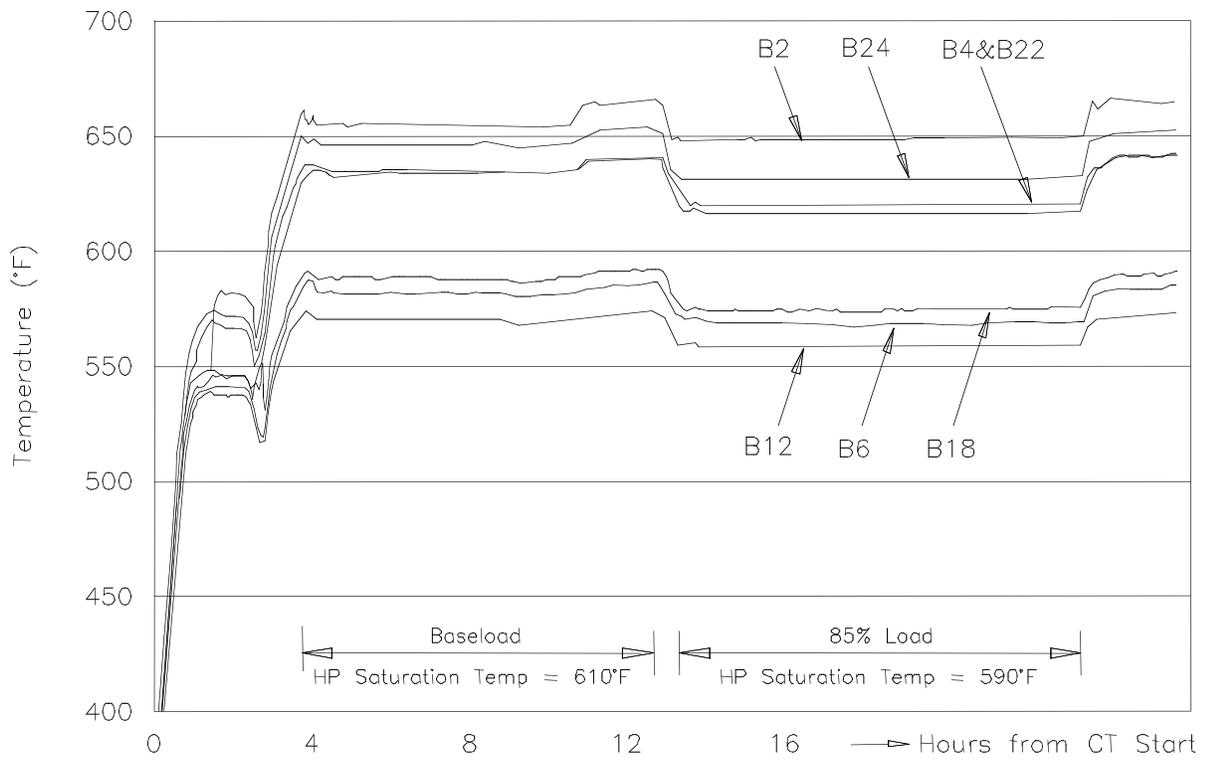
Fig. 9 – HP Final Economizer Module – Final Hairpin Tubes Below Bend

thermocouple remain 15 to 45°F above the saturation temperature of feedwater in the tubes and close to the gas inlet temperature to the section, indicating that the upper parts of these tubes are dry, and whatever water is in the lower parts of these tubes is stagnant. The other three tubes with thermocouples, and probably the majority of the hairpin tubes in the same row without thermocouples, operate with feedwater temperature about 25 to 45°F below saturation temperature. In the first hairpin tube row following the economizer inlet tubes one tube is vapor-locked or air-locked continuously and the adjacent hairpin tube is also obstructed by vapor for several hours, Fig. 10. The hairpin tubes with stagnated flow are those closest to the end of headers, which have a smaller pressure drop than those closer to the inlet and outlet branches, and are also most affected by leakage of any hot gas along duct sidewall and in the gap between adjacent modules. The stagnation of feed flow through the hairpin tubes at each end of the header also caused flow to stagnate or recirculate upwards in the end tubes of the inlet row of the economizer, Fig 11. Four of seven inlet row tubes installed with a thermocouple at tube inlet record temperatures of the order of 100°F above the temperature of the incoming feedwater.

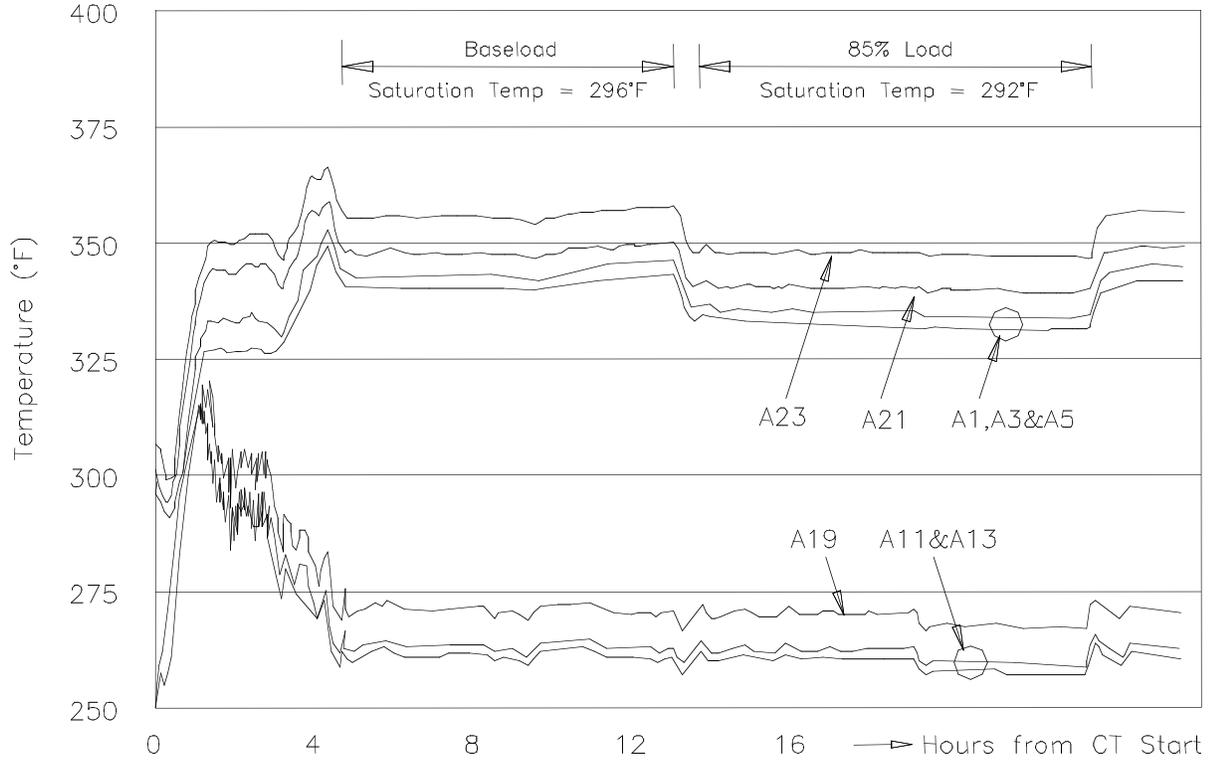
Fig. 12 – LP Economizer Module – Tubes Before Outlet to Outlet Header

The phenomenon, of large differences in temperatures of tubes in the same row attributed to air- or vapor-locks obstructing flow in some hairpin tubes, occurred consistently during many startups over several months. The phenomenon was equally evident and more pronounced in IP and LP economizers. For example, during the same event recorded for the final HP economizer in Figures 8 to 11, four of seven LP economizer outlet row tubes fitted with a thermocouple at their outlet end operated consistently between 35 and 70°F above saturation temperature and close to the gas temperature at the inlet to the LP economizer, Fig 12. Furthermore, after feedwater flow commenced the temperature of some tubes fluctuated numerous times during a single startup of the CT as they cleared and re-stagnated in synchronism with sharp changes in feedwater flowrate probably caused by the continually fluctuating system resistance as vapor obstructions were cleared from tubes and then returned, Fig 13.
