LESSON 4:

Hydrogen Damage

R. Barry Dooley and Albert Bursik

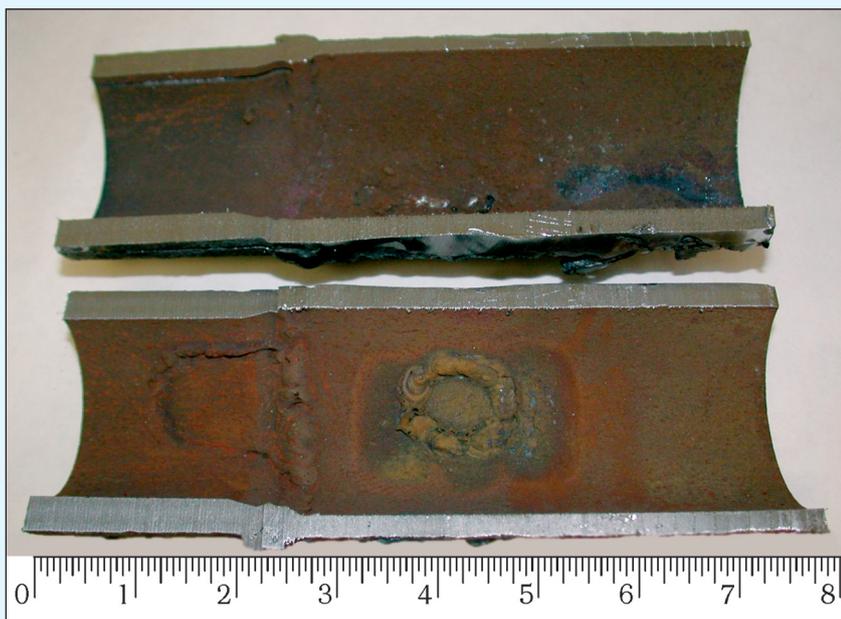
Figure 3:
Weld repair showing through to the tube inside becomes a flow disruption.

Figures 1–3 show some geometrical flow disruptors related to incorrect weld repairs.

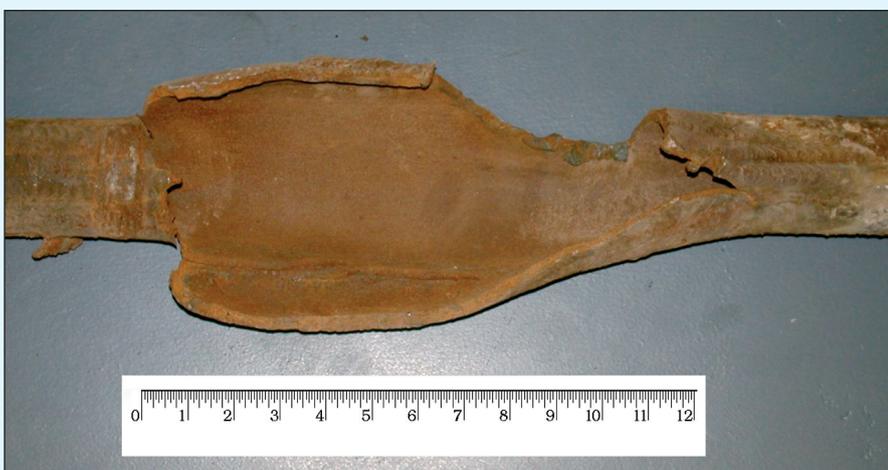
Figure 8:
Large hydrogen damage failure.

Figures 7 and 8 show hydrogen damage failures.
